LICENSEE EVENT REPORT (LER)

FACILITY NAME (1) SURRY POWER STATION, UNIT 1										DOCKET NUMBER (2) 0 5 0 0 0 2 8 0					PAGE (3) 1 OF 0 4	
---	--	--	--	--	--	--	--	--	--	---	--	--	--	--	-----------------------------	--

TITLE (4) SPURIOUS SAFETY INJECTION																
---	--	--	--	--	--	--	--	--	--	--	--	--	--	--	--	--

EVENT DATE (5)			LER NUMBER (6)			REPORT DATE (7)			OTHER FACILITIES INVOLVED (8)											
MONTH	DAY	YEAR	YEAR	SEQUENTIAL NUMBER	REVISION NUMBER	MONTH	DAY	YEAR	FACILITY NAMES				DOCKET NUMBER(S)							
1	1	6	8	4	0 2 4	0 0	1	2	1	7	8	4					0 5 0 0 0			
																	0 5 0 0 0

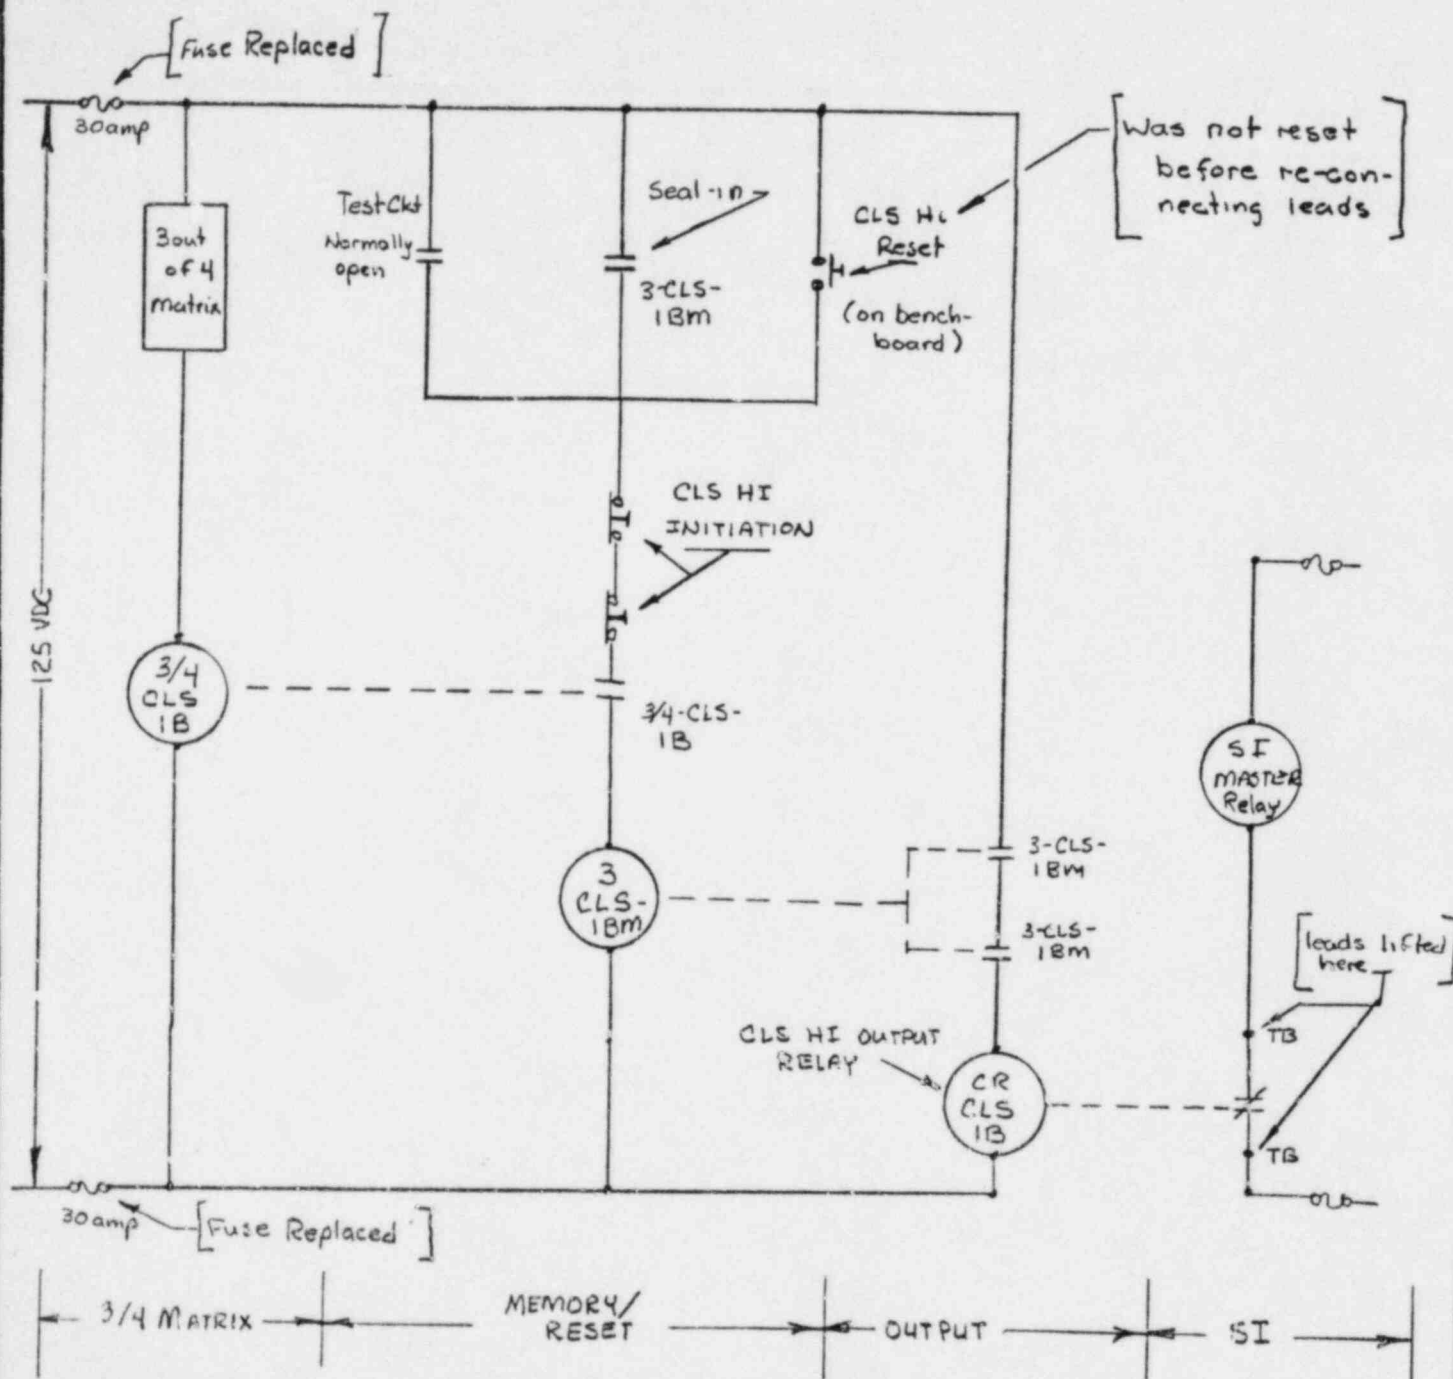
CLS-HI TRAIN B

The spurious SI was due to an inadequate procedure. The inadequate procedure was due to an oversight during the procedure development, review and approval process.

For the remaining discussion, refer to the attached figure. To prevent an inadvertent SI, whenever CLS-HI is de-energized, the interface between CLS-HI and SI must be removed (lifting of leads). Due to the arrangement of the CLS-HI relays, the CLS-HI memory circuit (3-CLS-1BM) must be reset before the CLS-HI/SI interface is re-instated. The controlling procedure did not require the resetting of CLS-HI, hence a spurious SI occurred when the CLS-HI/SI interface was re-instated.

Outstanding work procedures that required the de-energizing of CLS-HI were held in abeyance until the procedures could be modified to require the resetting of CLS-HI.
