SONGS 2 EMERGENCY DIESEL GENERATOR 2G003
CAMSHAFT ASSEMBLY FAILURE
RCE 91-022

EXECUTIVE SUMMARY

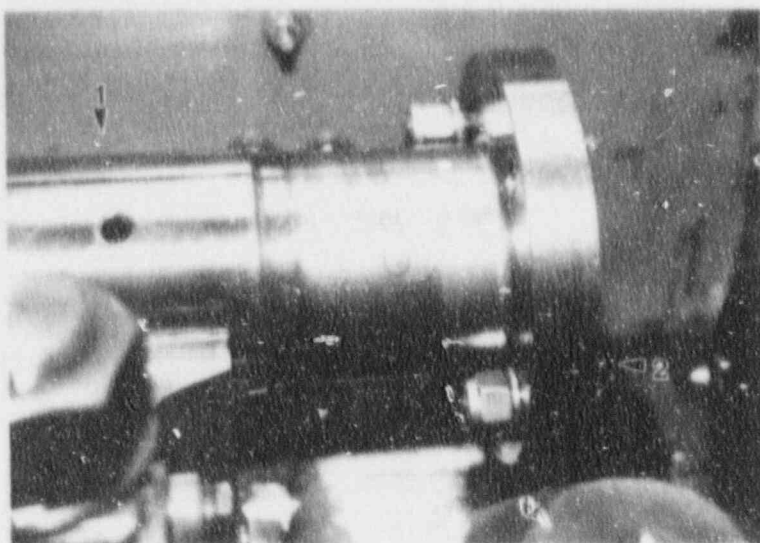
Figure B.3: View of the rear end of the left rear camshaft segment. Arrow 1 points to the camshaft bearing surface associated with camshaft bearing block number 1, and arrow 2 points to the broken dowel bolts at the separated camshaft to stubshaft flange connection. The good condition of the camshaft bearing surface for bearing block number 1 supports the accepted failure scenario, where the initiating event was the bearing cap coming loose.

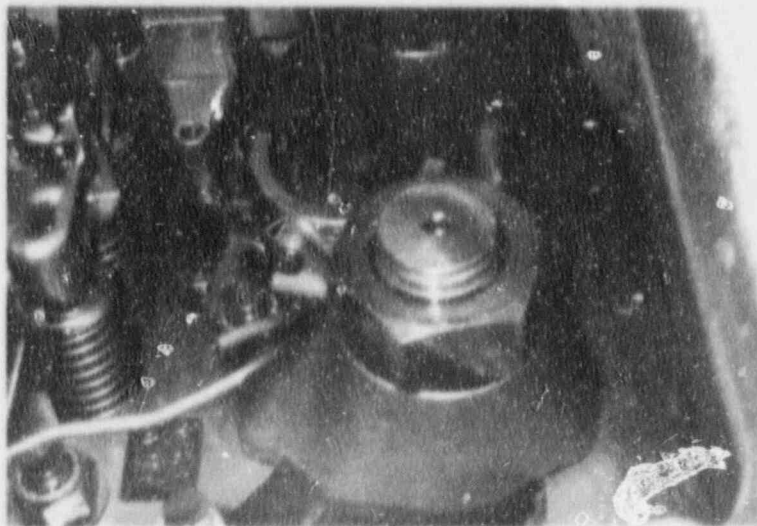
The inboard and outboard bolts from the Number 1 Camshaft Bearing Block were found loose on the top deck of the EDG indicating that the bolts came out of position during the event. A 5th order torsional resonance has been known to exist in the 20 cylinder engine, which caused a detrimental vibratory motion in the gear train and left rear camshaft assembly. This resonance coupled with normal vibration provided a motive force for the short bolts to lose preload and back out. Appendix D discusses in detail the 5th order torsional resonance.

Figure B.4: View of the left rear top deck area in the vicinity of cylinder number 20. The arrow points to bearing cap number 1, shown where it was found lying on the top deck.

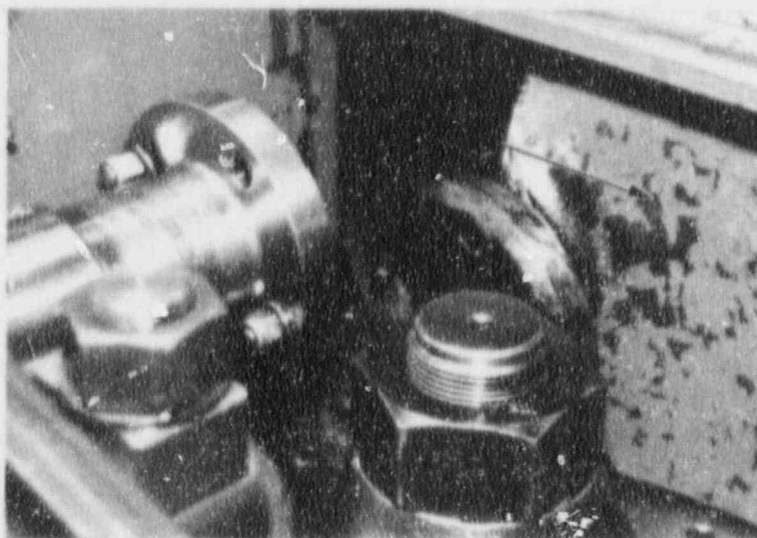
Figure B.5: View of the rear end of the left rear camshaft segment flange and the stubshaft flange. The arrow shows the direction in which the stubshaft moved after the bracket detached from the end sheet and the flange connection was pulled apart. Note, the deformation and discoloration of the end sheet. The chamfered wear surface on the stubshaft flange was the result of the flange rubbing against a crab bolt, when the camshaft gear and stubshaft continued to rotate, after the bracket detached from the engine.

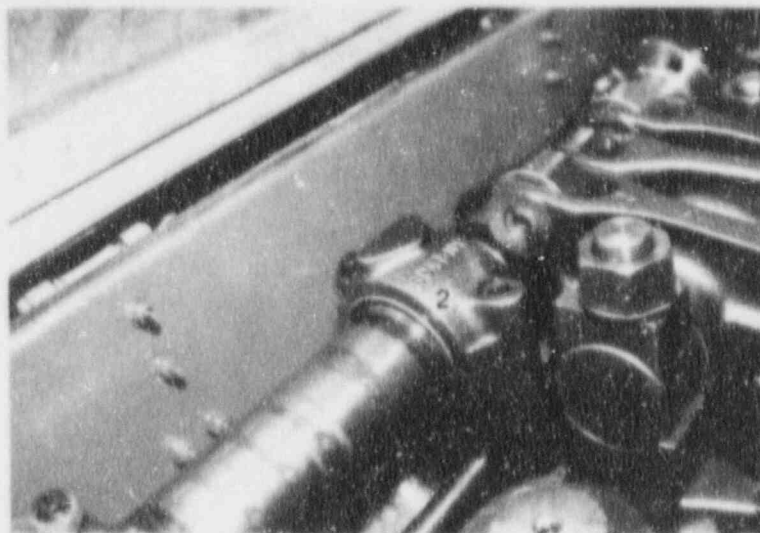
The outboard bolt of bearing block 2 was found lying on the top deck while the outboard bolt of bearing block 3 was found loose but in place. The outboard bolts on bearing blocks numbers 2 and 3 were short bolts. The outboard bolts of both bearing block 2 and 3 were found with approximately 5 deformed threads and the bolt holes had approximately 5 stripped threads indicating the bolts had lost preload and backed partially out, prior to being stripped out. The inboard bolts on bearing blocks 2 and 3 were correct length bolts. The inboard bolt on bearing block 2 was found loose, but not backed out, while the inboard bolt of bearing block 3 was found tight. The inboard bolt threads and hole threads for both bearing block 2 and 3 were basically intact but excessively worn. Thus, it is evident that the correct length inboard bolts in bearing block 2 and 3 held better in the event than the short bolts in the outboard locations of bearing blocks 2 and 3, and the short bolts in the inboard and outboard locations of bearing block 1.

Figure B.7: View of the left rear top deck and bearing block number 2. The inboard bearing block bolt was in place but loose, and the outboard bolt was found lying on the top deck.

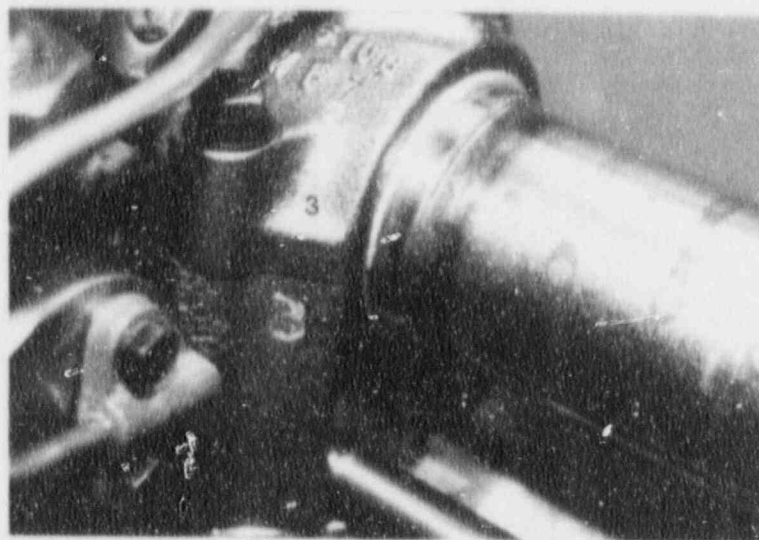
Figure B.8: View of the left rear top deck and bearing block number 3. The inboard bearing block bolt was found in place and tight, and the outboard bolt was found in place but backed out a few threads.

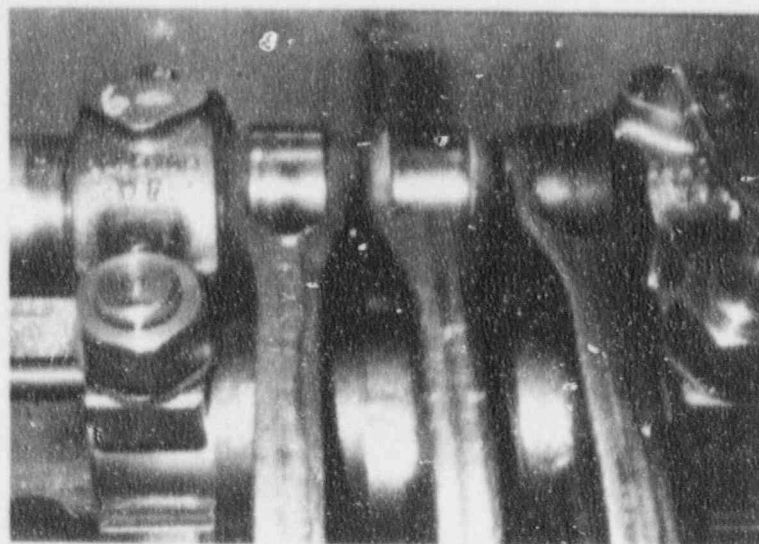
Figure B.9: View of the left rear top deck and bearing blocks number 5 and 6 which correspond to cylinder number 18. Note, the lack of lubrication damage and discoloration of the rocker arm rollers, and the charred material sprayed on the top deck.

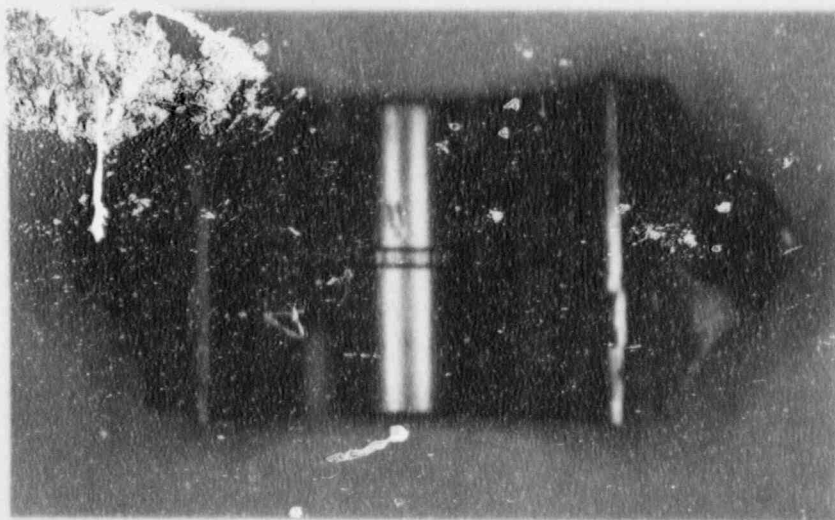
The bearing shells for camshaft bearing block number 1 were found to be free of damage while most of the downstream bearings were found to be damaged due to inadequate lubrication. This indicates that bearing block number 1 was the source of the loss of lubrication for the downstream bearings.

Figure B.11: View of the bearing surface of bearing block number 1. Note, there is no loss of lubrication damage, which supports the accepted failure scenario, where the initiating event was the bearing cap coming loose.

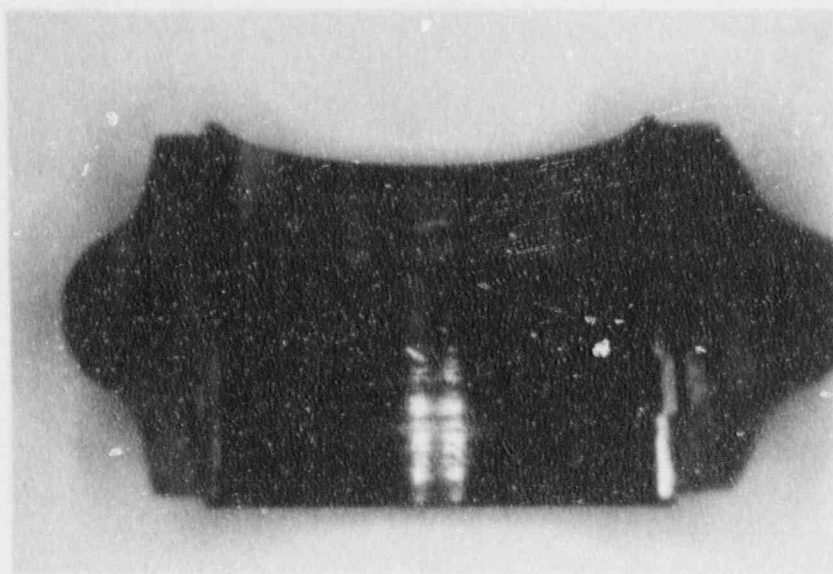
Figure B.12: View of the bearing surface of bearing block number 5. Note, the damage due to loss of lubrication.

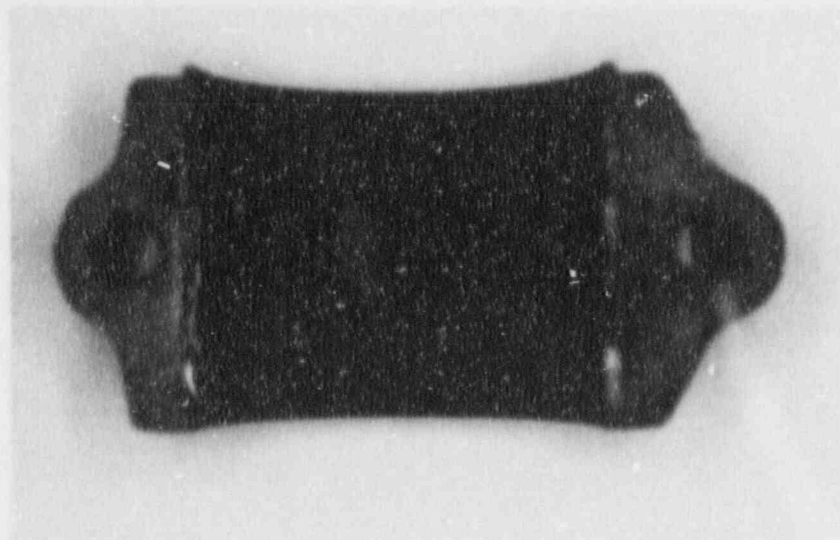
Figure B.13: View of the bearing surface of bearing block number 20. Note, the damage due to loss of lubrication. The lack of lubrication damage was greatest in this area.

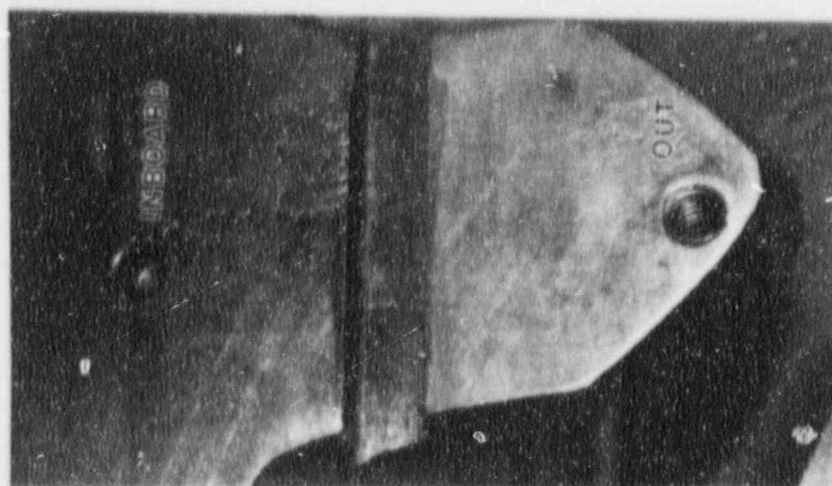
On bearing block 1, the threads of the outboard bolt and bolt hole were found intact indicating that the outboard bolt must have lost preload and backed completely out under vibration. The first approximately 5 threads of the inboard bolt were deformed and the first approximately 5 threads of the bolt hole were stripped, indicating that the inboard bolt lost preload, vibrated partially out, and then was pulled out. Since approximately 6 1/2 threads is the engagement of a short bolt, the bolt had vibrated approximately 1 1/2 threads out, 1/16 inch, prior to being stripped out. The inboard and outboard bolts for bearing block number 1 had polished areas and wear marks corresponding to the bolts coming loose, backing out, and vibrating in place for sometime.

Figure B.14: View of engine block top left deck at the location of camshaft bearing block number 1. Note, approximately 5 threads of the inboard bolt hole are stripped while the threads of the outboard bolt hole are basically intact. The condition of these bolt holes supports the accepted failure scenario, where the initiating event is the bearing cap coming loose as a result of the bolts losing preload. Both the inboard bolt and outboard bolt were found to be short.

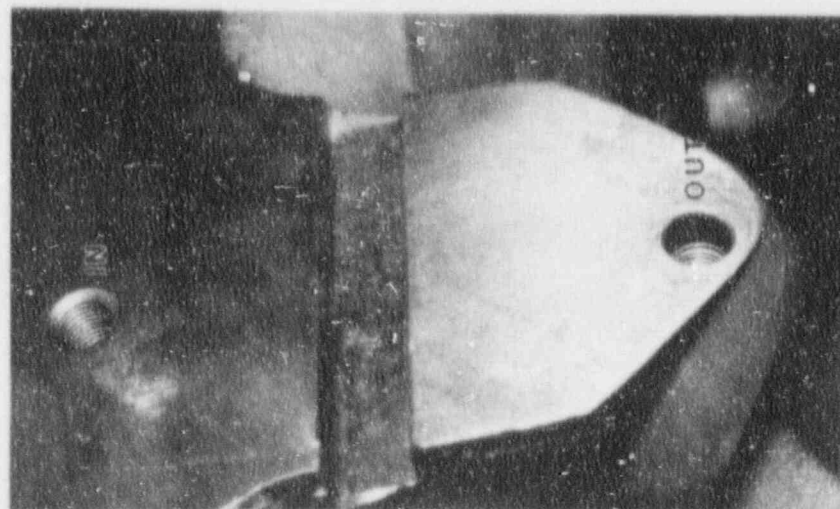
Figure B.15: View of engine block left top deck at the location of camshaft bearing block number 2. Note, the threads of the inboard bolt hole are basically intact while approximately 5 threads of the outboard bolt hole are stripped. The inboard bolt was found to be the correct length while the outboard bolt was found to be short.

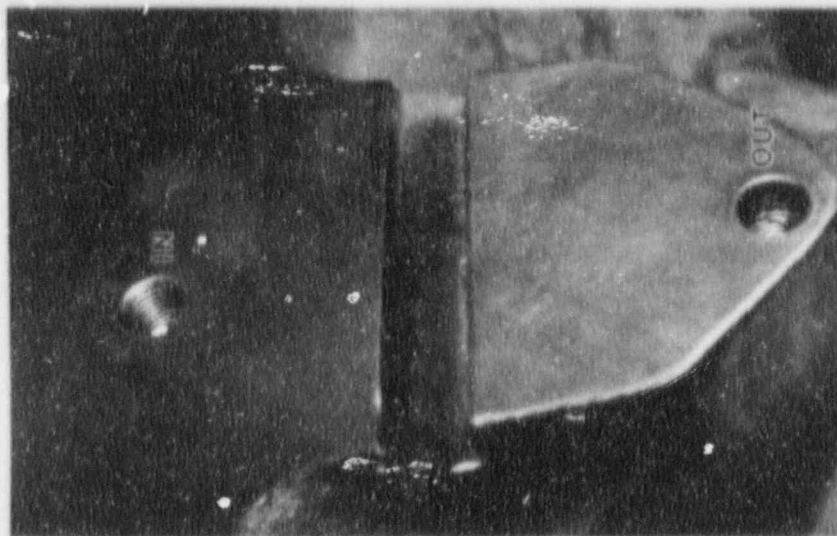
Figure B.16: View of engine block left top deck at the location of camshaft bearing block number 3. Note, the threads of the inboard bolt hole are basically intact while approximately 5 threads of the outboard bolt hole are stripped. The inboard bolt was found to be the correct length while the outboard bolt was found to be short.

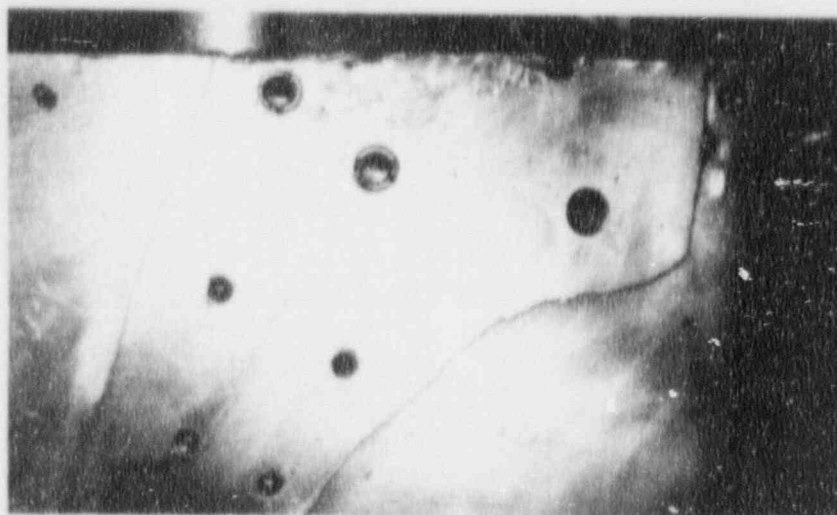
The camshaft stubshaft bracket detached from the end sheet shortly before the camshaft to stubshaft flange connection separated due to the evidence of material deformation on the top of the end sheet, and the absence of flange wear marks which would indicate that the flange connection failed first.

Figure B.17: Side view of the left rear end sheet at the location of the stubshaft support bracket. Note, the deformation of metal cause by a hammering of the bracket against the end sheet, for a short time, after the bracket detached from the end sheet.

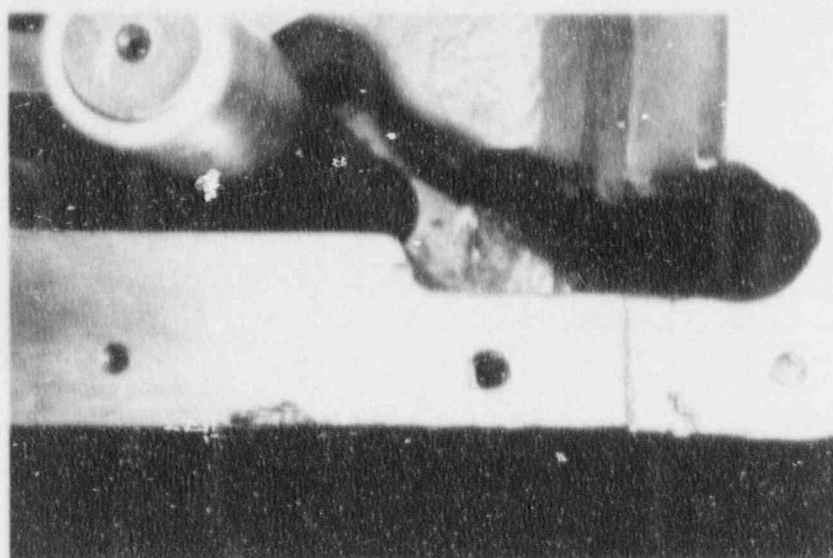
Figure B.18: Top view of the left rear end sheet at the location of the stubshaft support bracket. Note, the deformation of metal cause by a hammering of the bracket against the end sheet, for a short time, after the bracket detached from the end sheet.

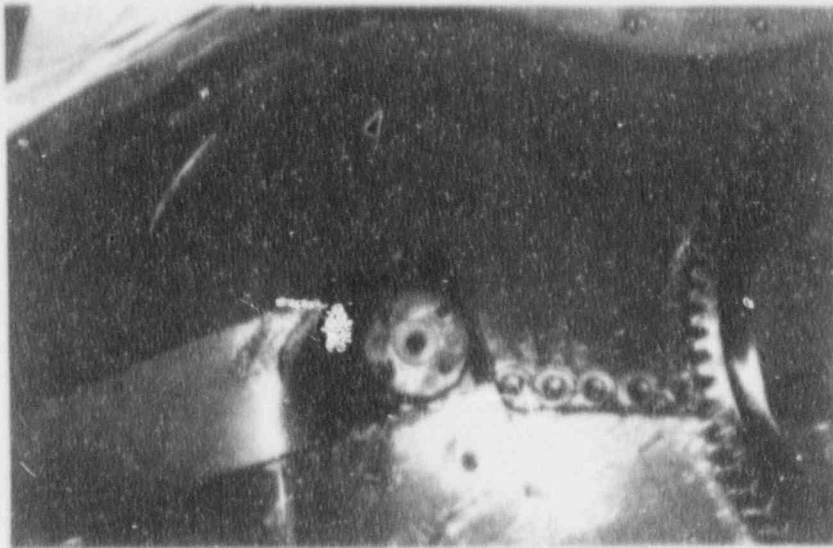
Figure B.19: Side view of the left rear end sheet. Note, the arrow shows where the camshaft gear contacted the camshaft gear housing just prior to the bracket detaching from the end sheet, and after the bracket detached from the end sheet.

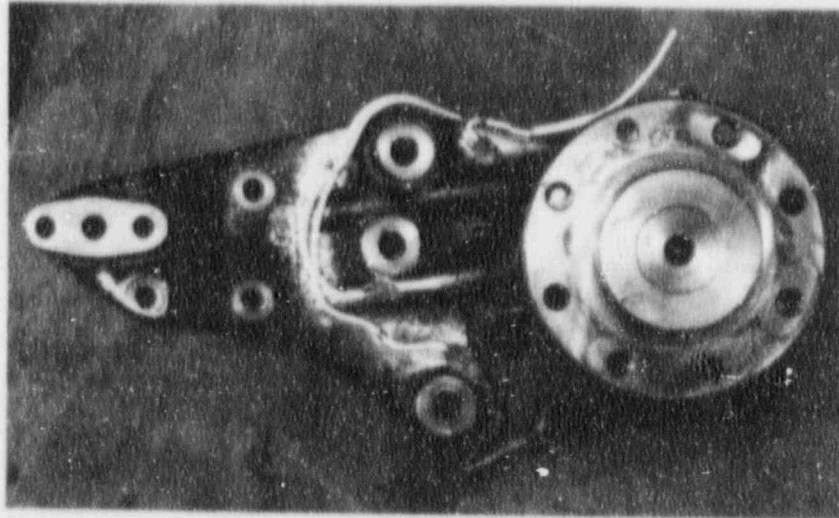
Figure B.20: View of the left rear stubshaft support bracket. Note, the bracket was not broken as in previous EDG failures. The wires are associated with strain gages which were used during previous testing of the bracket.

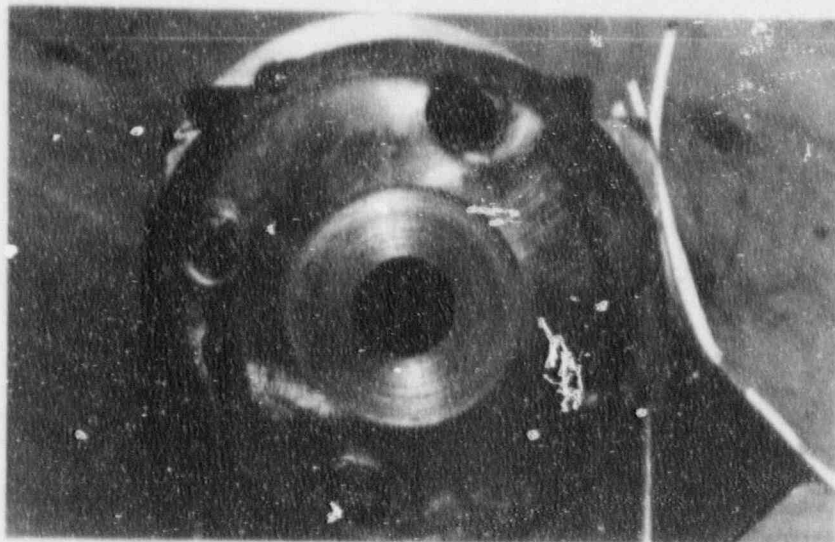
Figure B.21: View of the left rear stubshaft flange. Note, the elongation of the dowel bolt holes due to torsional loading of the flange as the camshaft was seizing, and rubbing against the crank bolt.

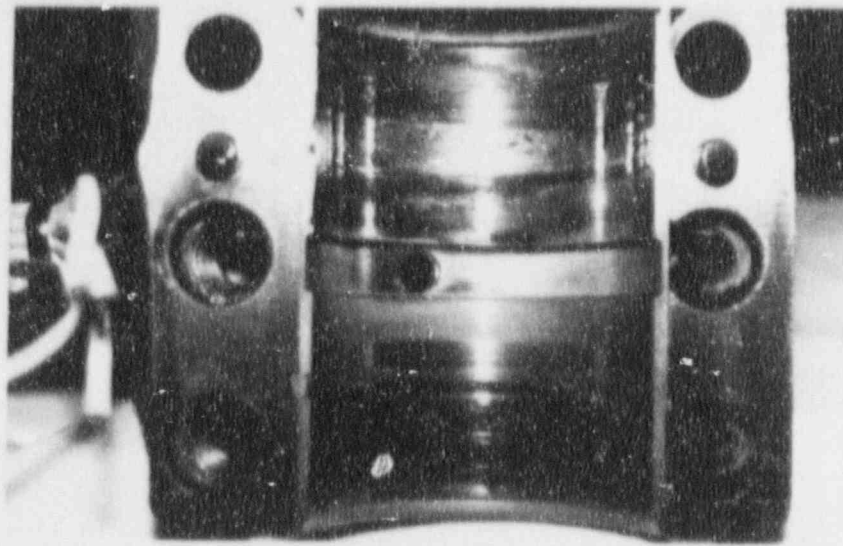
Note, the left rear stubshaft bracket bearing, which is upstream of bearing block number 1, was found with some damage due to severe camshaft gear vibration and loss of lubrication. However, the loss of lubrication damage has been attributed to a loss of lubrication flow after the bracket detached from the engine case, and the fact the camshaft gear continued to rotate on the idler gear until the engine was shutdown.

Figure B.22: View of the lower half of the stubshaft support bracket bearing. Note, the damage to the top half of the bearing surface was similar to the bottom half of the bearing. The damage has been attributed to severe camshaft gear vibration after the stubshaft flange began to fail, and a loss of lubrication damage after the bracket detached from the end shell and the camshaft gear continue to rotate on the idler gear.

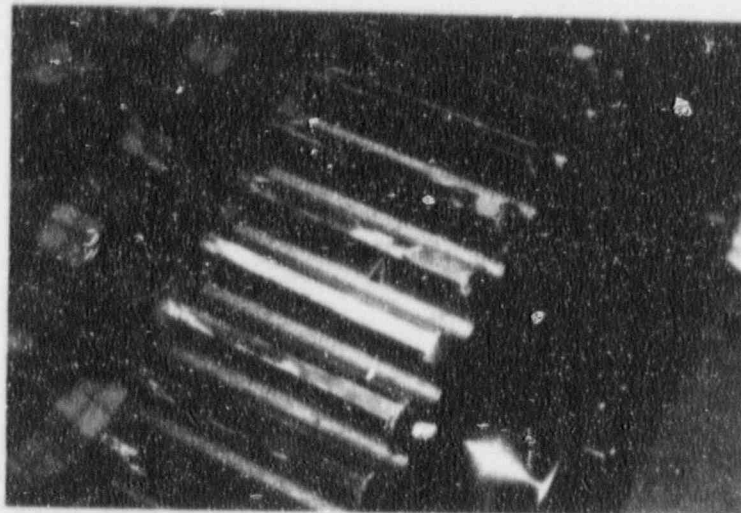
An inspection of the gear train revealed extensive damage with evidence of gear misalignment and broken bolts meshing between the gears.

Figure B.23: View of the teeth of the left rear camshaft gear. The arrow points to damage due to the meshing of a metal fragment in the gear train. Note, there was extensive damage to the entire gear train due to gear misalignment and the meshing of metal fragments.

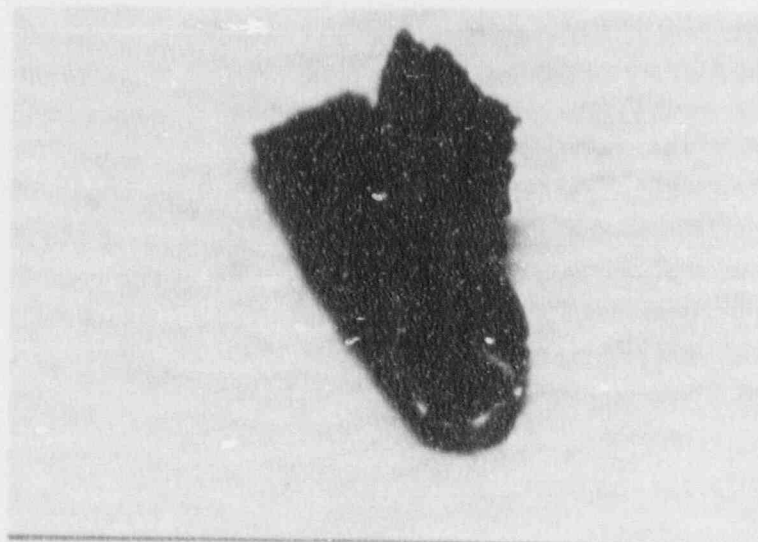
Figure B.24: View of a metal fragment that was meshed in the gear train. Note, the fragment has taken the shape of the gear teeth.

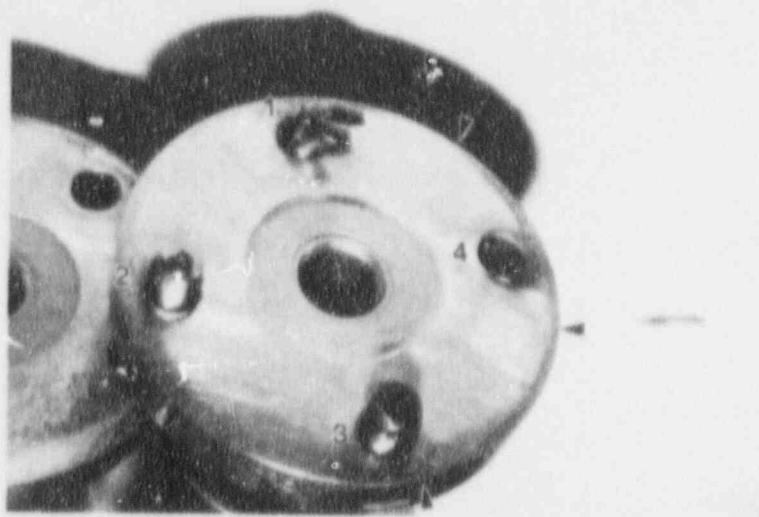
The camshaft flange was found with a crescent shaped polished wear mark in the vicinity of a dowel bolt hole indicating that one dowel bolt failed first and that the flange connection lost some rigidity during operation. The failure of the one dowel bolt resulted in increased vibration in the vicinity of the camshaft to stubshaft flange connection, the stubshaft bracket, and the camshaft bearing blocks. Appendix E discusses in detail the analysis of the stubshaft flange failure, and Appendix G discusses in detail the mechanical testing of the dowel bolts.

Figure E.1: View of the left rear camshaft flange with remnants of the 3 broken dowel bolts. The numbering of the bolts is arbitrary and for discussion purposes only. The arrows point to the crescent wear mark which indicated bolt number 4 fractured first. Note the bluish discoloring and deformation of the broken bolts, and the elongation of the flange bolt holes.

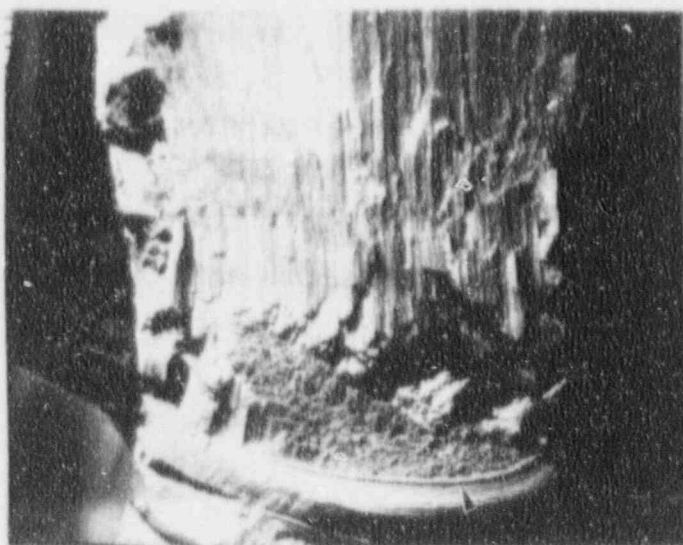
Figure E.6: SEM fractograph of fractured dowel bolt number 4, at 4 X magnification. The arrow points to fracture initiation.

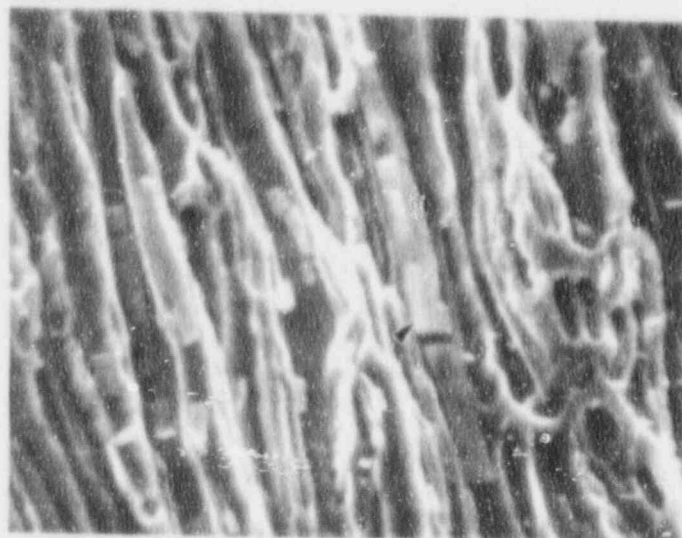
Figure E.8: SEM fractograph of fractured dowel bolt number 4, at 2000 X magnification. The arrow points to a sulfide inclusion.

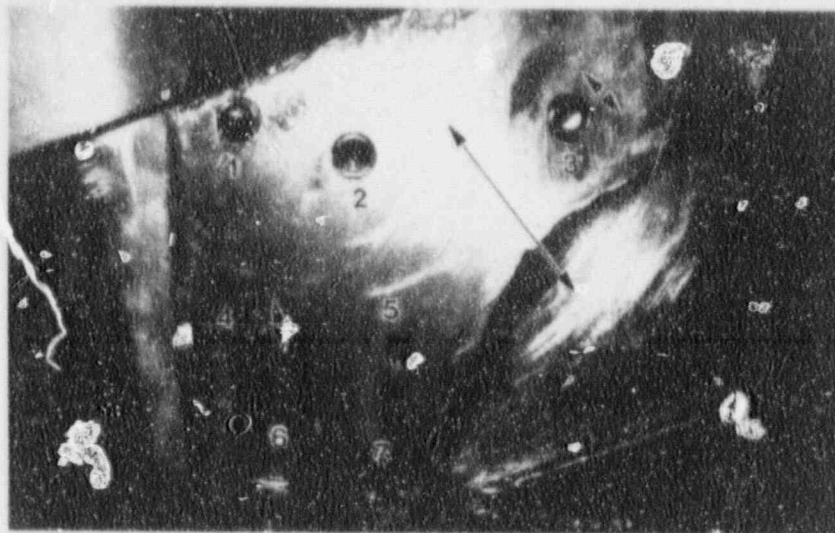
Figure F.1: Side view of the left rear end sheet at the location of the stubshaft support bracket. Note, bolt holes numbered 1-5 and 7 are the location of the primary bolts that attach the bracket, while bolt hole number 6, and a bolt hole directly below bolt hole number 6, attach the lubrication oil manifold to the bracket. The small arrows show the direction of reverse bending of the bolts while the long arrow shows the direction of reverse loading of the entire bracket.

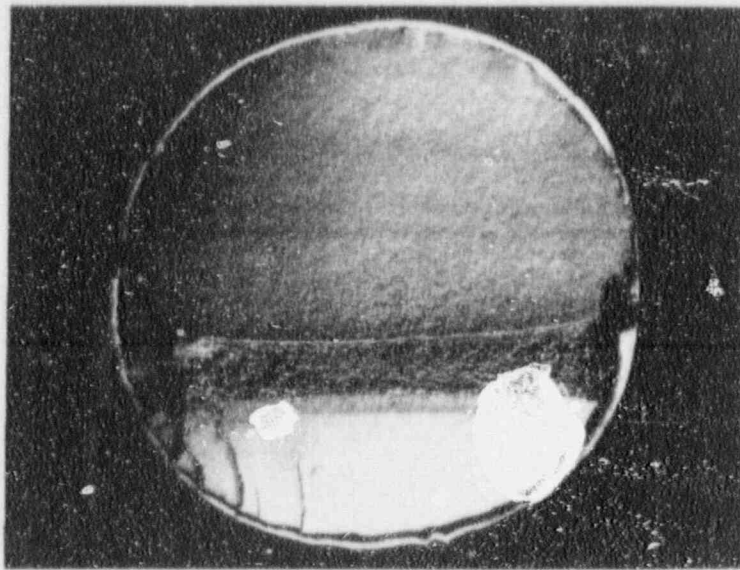
The 6 horizontal and 2 vertical bolts which hold the camshaft bracket to the end sheet failed by reverse bending fatigue followed by overload. Laboratory analysis determined that the bolts failed by overload after approximately 41,000 fatigue cycles. Since the EDG rotates at 900 rpm and is subject to 5th torsional resonance, 41,000 cycles equates to approximately 9 minutes of operation. Appendix F discusses in detail the failure analysis of the stubshaft bracket failure.

Figure F.4: SEM fractograph of bolt number 3, illustrating the reverse bending fatigue fracture. The width of the overload zone with respect to the overall cross-section was estimated to be 10 percent, indicating the fracture occurred under relatively low stress conditions.

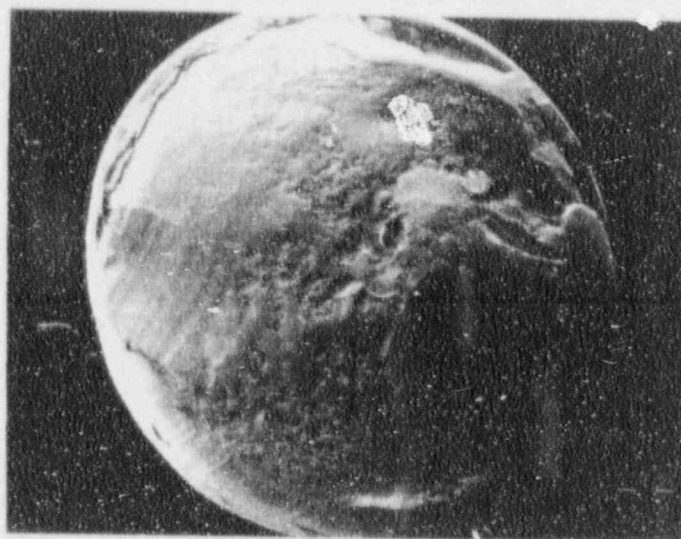
Figure F.13: View of the fracture surface of vertical bolt number 9, as shown in Figure F.2, which was significantly rubbed, but as determined by the mating fracture surface, the fracture was indicative of a reverse bending fatigue condition.

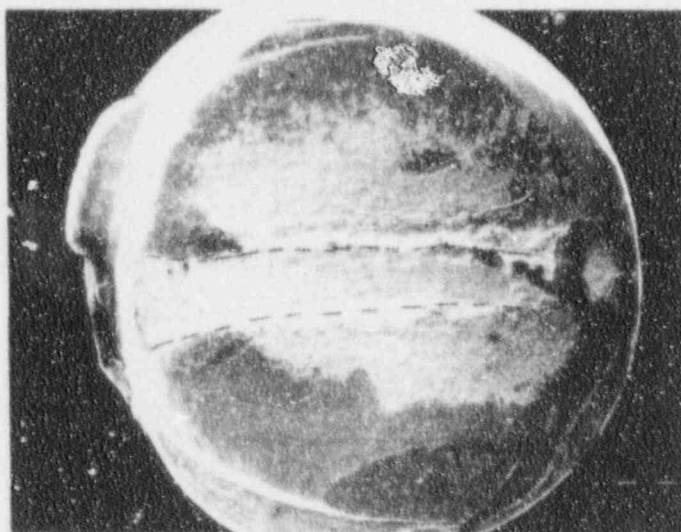
Figure F.14: View of the fracture surface of vertical bolt number 8, illustrating rubbing damage and reverse bending fatigue conditions. The location of the overload zone is in the center of the fracture face which is indicative of even reverse loading of bolt.

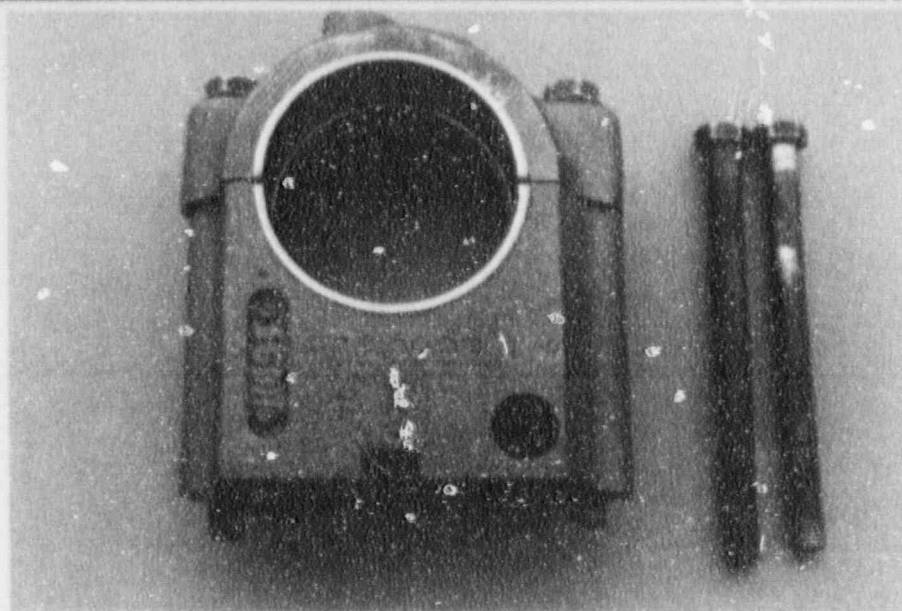
The inboard and outboard bolts on bearing block 1 were found to be a nominal 4 1/2 inches in length, rather than the 4 5/8 inches specified by the vendor manual. The bearing block bolt holes were worn due to previous failures and work activities. This resulted in less than normal thread contact area which contributed to the bolts losing preload and backing out. Appendix A briefly discusses the work history of 2G003, and Appendix C discusses in detail the short bolts and worn bearing block bolt holes. Appendix G discusses in detail the mechanical testing of bearing block bolts to determine the effect of short bolts.

Figure G.1: Typical camshaft bearing block, shown with a correct length bolt at the outboard (left) location and a short length bolt at the inboard (right) location. Also, a correct length and short length bolt are shown for comparison.

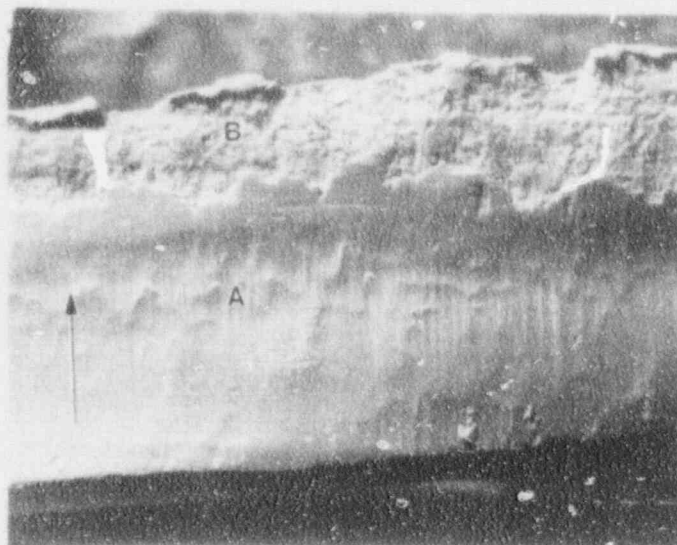
Figure G.3: Back scattered electron fractograph of the stripped threads found entrapped on the threads of the outboard bolt of bearing block number 3, illustrating the presence of rubbed zone (A) in a direction of the arrow and a relatively undamaged sheared zone (B), at 80 X magnification.

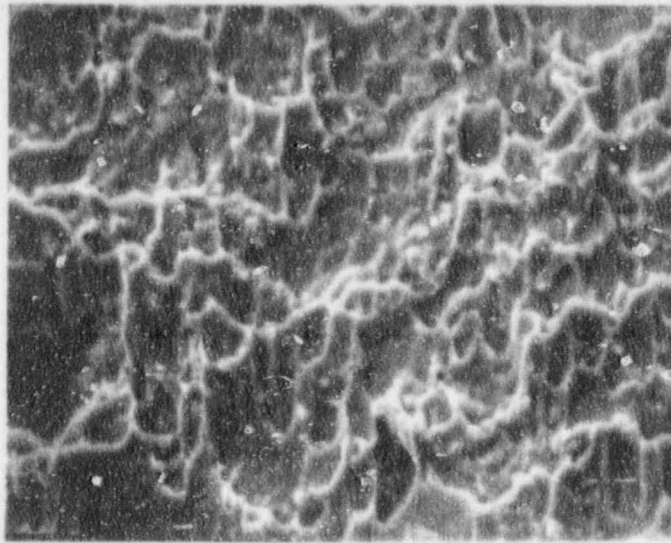
Figure G.4: Detail of sheared zone (B), as shown in Figure N.3, which illustrates elongated dimples typical of either a shear or tear fracture, at 1000 X magnification.

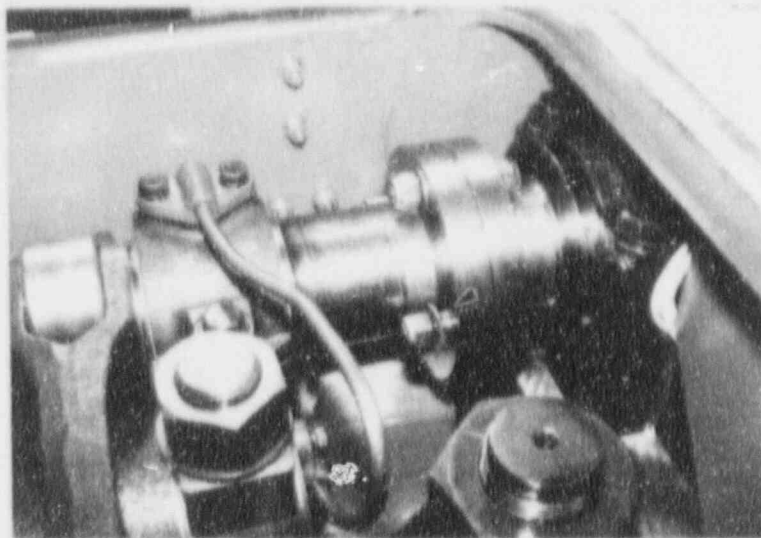
Figure K.1: View of the as-found condition of the degraded left rear camshaft to stubshaft flange connection on the 20 cylinder engine of 3G003. The arrow points to the dowel bolt that was found broken.

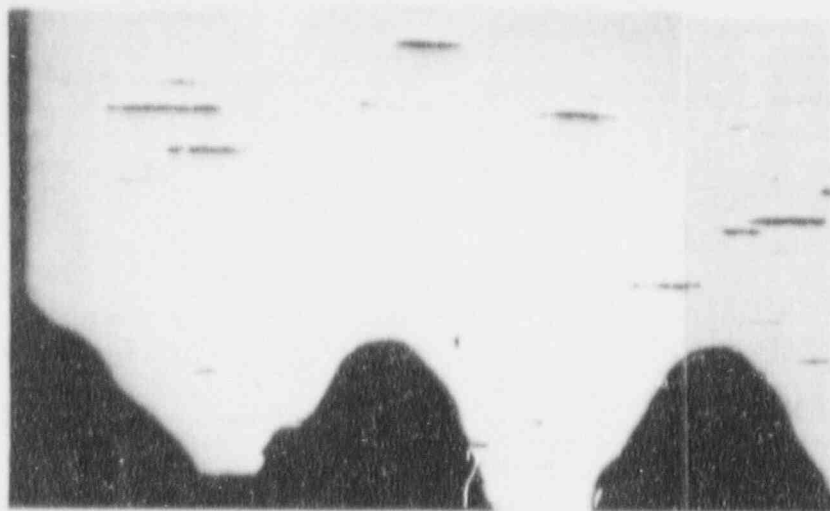
Figure K.4: An optical photograph of the longitudinal microsection of broken bolt 1, in the as-polished condition, illustrating the presence of large sulfide stringers and fine sulfide inclusions, at 50 X magnification.

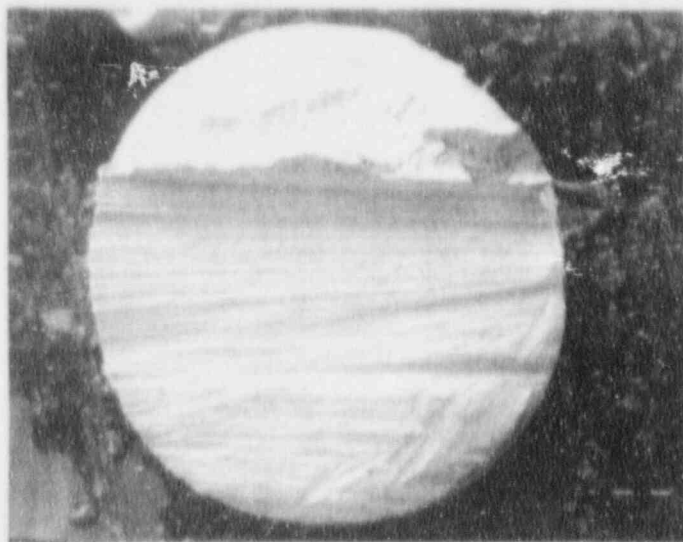
Figure K.7: A SEM fractograph of cracked bolt number 2, illustrating crack propagation to approximately 20 percent of the cross section of the bolt, at 6 X magnification.

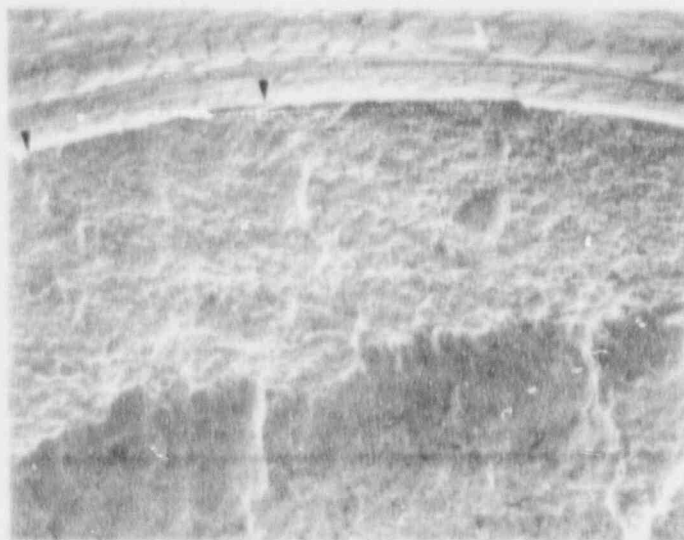
Figure K.8: A SEM fractograph of cracked bolt number 2, illustrating details of the fracture surface of the crack, with the arrows illustrating hackle marks, at 60 X magnification.

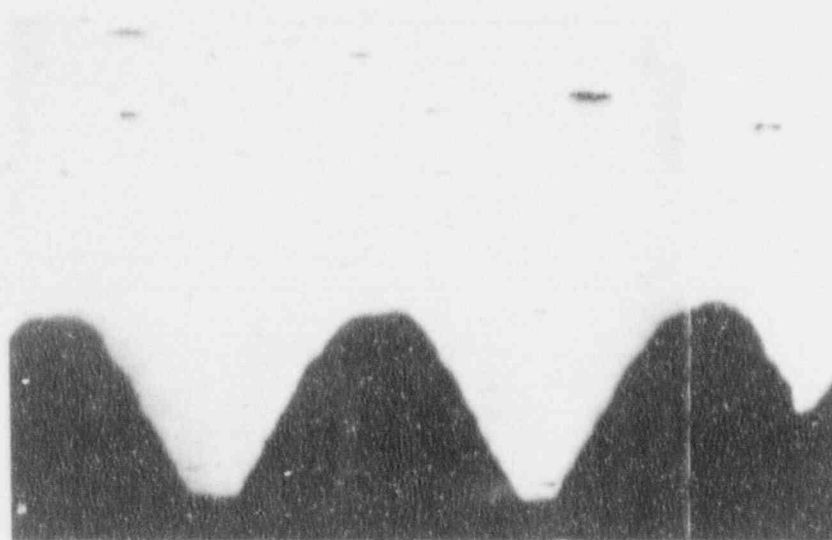
Figure K.9: An optical micrograph of cracked bolt 2, in the as-polished condition, illustrating the sulfide inclusion size and distribution, at 50 X magnification.

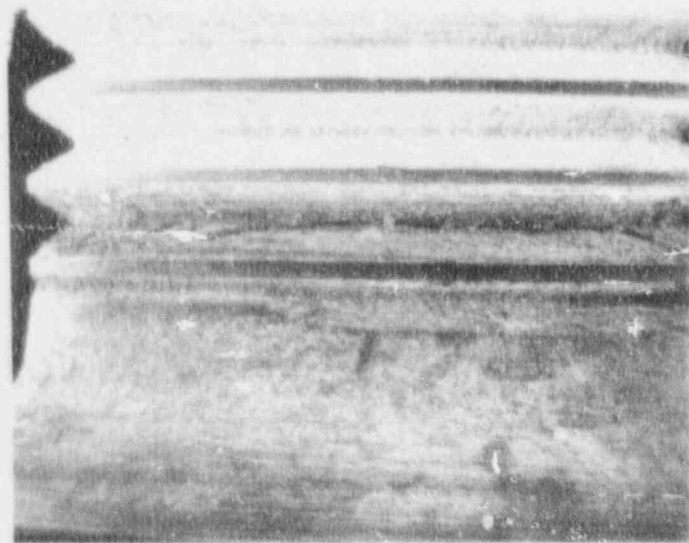
Figure K.11: A SEM photograph of cracked bolt 3, illustrating crack initiation the root of the first thread, at 10 X magnification.

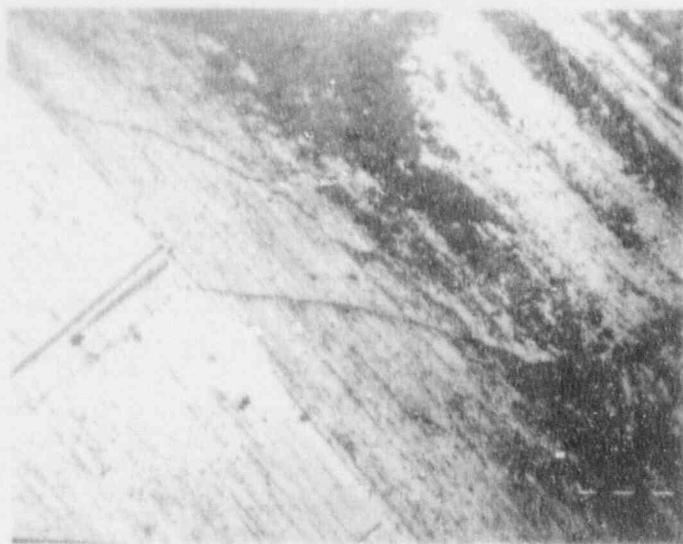
Figure K.12: A SEM photograph of cracked bolt 3, illustrating crack branching and propagation in the longitudinal direction, at 25 X magnification.

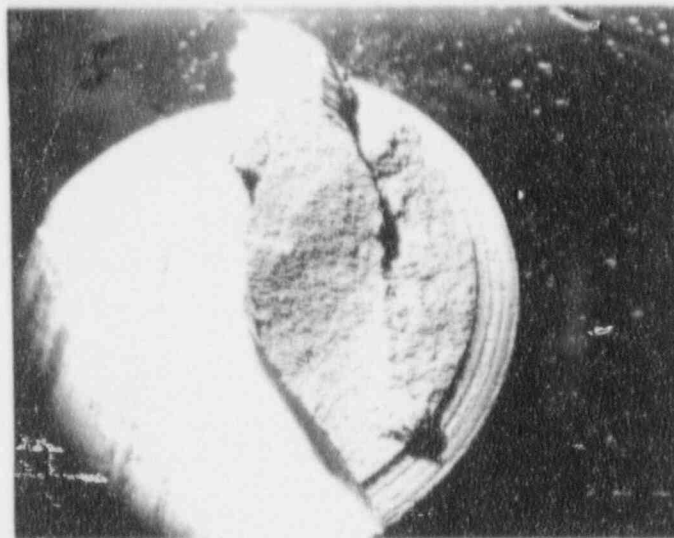
Figure K.13: A SEM photograph of cracked bolt 3, illustrating crack propagation to approximately 40 percent of the cross section of the bolt, at 9 X magnification.

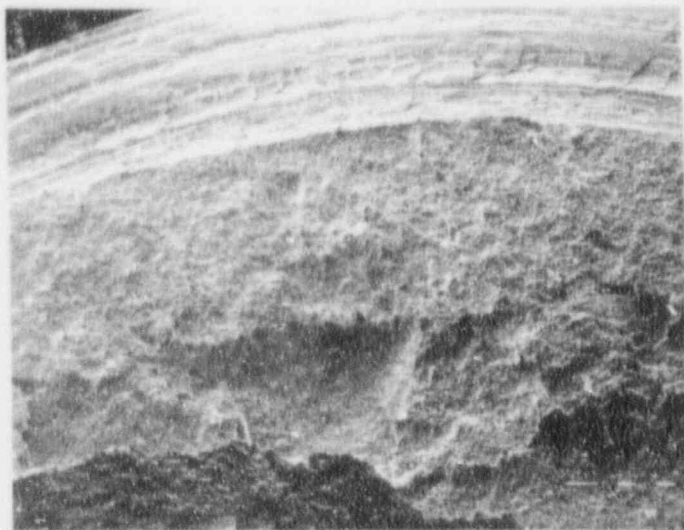
Figure K.14: A SEM photograph of cracked bolt 3, illustrating the fatigue fracture, at 50 X magnification.

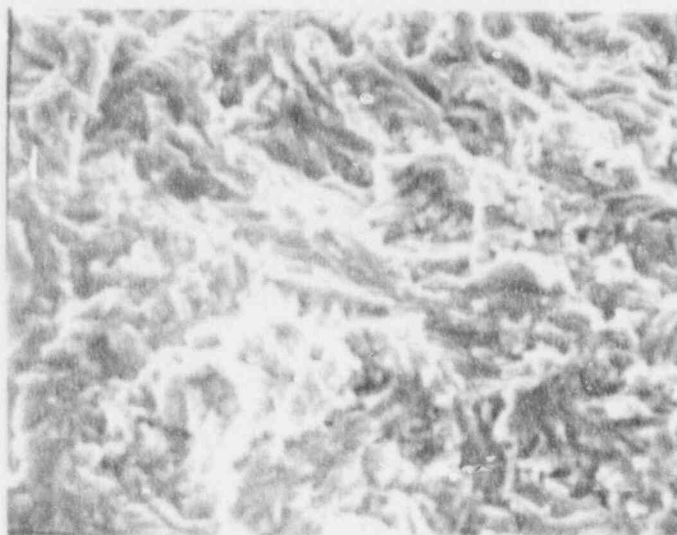
Figure K.15: A SEM photograph of cracked bolt 3, illustrating the fatigue zone of the fracture surface of the crack, at 1000 X magnification.

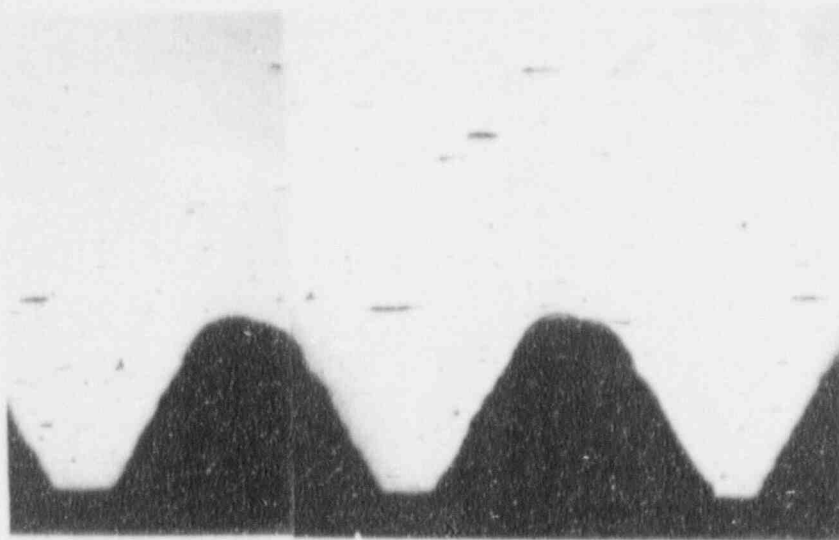
Figure K.16: A photograph of the longitudinal microstructure of cracked bolt 3, in the as-polished condition, illustrating the distribution and size of stringers, at 50 X magnification.

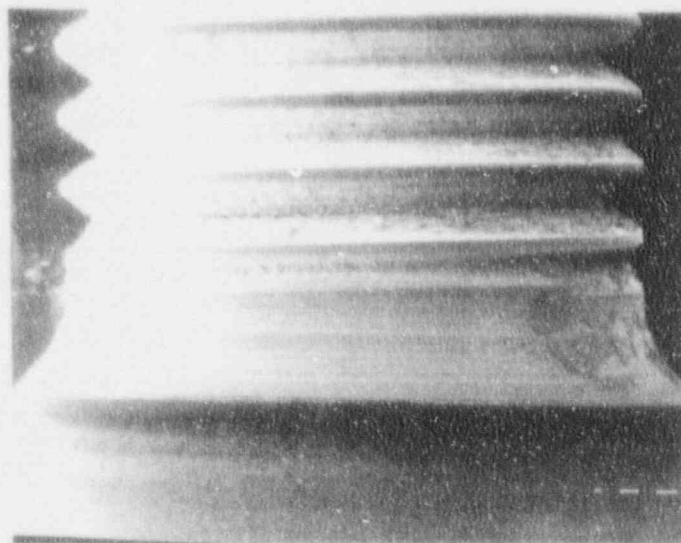
Figure K.18: A SEM photograph of cracked bolt 4, illustrating crack initiation the root of the first thread, at 7 X magnification.

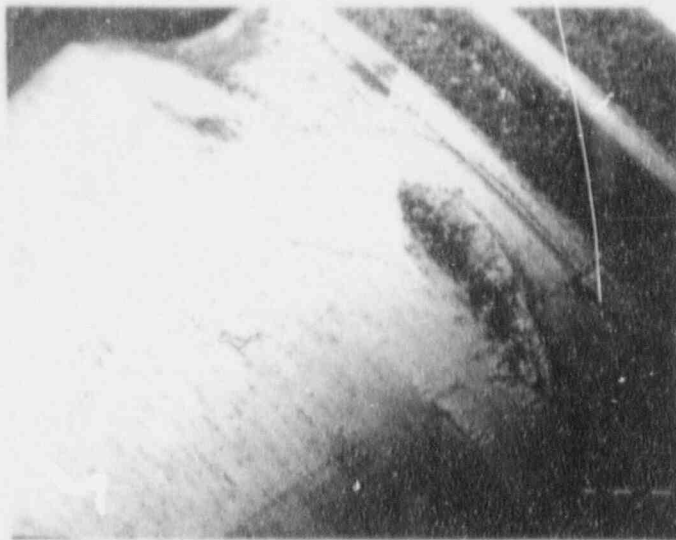
Figure K.19: A SEM photograph of cracked bolt 4, illustrating crack branching and propagation in the longitudinal direction, at 15 X magnification.

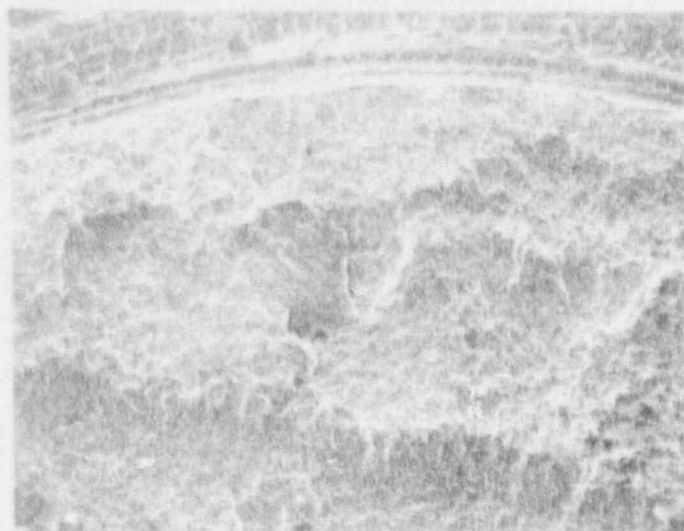
Figure K.21: A SEM photograph of cracked bolt 4, illustrating the fatigue zone of the fracture surface, at 50 X magnification.

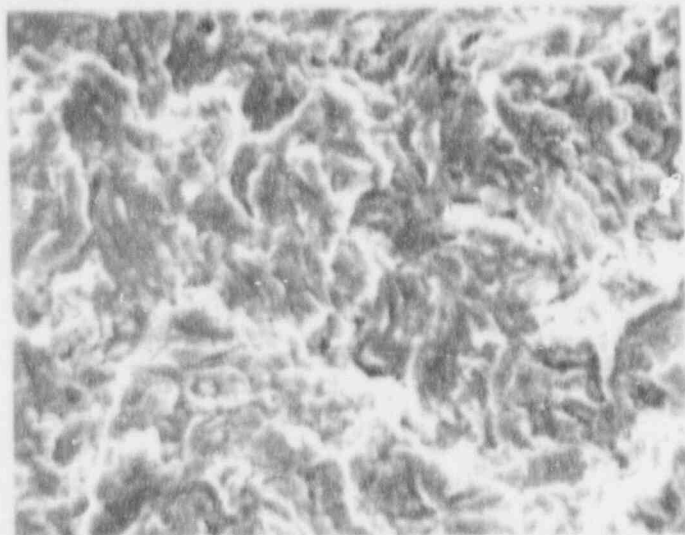
Figure K.22: A SEM photograph of cracked bolt 4, illustrating the fatigue zone of the fracture surface, at 1000 X magnification.
