SONGS 2 EMERGENCY DIESEL GENERATOR 2G003
CAMSHAFT ASSEMBLY FAILURE
RCE 91-022

EXECUTIVE SUMMARY

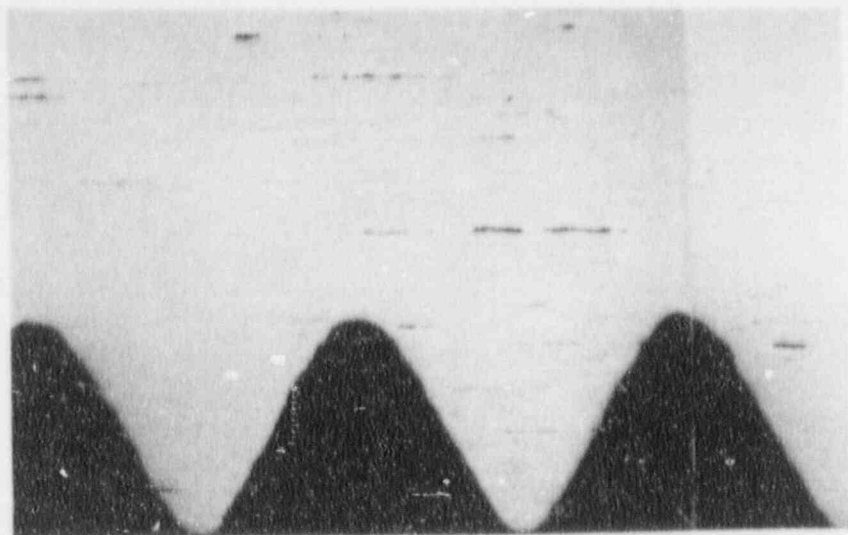
Figure K.23: A photograph of the longitudinal microstructure of cracked bolt 4, in the as-polished condition, illustrating the distribution and size of sulfide inclusions, at 50 X magnification.
