Houston Lighting & Power

June 18, 1992
ST-HL-AE-4125
File No.: G26
10CFR50.73

South Texas Project
Unit 1
Docket No. STN 50-498
Licensee Event Report 92-004
Regarding Shunt Trip Contacts for Manual
Reactor Trip Breakers Not Tested per Technical Specifications

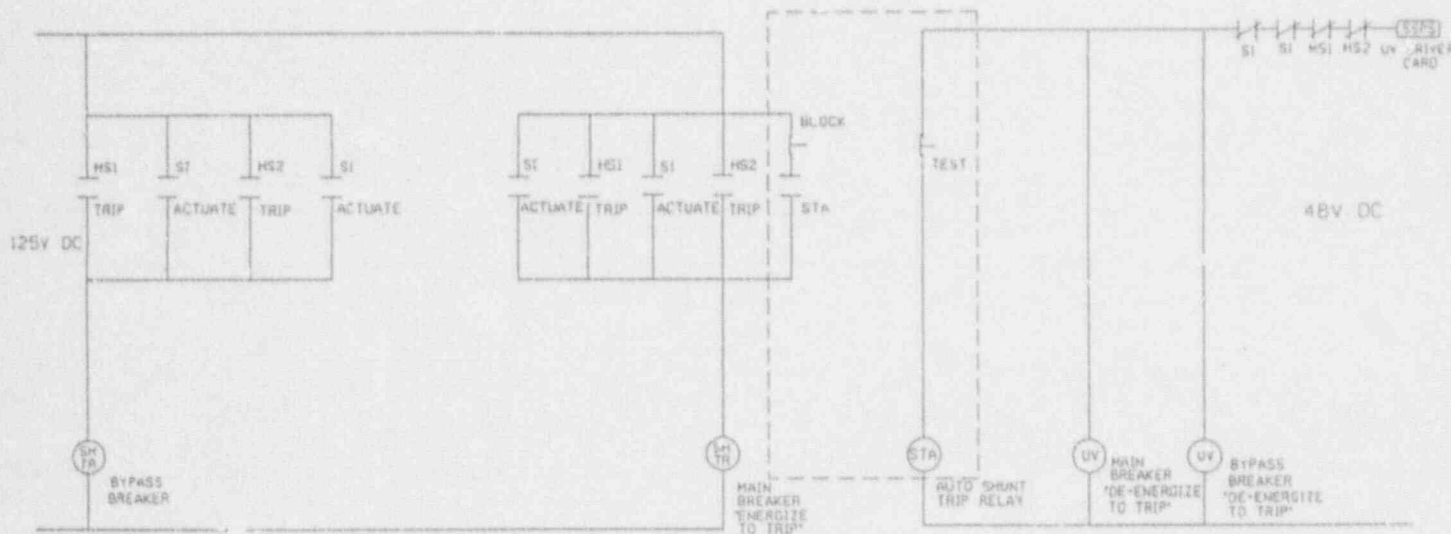
AUTO/MANUAL REACTOR TRIP CIRCUIT
TYPICAL TRAIN'S

The reactor trip breakers can be tripped by de-energizing the undervoltage (UV) device or energizing the shunt trip device. During performance of the test, the reactor trip handswitch is taken to the trip position. One set of contacts associated with the handswitch opens, which de-energizes the UV device and the auto shunt trip relay. De-energizing the auto shunt trip relay closes other contacts which completes a path to energize the shunt trip device and trip the breaker. This pathway is also energized during an automatic reactor breaker trip and is referred to as the automatic shunt trip feature. A second set of contacts associated with the handswitch if closed, completes a direct path to energize the shunt trip device and trip the breaker. This pathway would only function in the event of a manual reactor trip. The surveillance test procedure, as written, does not conclusively test the manual reactor trip pathway. The test procedure currently places the handswitch in the tripped position and then verifies that the UV device is de-energized and the shunt trip device is energized by taking voltage measurements across specified terminal blocks. To test the manual reactor trip pathway, the "Block Auto Shunt Trip" pushbutton in series with the contacts closed by the shunt trip relay must be depressed while holding the handswitch in the tripped position. This blocks the actuation signal initiated via the auto shunt trip relay and ensures that the continuity of the handswitch contacts, which directly energize the shunt trip device, is verified. This portion of the test was omitted in the original and subsequent revisions of the test procedure. (See attached figure)

A review of the initial and subsequent revision of the procedure indicates that Generic Letter (GL) 83-28 was included as a reference. The GL 85-09, which specified the Technical Specification changes for GL 83-28, states that if testing is performed using voltage measurements, two precautions must be taken to ensure accurate results. First, the "Block Auto Shunt Trip" switch needs to be used to preclude energizing the shunt trip coil via the automatic shunt trip feature. In addition, the red indicating light in parallel with the handswitch contacts would need to be removed to prevent ambiguous measurements. Neither of these precautions were included in the original procedure or revisions to the procedure. GL 85-09 was not referenced in the procedure, although it was available for review when the procedure was developed. A similar omission exists with testing associated with the Safety Injection (SI) handswitches.

The cause of this event is due to unfamiliarity of the individual responsible for developing the original procedure with the manual reactor trip feature. A contributing cause was the inadequate review of the procedure during various review cycles.

1. A temporary procedure has been initiated to test the manual shunt trip initiated by the reactor trip handswitch. Testing shall be performed during the next scheduled or unscheduled outage where the plant is in Mode 3 or lower for each unit.
2. The existing permanent plant procedure will be revised to test the manual reactor trip pathway of the reactor trip and SI handswitches. The test will be completed during the next refueling outage for each unit.
3. A verbal Temporary Waiver of Compliance to Technical Specification 4.3.1.1 was granted by the NRC on May 19, 1992, followed by a written authorization on May 21, 1992. An amendment to Technical Specification 4.3.1.1, Table 4.3-1 was approved by the NRC on June 2, 1992.
