Docket No. 50-336
B15611

LICENSEE EVENT REPORT (LER)

Millstone Nuclear Power Station Unit 2

Reactor Coolant System Cooldown Rate Exceeded Technical Specification Limit

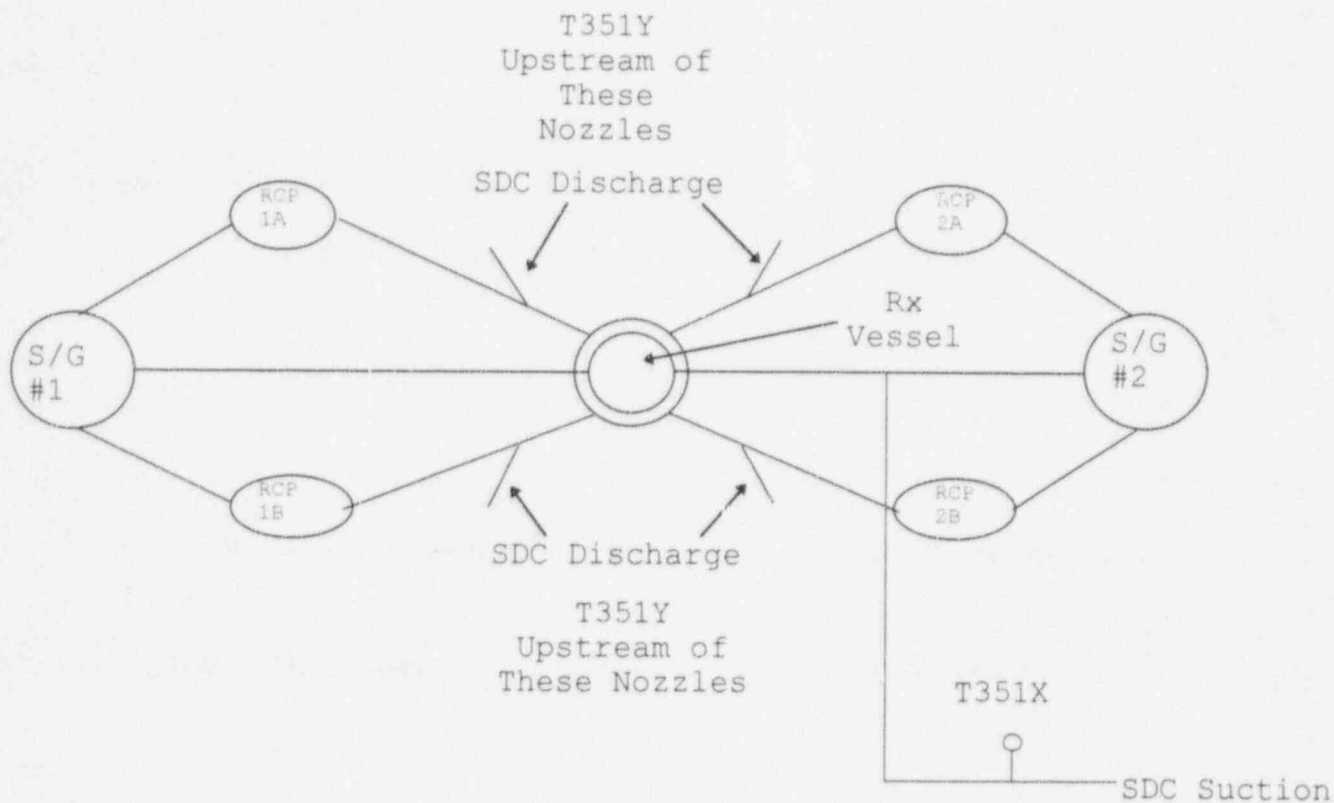
- The temperature sensor located in the SDC discharge to the RCS cold leg (RTD T351Y) reacts quickly to changes in SDC flow rate and reactor building closed cooling water (RBCCW) flow rate through the SDC heat exchangers. The temperature sensor reacts quickly since it is located, downstream of the discharge of the SDC heat exchangers, and before SDC mixes with the RCS.

- RTD T351Y more conservatively assesses cooldown rates at the reactor vessel downcomer due to changes in SDC system flow and RBCCW temperature changes than RTD T351X which is located on the SDC suction line off of the RCS Loop 2 hot leg. RTD T351X represents the temperature of the RCS water exiting the core region of the reactor vessel.

The plant surveillance procedure used to monitor RCS heatup and cooldown rates required that the RCS cooldown rate be assessed at least once every 30 minutes during a plant cooldown. During SDC operation, the procedure specified the use of RTD T351X temperature values, rather than T351Y, to monitor cooldown rate. The plant computer heatup/cooldown monitoring software program assists the operators and was developed to reflect the same procedure requirements. During the April 24, 1994, July 28, 1994, and December 15, 1995 RCS cooldowns, the RTD T351X temperature, which was being monitored, remained on a steady cooldown rate during SDC system manipulations. However, subsequent review of the RTD T351Y temperature exhibited large temperature swings in conjunction with the same SDC system manipulations. Using only RTD T351X temperature indications to calculate cooldown rate during the three events concealed the magnitude of the reactor vessel downcomer cooldown rate.

Shutdown Cooling System - RCS Penetrations Versus
Locations of T351X & 351Y

Changes to the plant operating and surveillance procedures, the plant heatup/cooldown monitoring computer program, and the operator training program will be implemented to allow operators to properly monitor and control the RCS heatup/cooldown rate. The procedure changes and operator training will be completed prior to entering mode 4 during plant startup.
