SUBJECT: Calvert Cliffs Nuclear Power Plant
Unit No. 2; Docket No. 50-318; License No. DPR 69
Licensee Event Report 96-001
Automatic Plant Trip Due to Partial Loss of Offsite Power

LICENSEE EVENT REPORT (LER)

Calvert Cliffs, Unit 2

Automatic Plant Trip Due to Partial Loss of Offsite Power

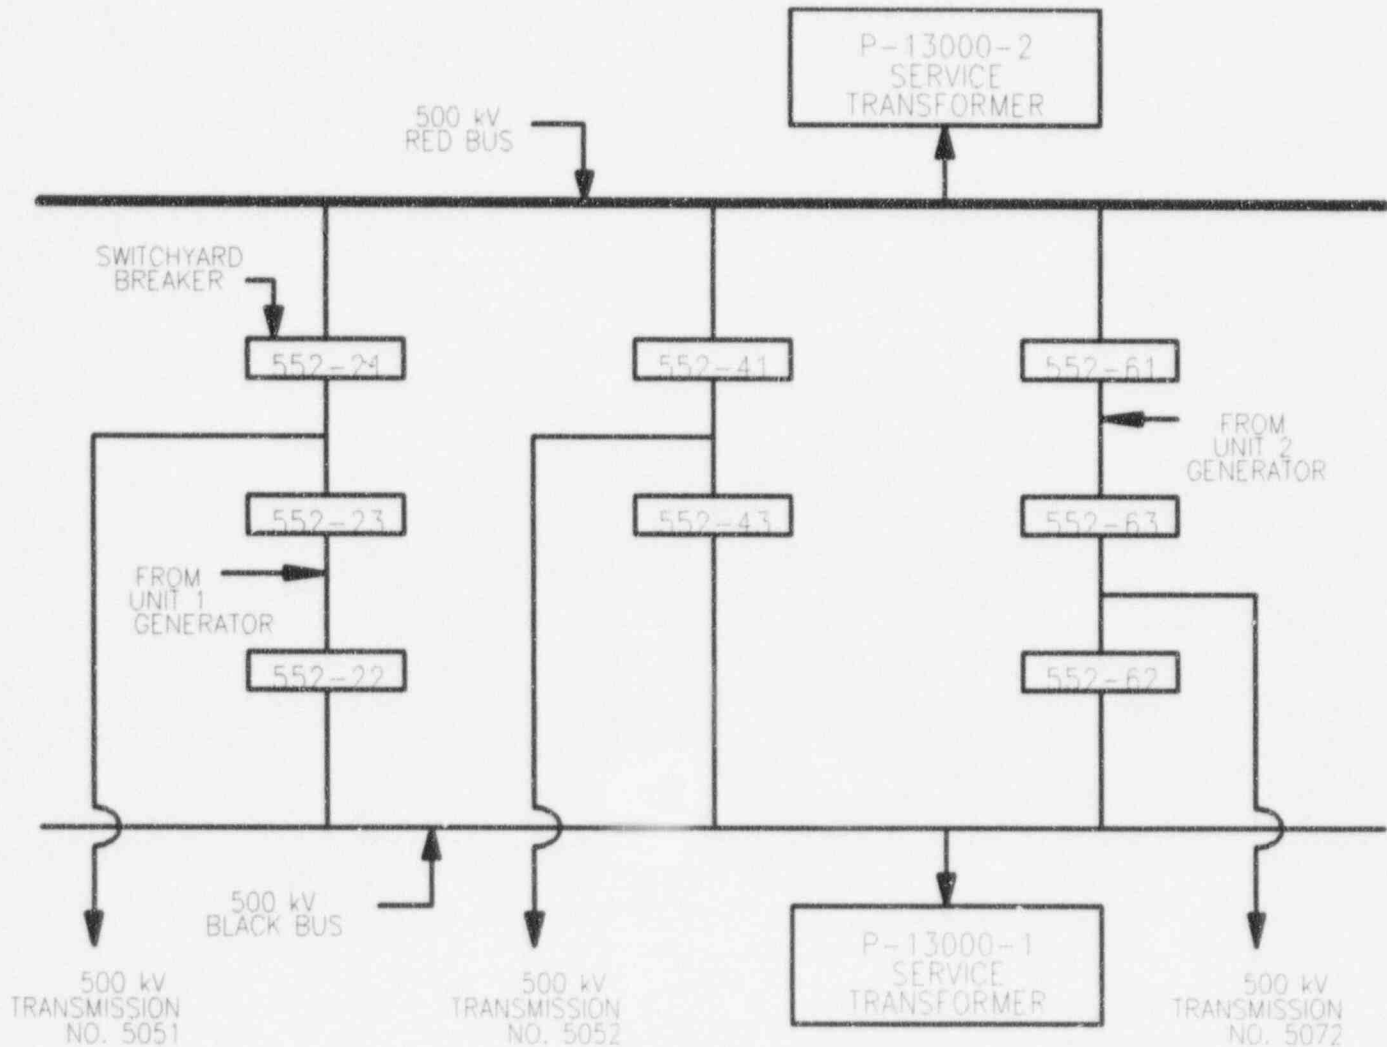
FIGURE 1

At the time of the event, 500 kV transmission line No. 5052 was removed from service for troubleshooting to isolate a control system failure on 500 kV Breakers 552-41 and 552-43. The other two 500 kV transmission lines, Nos. 5051 and 5072 were in their normal line ups. See Figure 1 for a schematic drawing of the Calvert Cliffs 500 kV switchyard ring bus. The 500 kV Red and Black Busses serve as common connection points between the 500 kV transmission system (offsite power) and the other 500 kV switchyard components. These busses also connect the 500 kV switchyard and the 13.8 kV system through the plant service transformers (Red Bus to P-13000-2 primarily for Unit 2, and Black Bus to P-13000-1 primarily for Unit 1). The plant service transformers supply power to reactor coolant pump 13.8 kV busses and to the plant's 4 kV transformers. The loss of the Red Bus caused a loss of power to the Unit 2 reactor coolant pumps, a loss of power to 4 kV vital Bus No. 24 (Unit 2), and a loss of power to 4 kV vital Bus No. 14 (Unit 1).

500 kV SWITCHYARD RING BUS
