Carolina Power & Light Company

BRUNSWICK STEAM ELECTRIC PLANT UNIT 1 and 2
DOCKET NO. 50-325 and 50-324
LICENSE NO. DRP-71 and 62
LICENSEE EVENT REPORT 1-92-017

TITLE (4) INCOMPLETE CLOSURE OF ITE TYPE K-3000 BREAKER CONTACTS

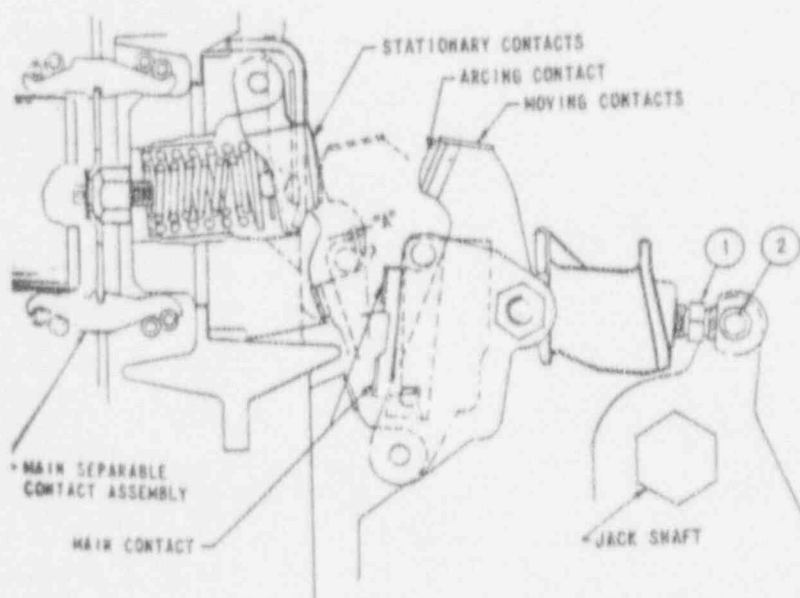
Fig. 3 — Contact Pressure Check and Adjustment

Step 7.7.9 - When the first leading arcing contact just touches, use feeler gauge to measure gaps on other leading arcing contacts.

Step 7.7.10 - If other leading arcing contacts are not within 0.032" of touching, loosen lock screw and turn adjustment screw for appropriate contacts so that all leading arcing contacts will touch within 0.032".

When the above steps were performed earlier, it was necessary to tighten down (i.e., increase the pressure of) the contacts to obtain 0.032". In order to meet the 0.032" parameter without increasing contact pressure, it was decided to adjust back the first leading arcing contact (the one that had touched first in step 7.7.9). This would allow the contact to touch later in the closing cycle, consequently bringing the other contacts within 0.032" without having to increase (or increase as much) their contact pressure (Step 7.7.10). The adjustment was made and the breaker did close completely; the reduction in contact pressure corrected the closing problem.

ABB was again contacted to discuss the failure of the breaker to completely close. When Technical Support explained to the vendor what had been done, the vendor indicated that the adjustment to reduce contact pressure on the leading arcing contacts may have compromised the contact pressure setting for the main contacts. [Note: The main contact pressure setting was performed in earlier steps in the OPM (steps 7.7.1 and 7.7.2)]. Technical Support was under the impression that the 7.7.1 and 7.7.2 steps were a "gross" setting and that 7.7.9/7.7.10 was the fine tuning. They were not aware/did not understand that steps 7.7.1/7.7.2 were critical and performance of these steps set the minimum desired contact pressure.

2. Revise OPM-BKR002C to clarify method for contact pressure adjustment.
3. Review other breaker OPMs to determine if revisions are required concerning contact pressure adjustment.
4. Prepare training course on operation/maintenance of breaker types used on site.
5. Review Technical Support training requirements to identify other potential areas concerning component training that require enhancement (possibly in conjunction with the new maintenance training facility).
