FORT CALHOUN STATION

IRRADIATED FUEL INSPECTION
FOLLOWING CYCLE IV OPERATION

November - December 1978

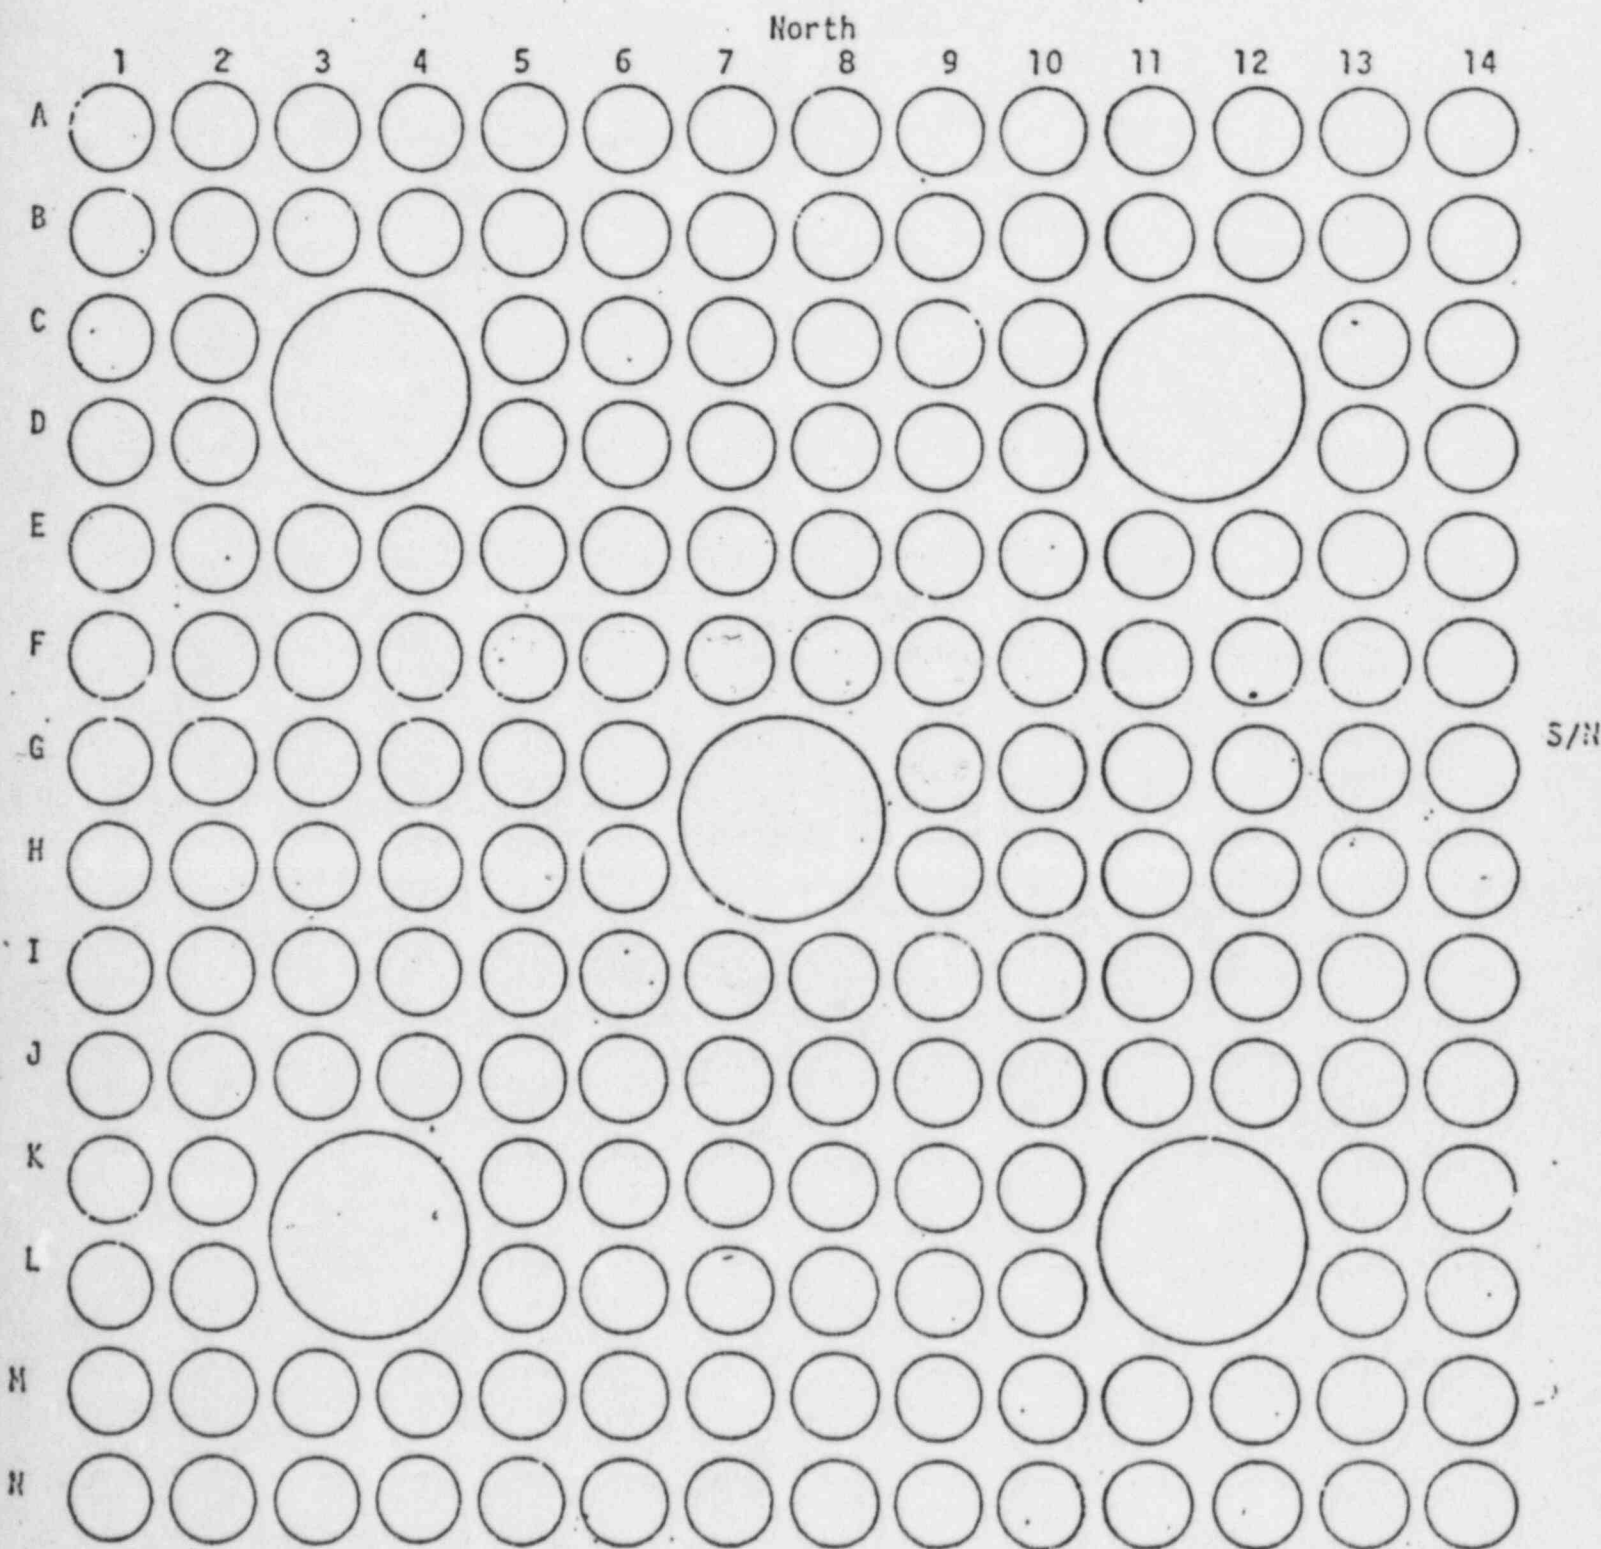
It should be noted that the pool-side television monitor has been modified to eliminate mirror-imaging which results from the use of a right angle mirror on the camera. The video tapes, however, record a mirror image, i.e., images appearing on the right really represent the left side of the object. The auto dubbing comment may refer to the right side of the assembly face but, when the video tape is viewed on a monitor without the mirror-image eliminator, the right side will appear on the left. The notation used to indicate the identity of the face being examined is defined by calling the face which faces the north direction when the assembly is in the southeast orientation as the north face. Figure 1 shows the assembly mapping scheme.
