Millstone Nuclear Power Station, Unit No. 3
Relief Request From ASME Code Section XI Requirements

Relief Request From ASME Code Section XI Requirements

FORM FOR RELIEF REQUEST FROM ASME SECTION XI REQUIREMENTS

UNIT: Millstone Unit 3 NCR # 392-189 DATE: 8/10/92
TIME: 1100

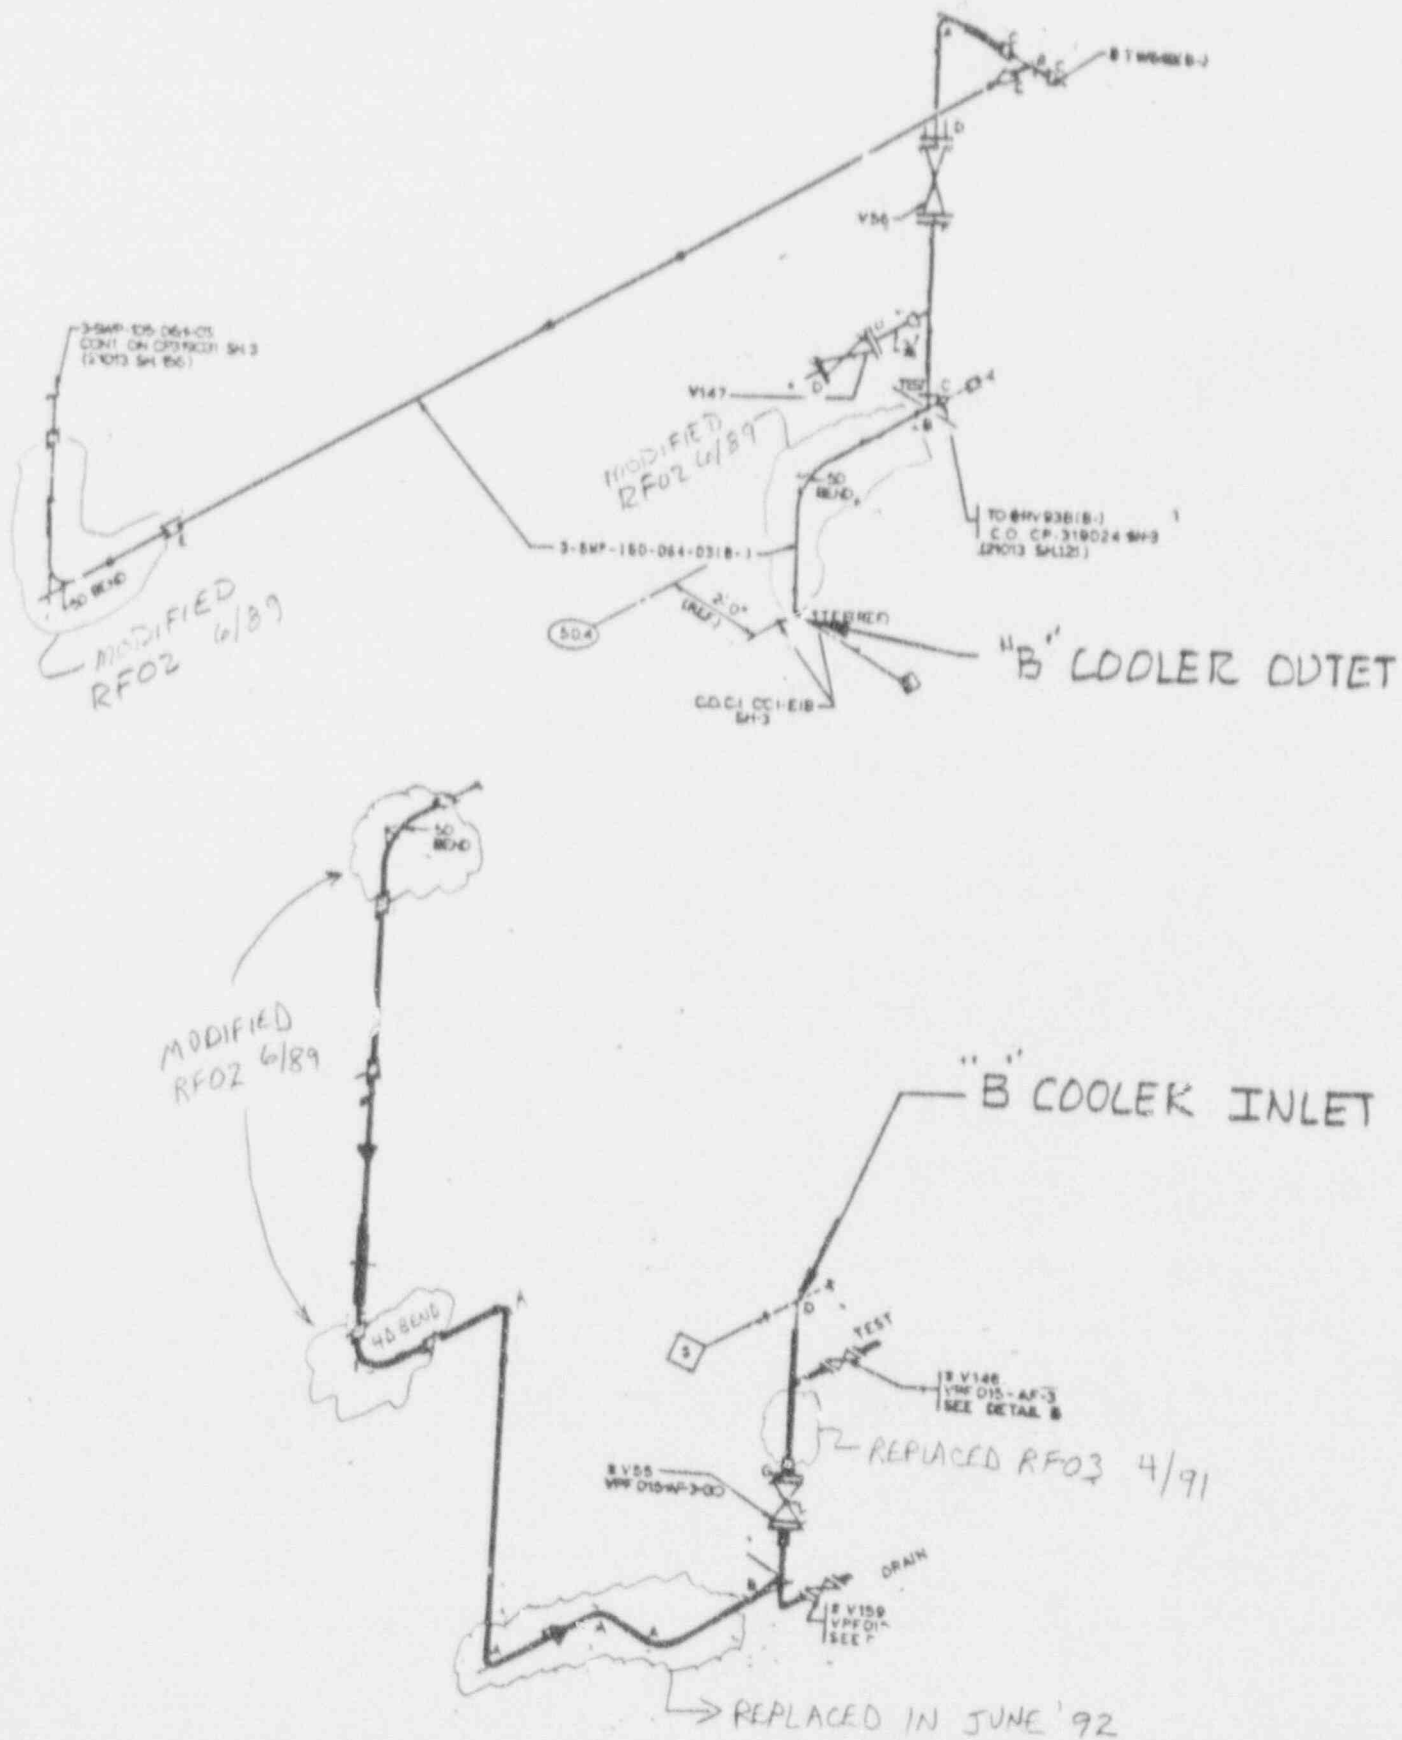
SERVICE WATER INLET & OUTLET PIPING

Leak in 1 1/2" 90/10 Cu-Ni piping, Line #3-SWP-150-072-03 (A-) at FW 3, SWP outlet from 3CCI*E1A.

Root Cause Description: Erosion corrosion of solid 90/10 copper nickel due to turbulent flow at elbow.

Flaw Location: In pipe at field weld 3 to elbow at the bottom (180°-190° from TDC) of the horizontal run.

Leak is isolable, code repair practical. NUSCO is currently preparing to modify the outlet piping from the "A" CCI cooler. This work will restore Code compliance and is designed to improve flow and reduce turbulence. This work will be completed within 90 days.

Wrap with rubber tape, secure with hose clamp.

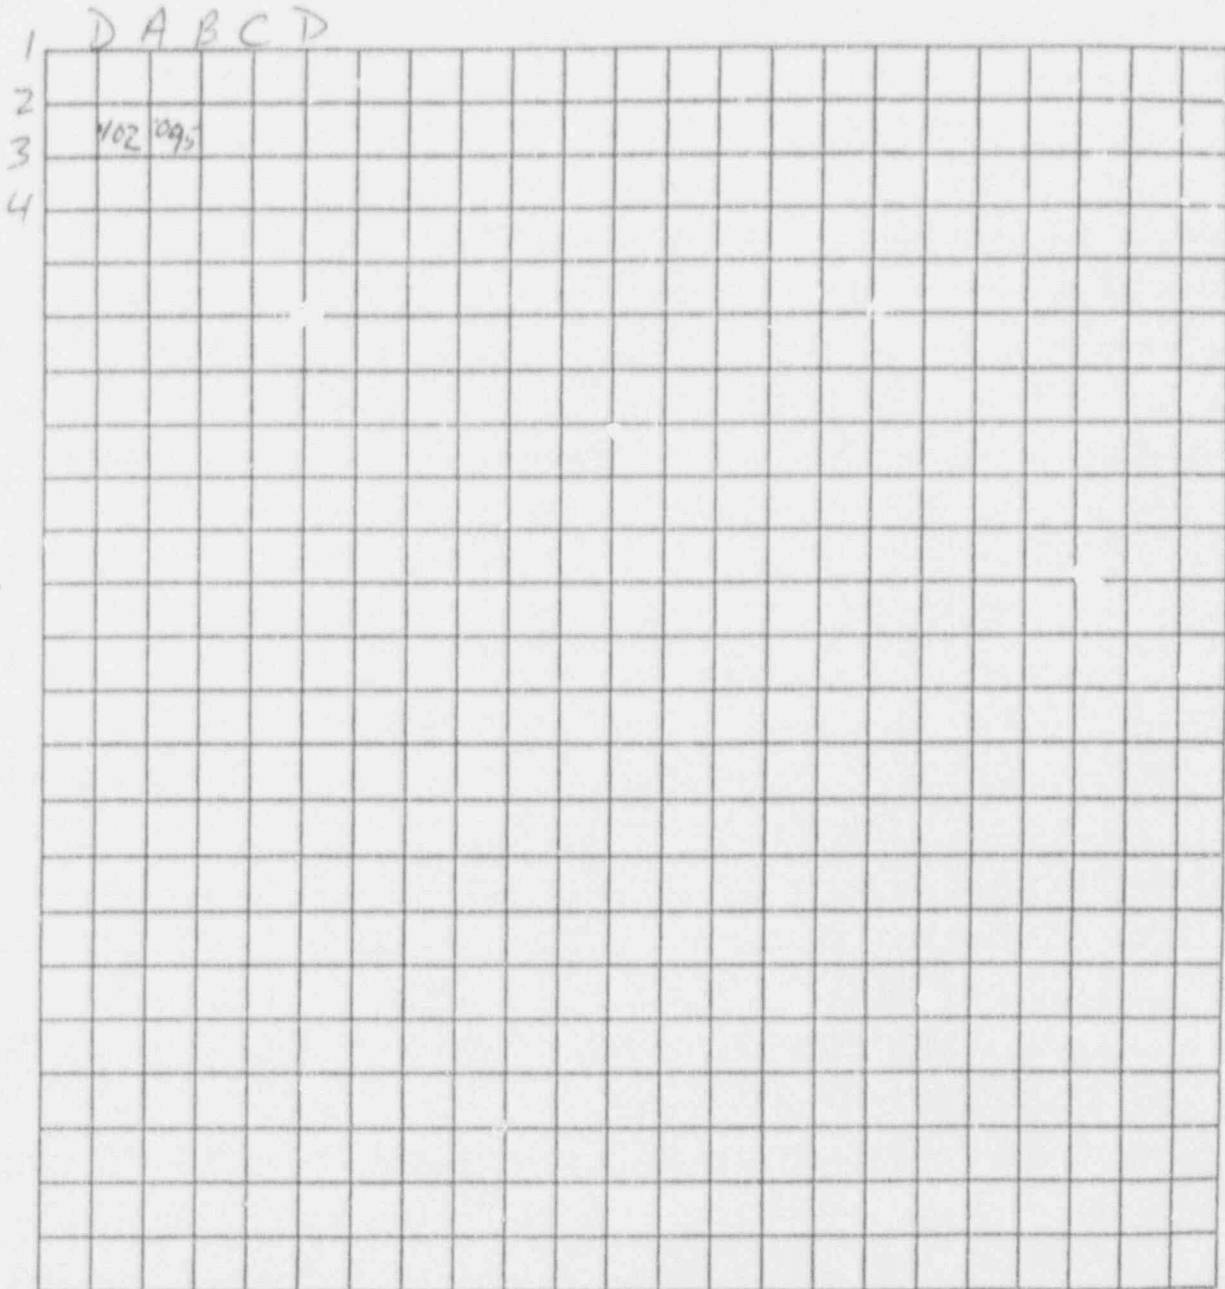
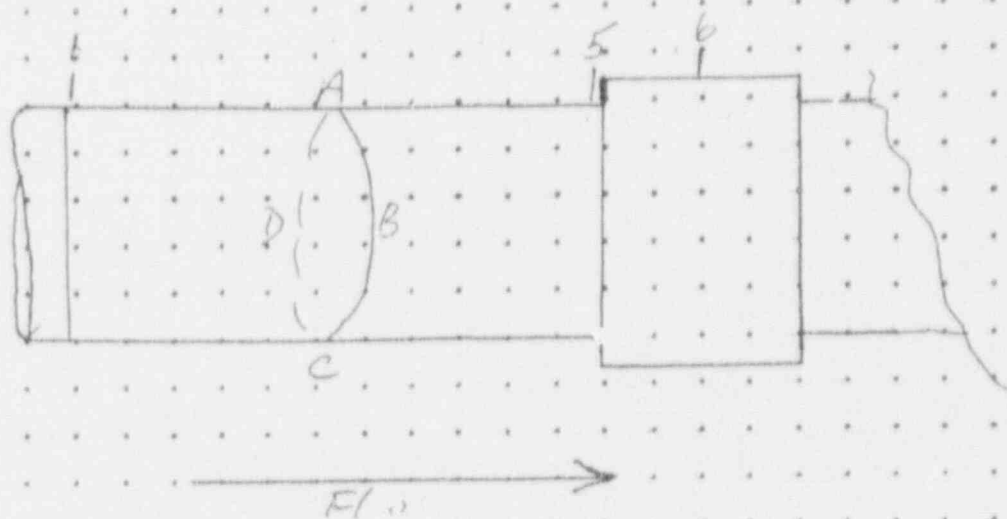
COMPONENT ID C 40 (FW 6-1) EXAMINER J. Jacobson DATE 9-1-92

Discussion of Augmented Inspection Results: Field welds FW 6-1, 8-1 and 12 on inlet to "A" train CCI cooler and FW 27 on the "B" train outlet have experienced wall loss with low readings below 0.100". The remaining wall is above the Code minimum and will be monitored. NUSCO is currently pursuing a permanent piping modification for both the "A" cooler inlet and outlet piping. These areas are structurally acceptable based on the criteria for the current leak. See attached sketches for a description of past and future repairs of A & B train CCI service water piping.

Maximum Reading = 0.164 (1, B) Average = 0.141
 Minimum Reading = 0.073 (2, A) Standard Deviation = 0.025
 Total Readings = 19

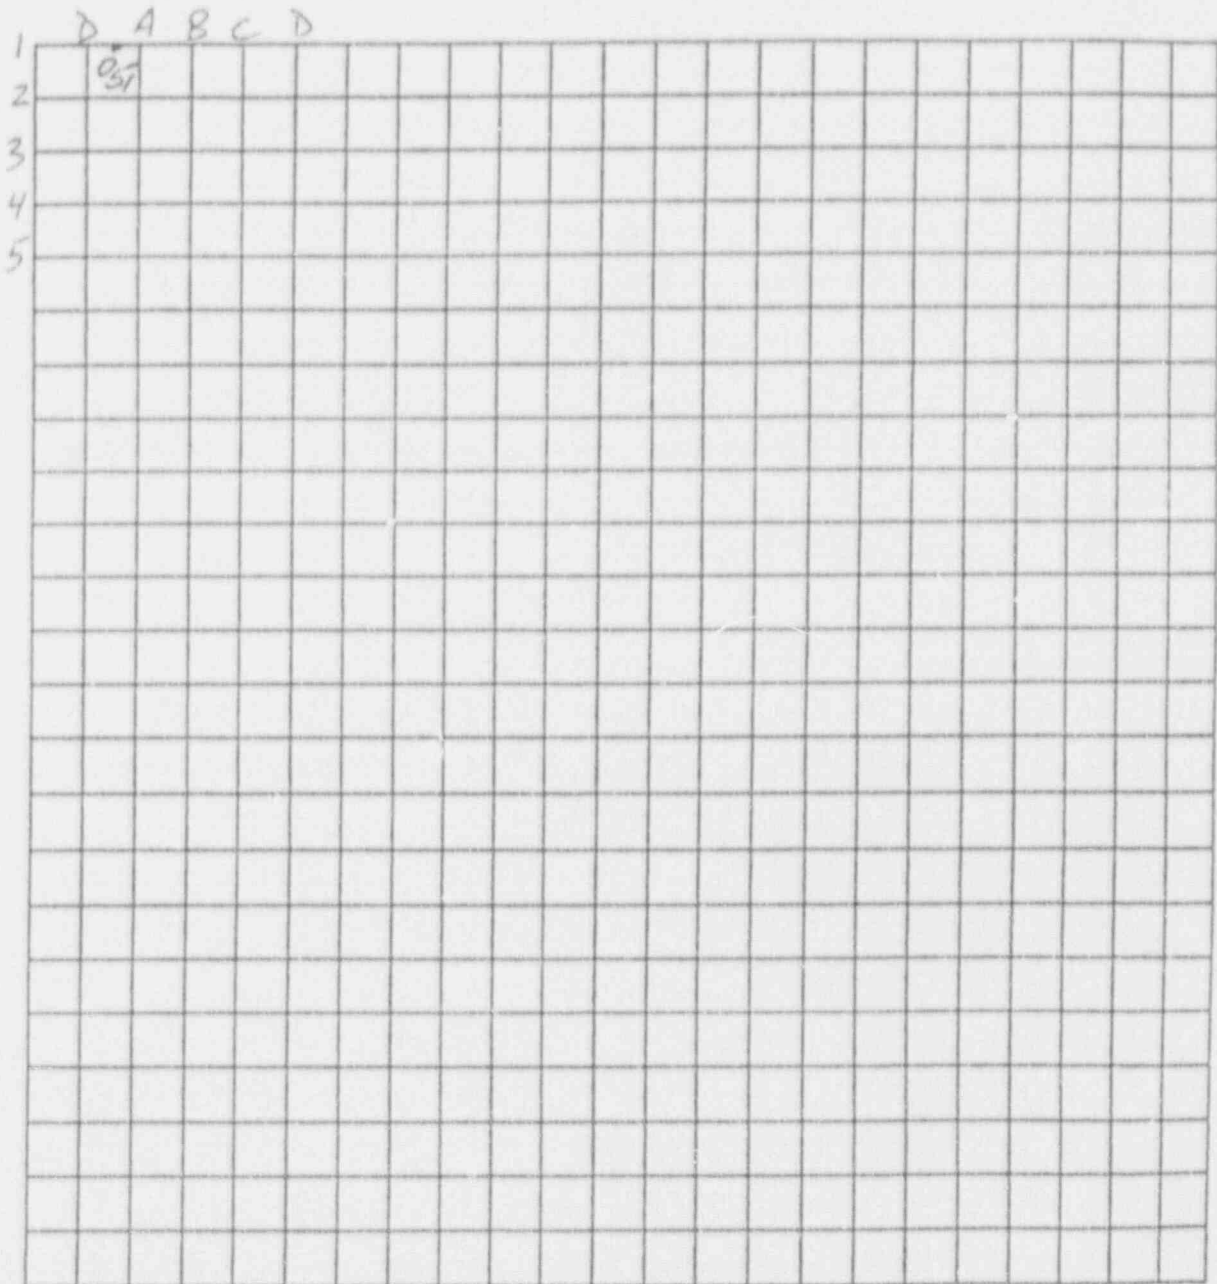
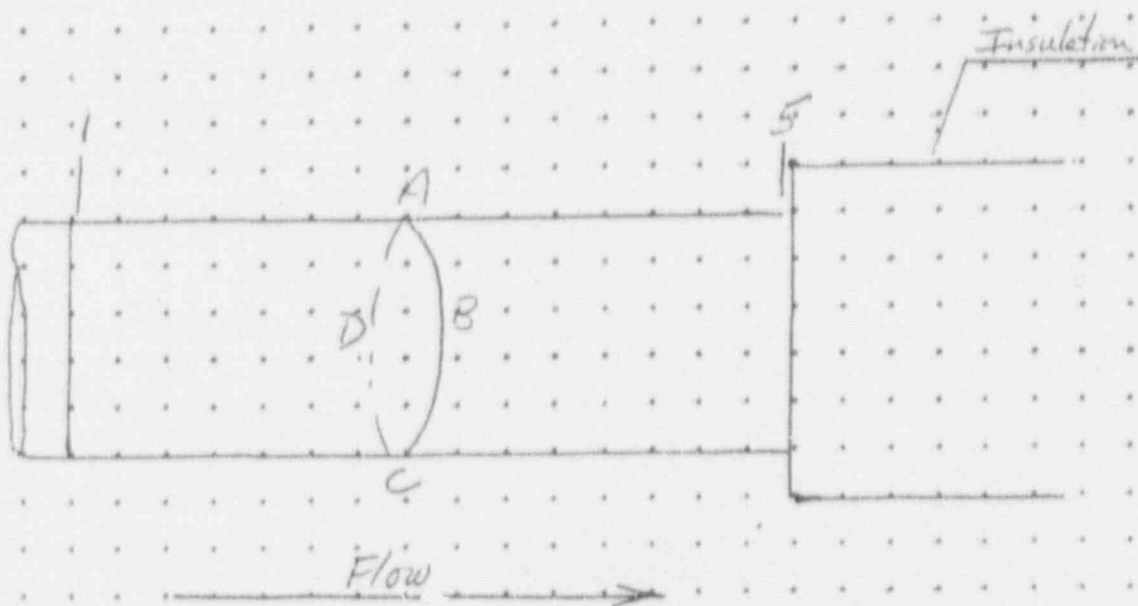
COMPONENT ID C 43 (FW 8-1) EXAMINER John Jackson DATE 9-1-92

Maximum Reading = 0.168 (5, B) Average = 0.150
 Minimum Reading = 0.139 (1, D) Standard Deviation = 0.006
 Total Readings = 20

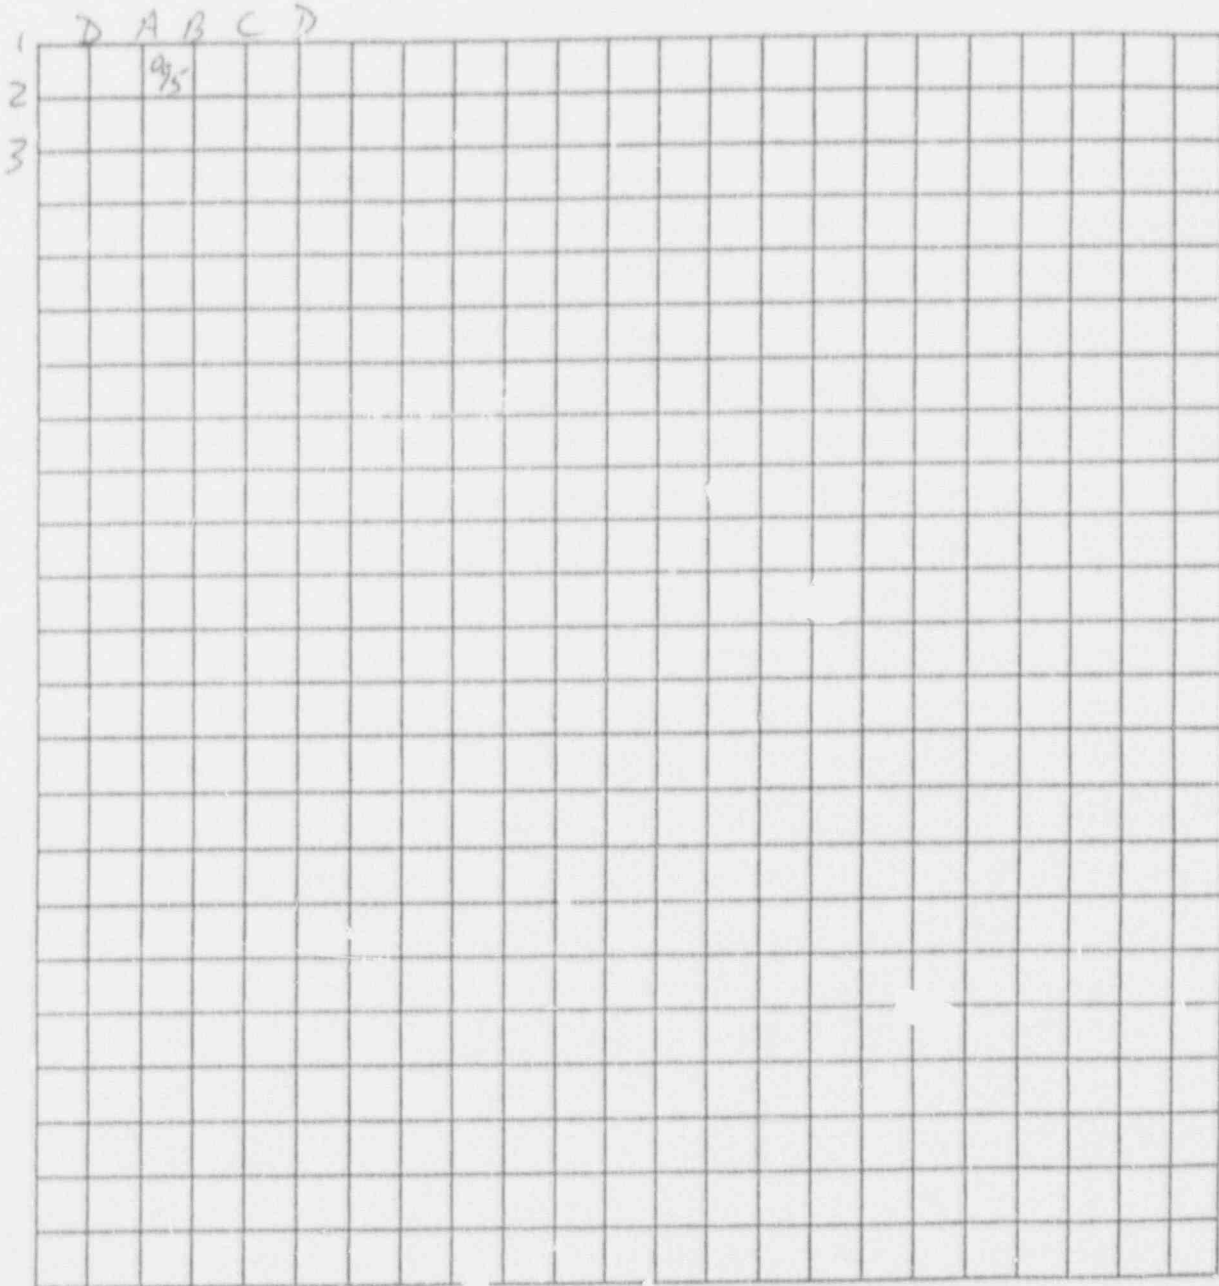
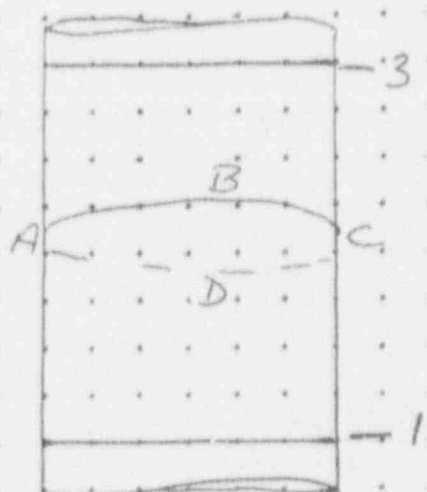
COMPONENT ID C8(Fw12) EXAMINER John Jacobson DATE 9-1-92
 PLANT/UNIT Hillstone III SYSTEM Service Water
 GRID SIZE 1" COLUMN - CIRCUMFERENTIAL LOCATION

Maximum Reading = 0.151 (3, A)	Average = 0.146
Minimum Reading = 0.117 (1, A)	Standard Deviation = 0.010
Total Readings = 12
