TU ELECTRIC
COMANCHE PEAK STEAM ELECTRIC STATION
UNIT 2 ENGINEERING

BWIP CHECK VALVE 2AF-0083
FAILURE INVESTIGATION

PTR-32, Revision 0

AUGUST 1992

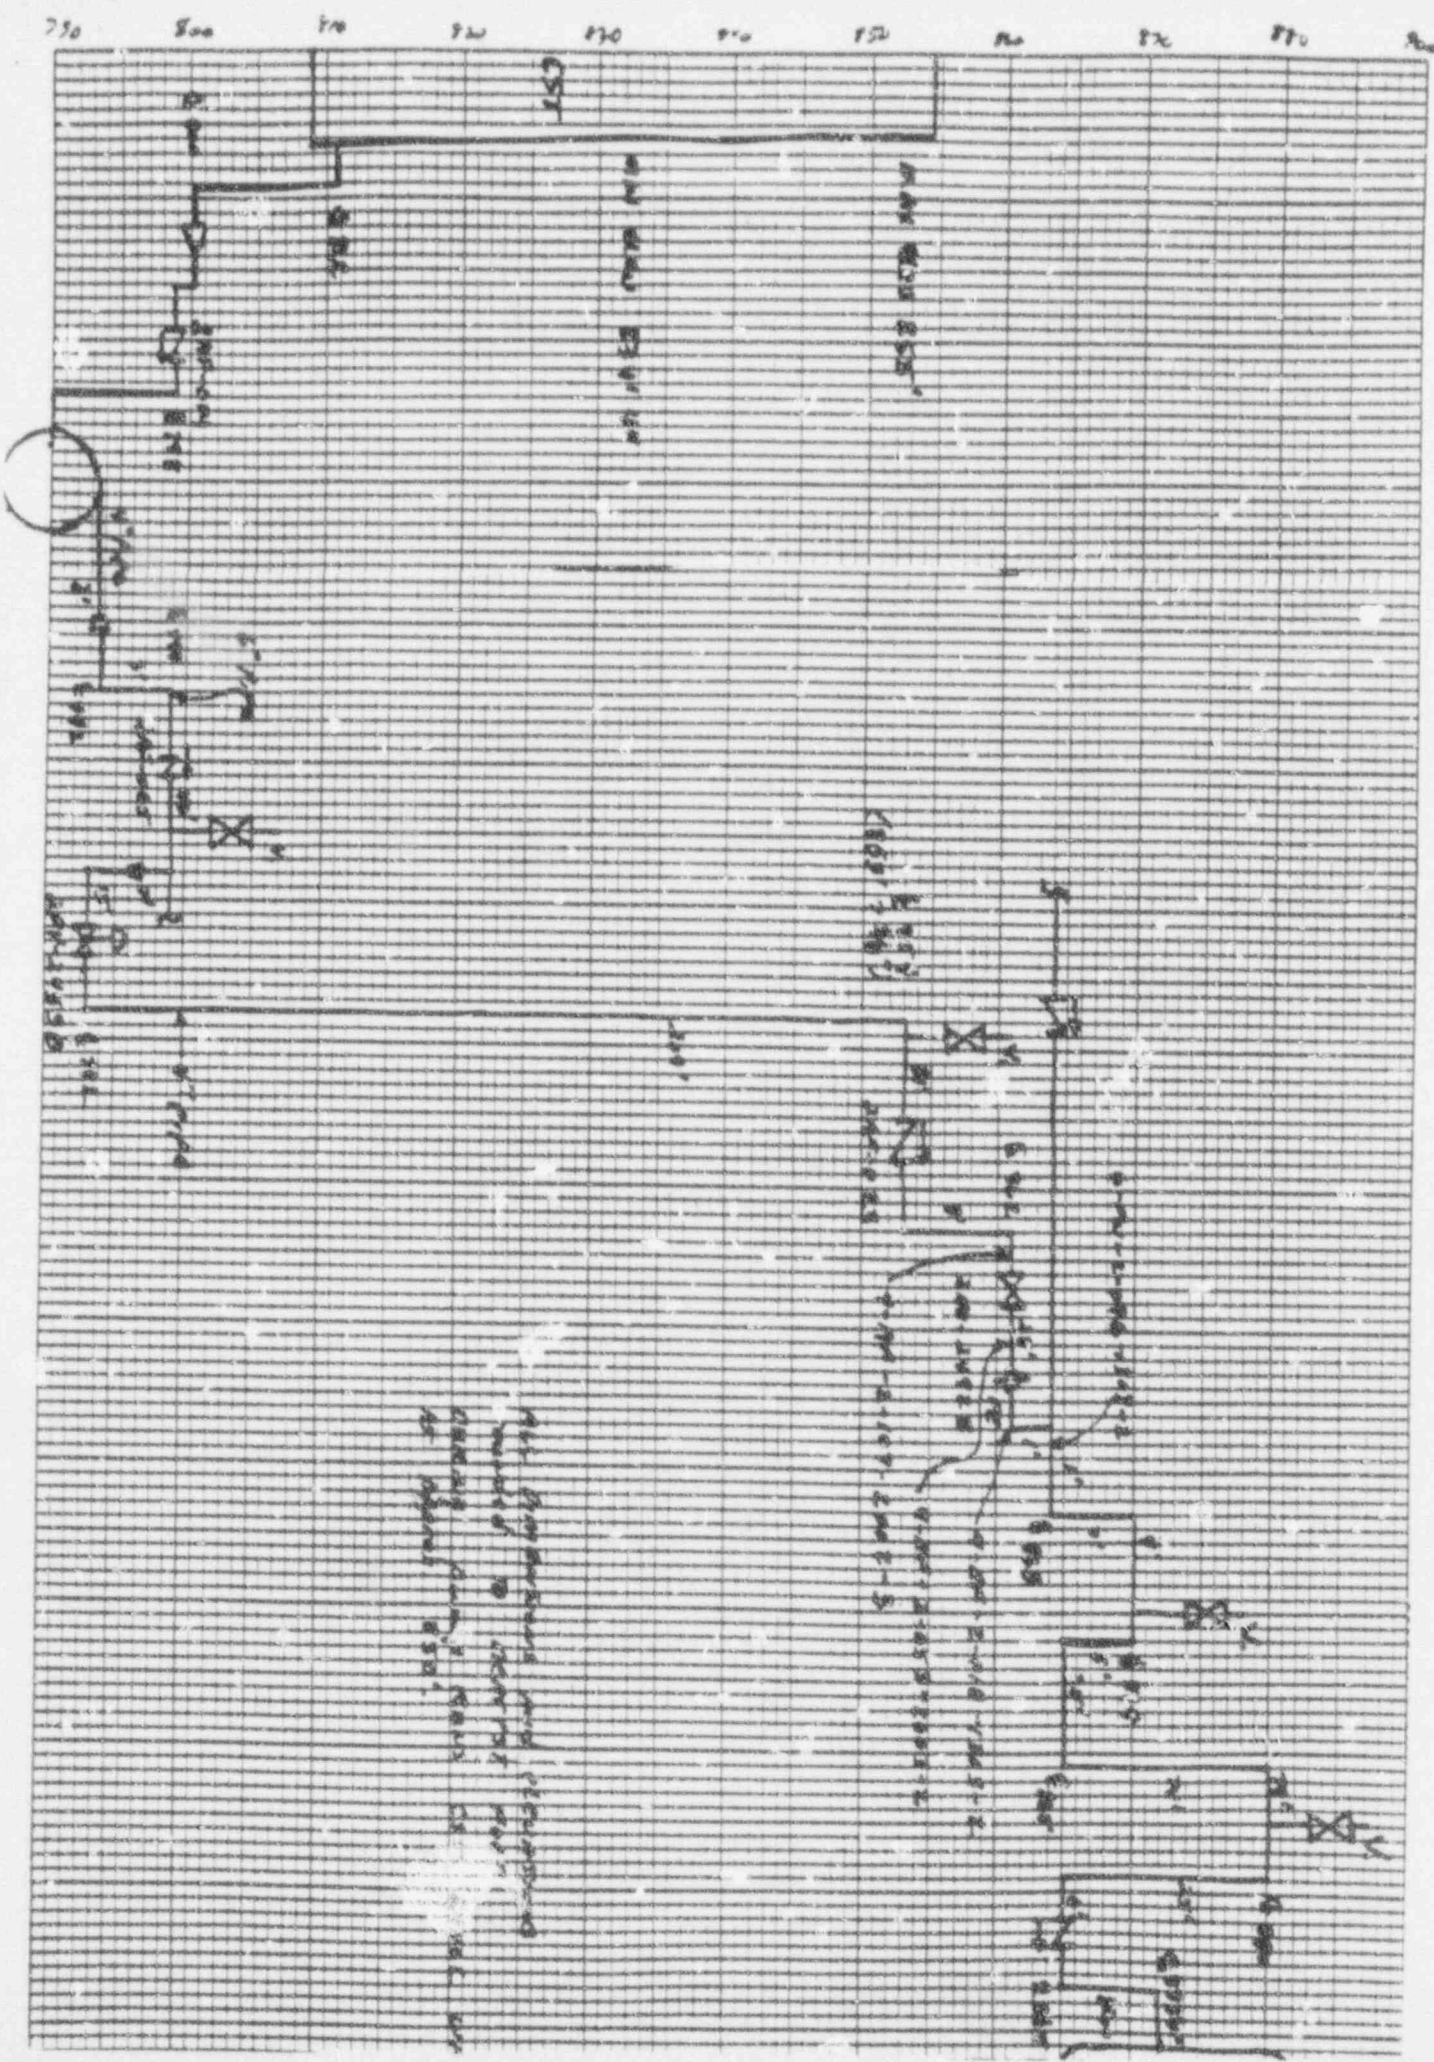
An auxiliary feedwater system elevation diagram was developed (Attachment 1). This diagram shows that the system has a potential to drain down to the elevation of water (853'-4" to 834'-3") in the condensate storage tank (CST) which is between 8" to 19'-9" below the check valve which corresponds to between 29 linear ft to 70 linear ft. This drain down could occur when the associated steam generator is not receiving flow through the preheater nozzle, the steam generator is at atmospheric pressure, and in addition if the check valve has any leakage. The check valve in question had not been backflow tested prior to the failure.
