Subject: Oconee Nuclear Station, Units 1, 2, and 3
Docket Nos. 50-269, -270, -287

Duke Power Company
Oconee Nuclear Station
Special Report

230KV Overhead Line Between Keowee and
Oconee Isolated Due to Opening of PCB-9

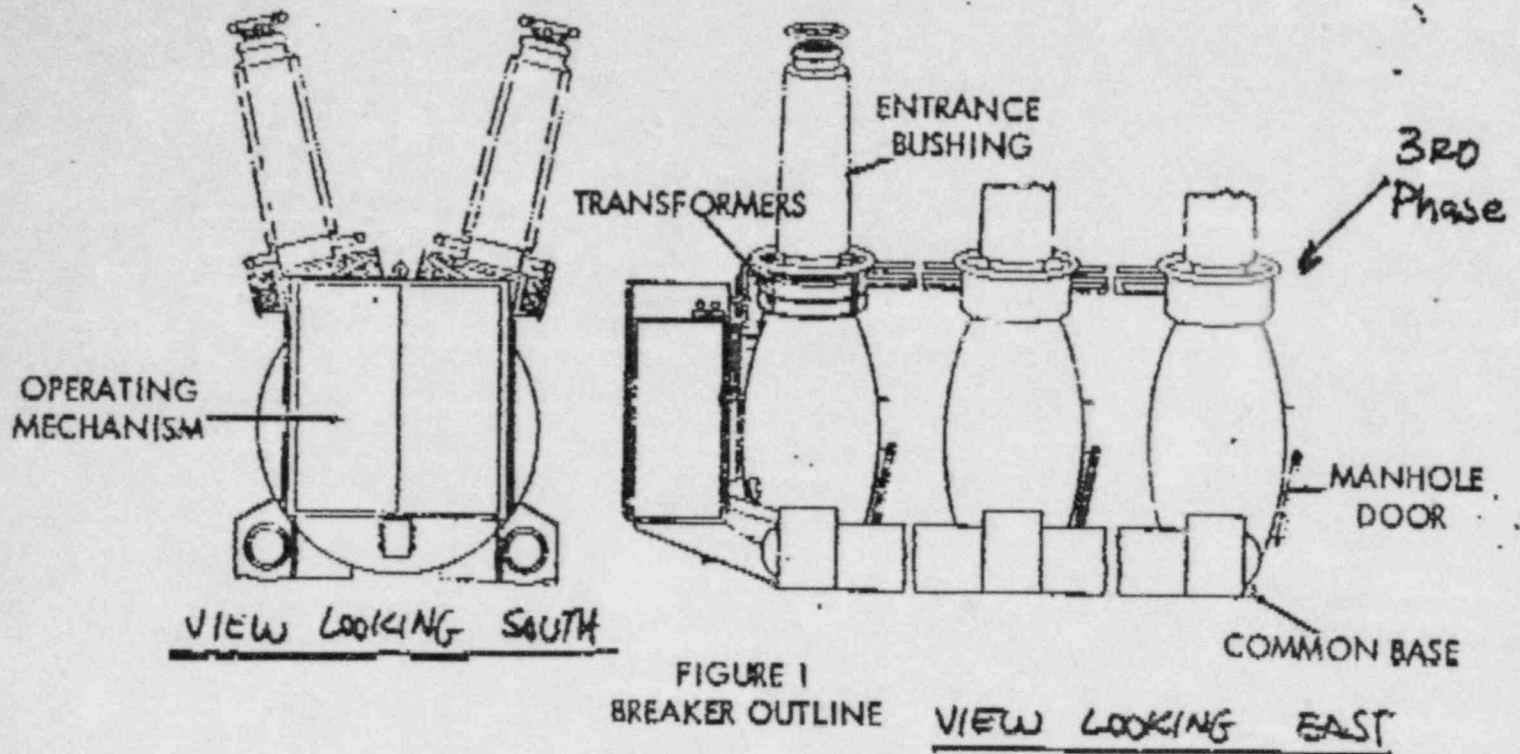
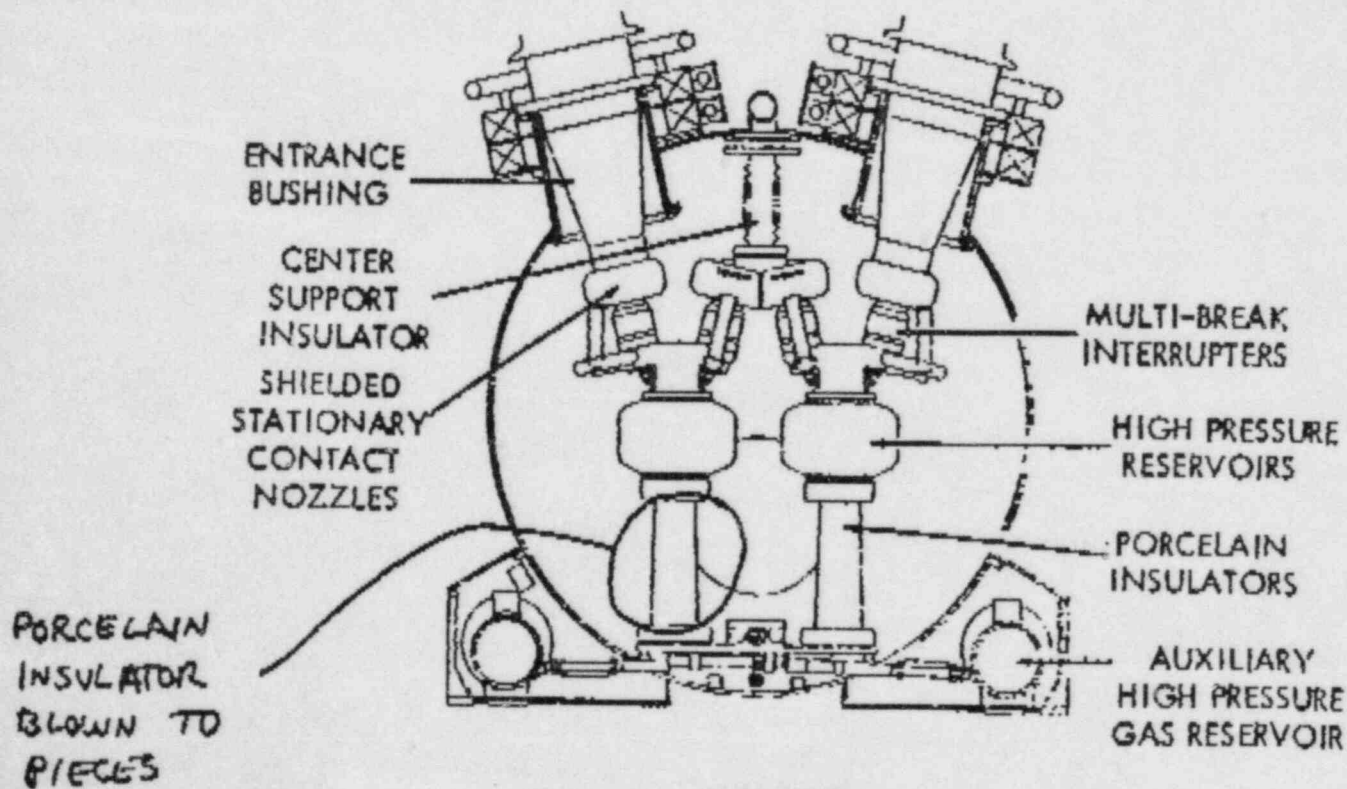
FIGURE 2

An SF₆ gas leak had been identified prior to September 25, 1984 when PCB-22 was isolated for maintenance. The leak was found in a cracked weld in the lower part of the third (3rd) phase support section. The weld was repaired but a smaller leak still existed on September 28, when PCB-22 was being put back into service. The leak was small enough that PCB-22 was to be put into service during the period of September 29th and 30th and then removed from service October 1st for the smaller gas leak to be repaired.

Figure 1 is an electrical schematic diagram of the Oconee switching station which shows the relative positions of the various breakers. A drawing of power circuit breaker PCB-22 is included as Figure 2. The short circuit occurred inside the third (3rd) phase section of PCB-22. The porcelain insulator on the west side of this section was shattered by the short circuit. The cause of the short circuit had not been determined as of October 3rd.

Following an on-the-spot safety evaluation by Operations personnel, PCB-9 was reclosed, thus ensuring that station operation would proceed in accordance with the technical specification. The Keowee Unit 2 maintenance outage was completed earlier than scheduled and a routine maintenance step requires Unit 1 to be temporarily removed from service so that both units can be returned to service. Return of the units is expected by October 5, 1984, at which time the affected technical specification will no longer apply. Repair work is proceeding on PCB-22. While the Keowee units are out of service, tests using input signals are being conducted to determine why PCBs 8 and 9 opened on the red bus differential lockout.
