CATAWBA NUCLEAR STATION
DIESEL ENGINE 1B COMPONENT REVALIDATION INSPECTION
FINAL REPORT

PREPARED BY
DUKE POWER COMPANY

September 28, 1984

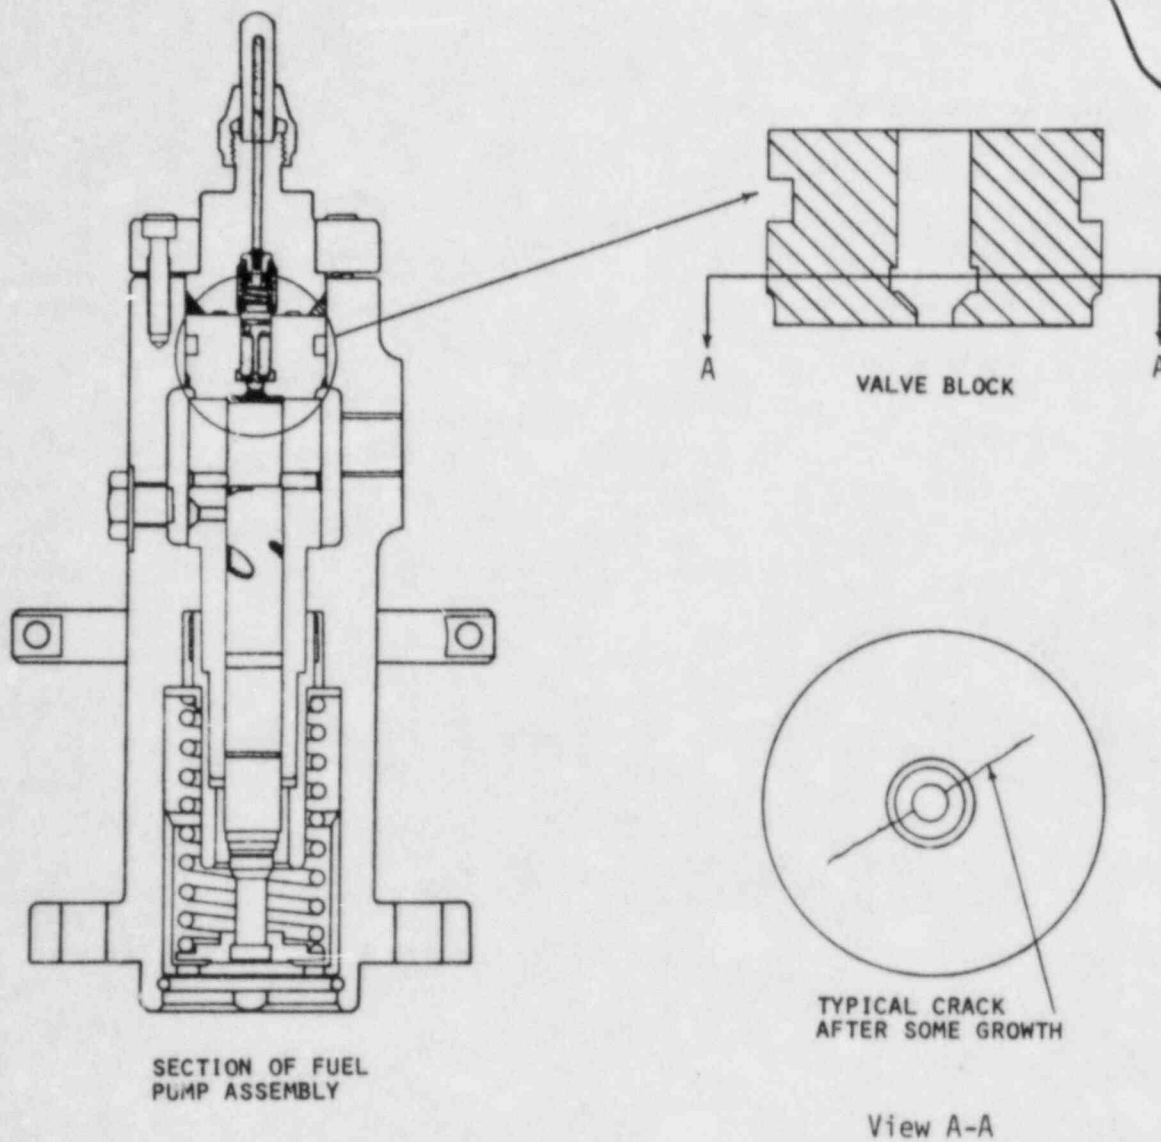
Figure 2-1. Cracked Fuel Pump Delivery Valve Block

A total of three delivery valve blocks were found to be cracked. Two were noted during the extended operation test. These were detected by a gradually falling cylinder temperature. One delivery valve block was found partially cracked during inspection after the extended operation test. The cracks are axial in nature and are produced by fuel pressure induced hoop stresses. Operationally a valve block crack results in less fuel being injected into the cylinder, i.e. it bypasses more fuel back to the fuel oil tank. Metallurgical examination results show that the cracks were fatigue induced, initiating from the valve seat. Based on discussions with the vendor, the cracks originated from heat check cracks in the valve seat caused by excessive grinding temperatures during manufacture. Other valve blocks on 1B have been magnetic particle inspected with no sign of the heat checking. The failure is shown in Figure 2-1 and further discussed in Section 4.2.2.
