DUKE POWER COMPANY

Re: Oconee Nuclear Station
Docket Nos. 50-269, -270, -287
IE Bulletin 84-03

Response
to
IE Bulletin 84-03

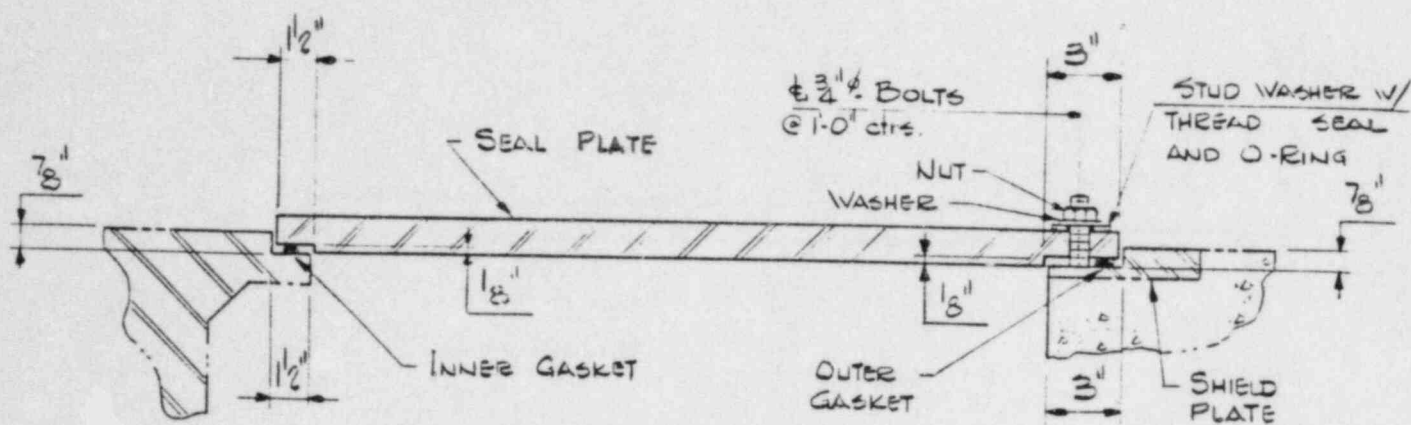
FIGURE #1

Considering the difference in seal plate and gasket configuration between that at Oconee (Fig. 1) and that described in IEB 84-03, a gross seal failure of the magnitude experienced at Haddam Neck is not a credible event at Oconee. Correct alignment of the seal plate is assured by 4 alignment studs and 72 threaded studs. Water pressure above the seal plate, gasket sealant, the 1/8 inch recessed edges, and a final torque value of 150 ft.-lb. per nut ensure gasket stability.
