CALVERT CLIFFS NUCLEAR POWER PLANT  
1650 CALVERT CLIFFS PARKWAY • LUSBY, MARYLAND 20657-4702

SUBJECT: Calvert Cliffs Nuclear Power Plant  
Unit No. 2; Docket No. 50-318; License No. DPR 69  
Licensee Event Report 92-007  
Manual Trip Caused by Stuck Open 23 Moisture  
Separator/Reheater Relief Valve

## LICENSEE EVENT REPORT (LER)

Manual Trip Caused by Stuck Open 23 Moisture Separator/Reheater Relief Valve

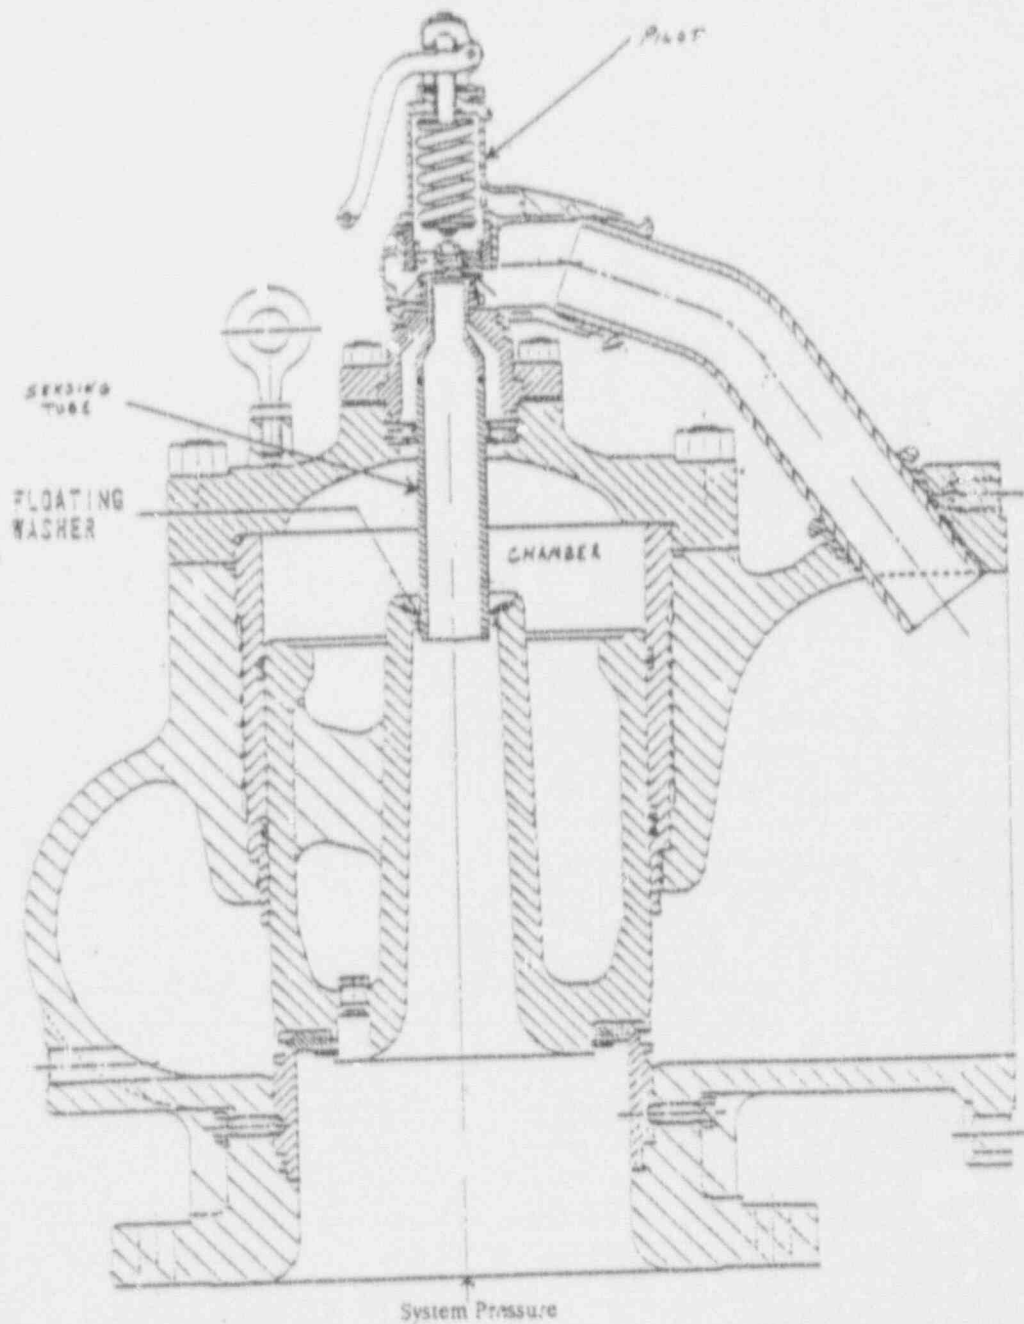
FIGURE 1

The primary cause of this event was the lifting and failure to reseal of 2-RV-4024. Failure of this valve to reseal resulted in a differential pressure across the HP turbine leading to an increase in turbine thrusting and high thrust bearing face temperatures. The plant was tripped in accordance with

The relief valve on 23 MSR, 2-RV-4024, is a pilot operated safety relief valve (see Figure 1). The operation of the valve is as follows: System pressure (hot reheat steam) enters the main valve and flows up through the sensing tube. Steam also flows out through a clearance between the tube and a floating washer on the main valve disc into the top of the chamber to pressurize the top of the main valve disc. Additional flow occurs between the top of the sensing tube and the disc for the pilot valve, down into the top of chamber to help pressurize the top of the main valve disc. When system pressure increases and the pilot valve setpoint is reached, the pilot opens allowing pressure in the chamber to exhaust through an outlet. When pressure in the chamber decreases to approximately 58 percent of the system pressure a lifting force on the main valve disc is created causing the main valve to open.

After 2-RV-4024 lifted on September 29, 1992, the valve was opened and inspected for damage in accordance with the outstanding MO. First the pilot valve was removed and tested. Three simulated lift tests were performed and in all three the pilot relieved at approximately 12<sup>+</sup> psi, which is lower than the required 150 psi setpoint. Further inspection determined there was excessive leakage past the pilot disc. A root cause analysis performed by Plant Engineering concluded the combination of the pilot setpoint drifting low plus leakage past the pilot disc allowed excessive leakage to develop through the pilot and thus the pressure in the chamber bled off. When pressure in the chamber reached approximately 58 percent of system pressure, the main valve opened. The valve manufacturer has also confirmed that if excessive leakage exists on the pilot valve, the chamber can depressurize and allow the main valve to open.

The main valve body was also inspected for damage. Corrosion and pitting were discovered on the guide for the main plug. Additionally, excessive wear was found on the packing rings and O-rings. This condition appears to have contributed to the disc becoming stuck and unable to reseat without assistance.

- A. Immediately following the event, an engineering root cause analysis was performed by Plant Engineering and Maintenance to determine why 2-RV-4024 had lifted and failed to reseat. The valve was disassembled, inspected and completely overhauled. Both the engineering analysis and the maintenance repairs were completed prior to the restart of Unit 2.

- B. Changes will be initiated to modify the PM frequency for inspecting the MSR relief valves such that the pilots on the valves will be inspected every refueling outage versus the current interval of every two refuelings.

- C. All of the Unit 2 MSR shell-side relief valves will be inspected during the upcoming Unit 2 Spring Refueling Outage. Additionally a modification, suggested by the manufacturer, that will aid in closing the main disc will be scheduled for this outage. The existence of this potential modification was not communicated by the vendor to BGE prior to this event.
