ULNRC-2714

CALLAWAY PLANT
DOCKET NUMBER 50-483
ADDITIONAL INFORMATION REGARDING
REVISION TO TECHNICAL SPECIFICATION TABLE 3.3-4,
"ENGINEERED SAFETY FEATURES ACTUATION SYSTEM
INSTRUMENTATION TRIP SETPOINTS"

SUMMARY OF BECHTEL LETTER
TO UNION ELECTRIC, BLUE-91-0004, NOVEMBER 14, 1991,
"CALLAWAY NUCLEAR POWER PLANT/
CALLAWAY DEGRADED VOLTAGE SETPOINTS"

SUMMARY OF UNION ELECTRIC
SOS 91-0469

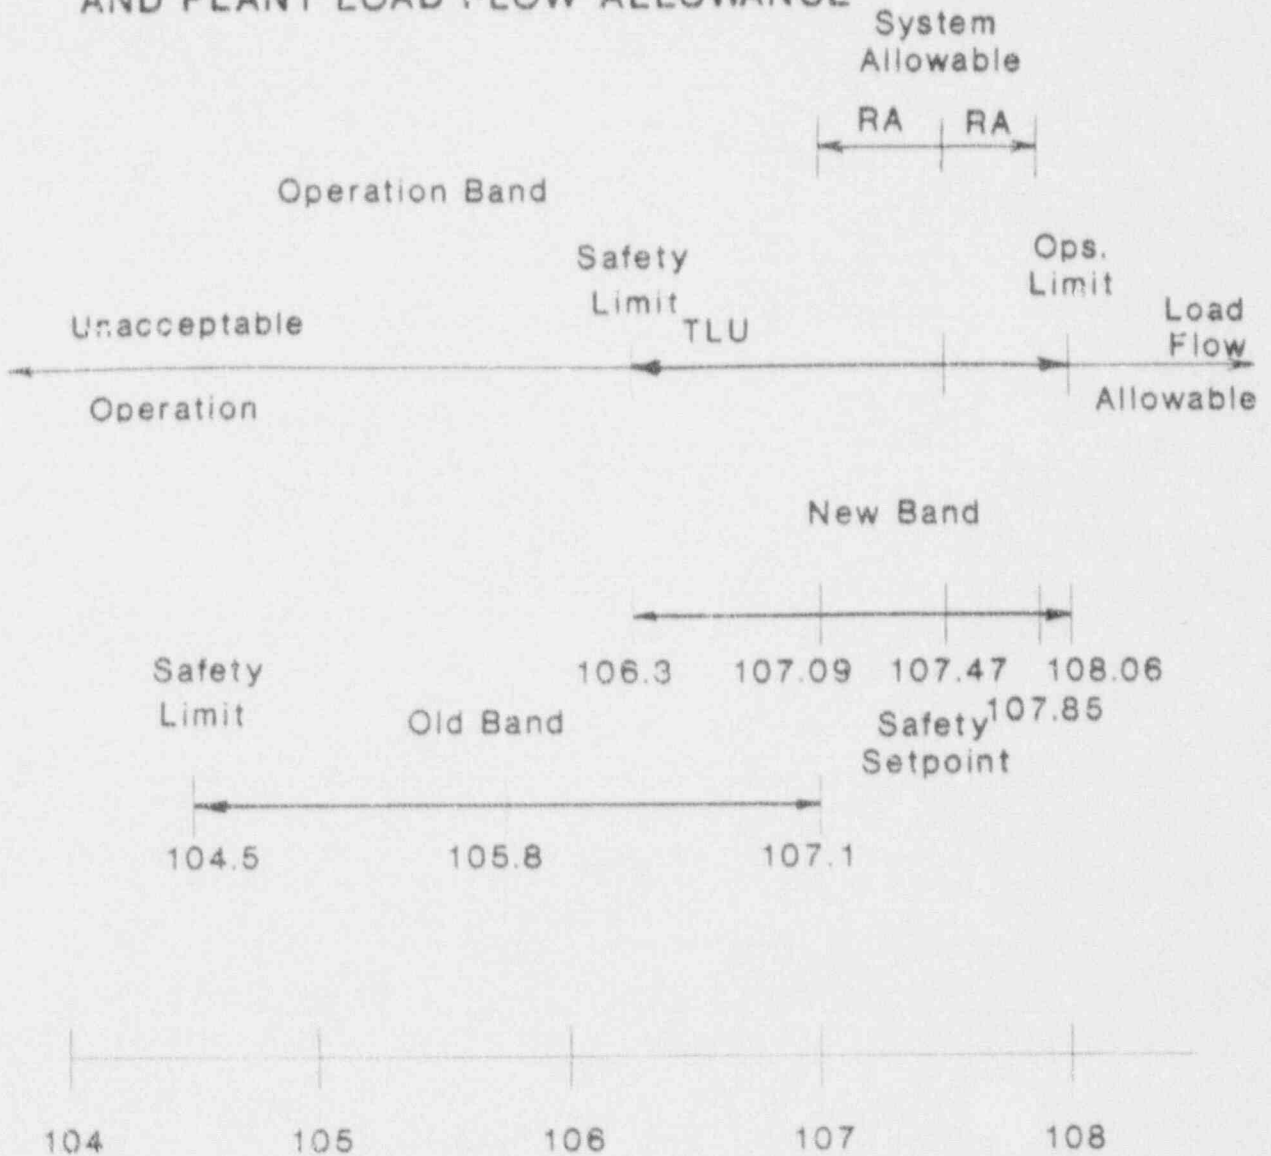
DEGRADED VOLTAGE LOOP UNCERTAINTY BREAKDOWN AND PLANT LOAD FLOW ALLOWANCE

Further analysis was performed by Union Electric to calculate the setpoints by a detailed analysis of the loop uncertainties. The uncertainties were analyzed using ISA Standard DRP 67.04. Attachment 2 includes a summary of the important design inputs, a graph showing the degraded voltage loop uncertainty breakdown and a diagram of the setpoint uncertainty breakdown. Union Electric also performed plant wide load flows to ensure that the plant voltages were coordinated with the new setpoints and the loop uncertainties.
