WOLF CREEK

Reference: Letter dated March 7, 1996, from J. L. Callan NRC,
to N. S. Carns WCNOG
Subject: Docket No. 50-482: Wolf Creek Generating Station Icing
Event Restart Issues

Reply to Enclosure 1
Wolf Creek Restart Issues

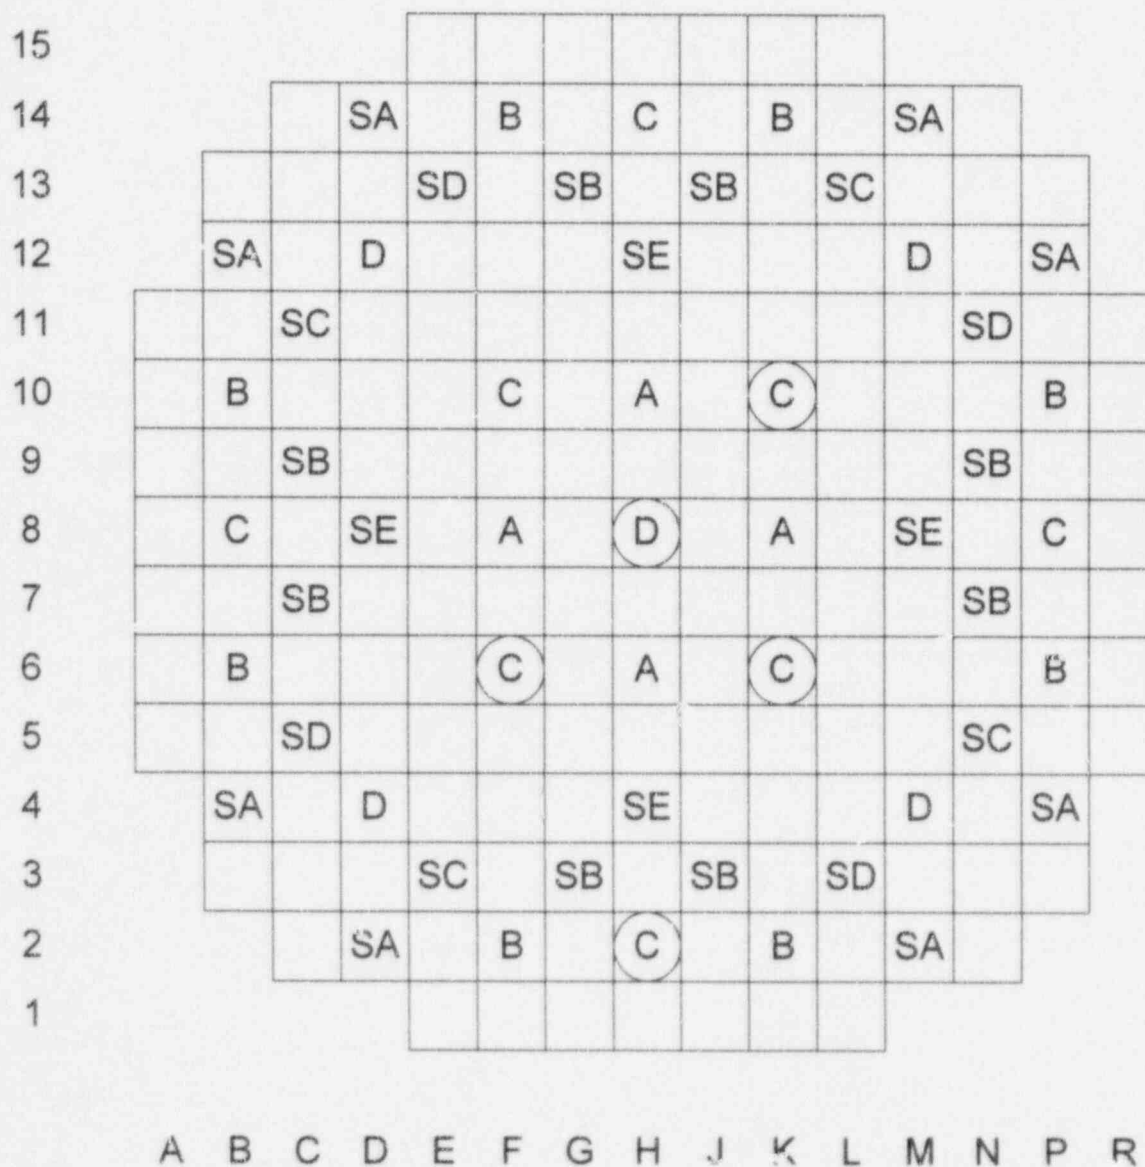
Figure 1-1 - Locations of Rodded Core Locations at WCGS

There were five RCCA's which failed to fully insert. The location of these assemblies is indicated in Figure 1-1 (see page 23). The following fuel assemblies were involved.
