January 24, 1985
PY-CEI/NRR-0173L

Perry Nuclear Power Plant
Docket Nos. 50-440; 50-441
IDI Inspection 84-29 Response

Enclosed is The Cleveland Electric Illuminating Company's response to the results and conclusions of the Integrated Design Inspection of the Perry Nuclear Power Plant. The inspection results are contained in NRC Inspection Report 50-440/84-29, transmitted by your letter of December 12, 1984. The response describes CEI's reviews, evaluations, and corrective actions conducted during and after the inspection. As noted in our response, CEI executive management has closely followed the Integrated Design Inspection and established our response as the top priority in the current PNPP design effort. The format of our response is as follows:

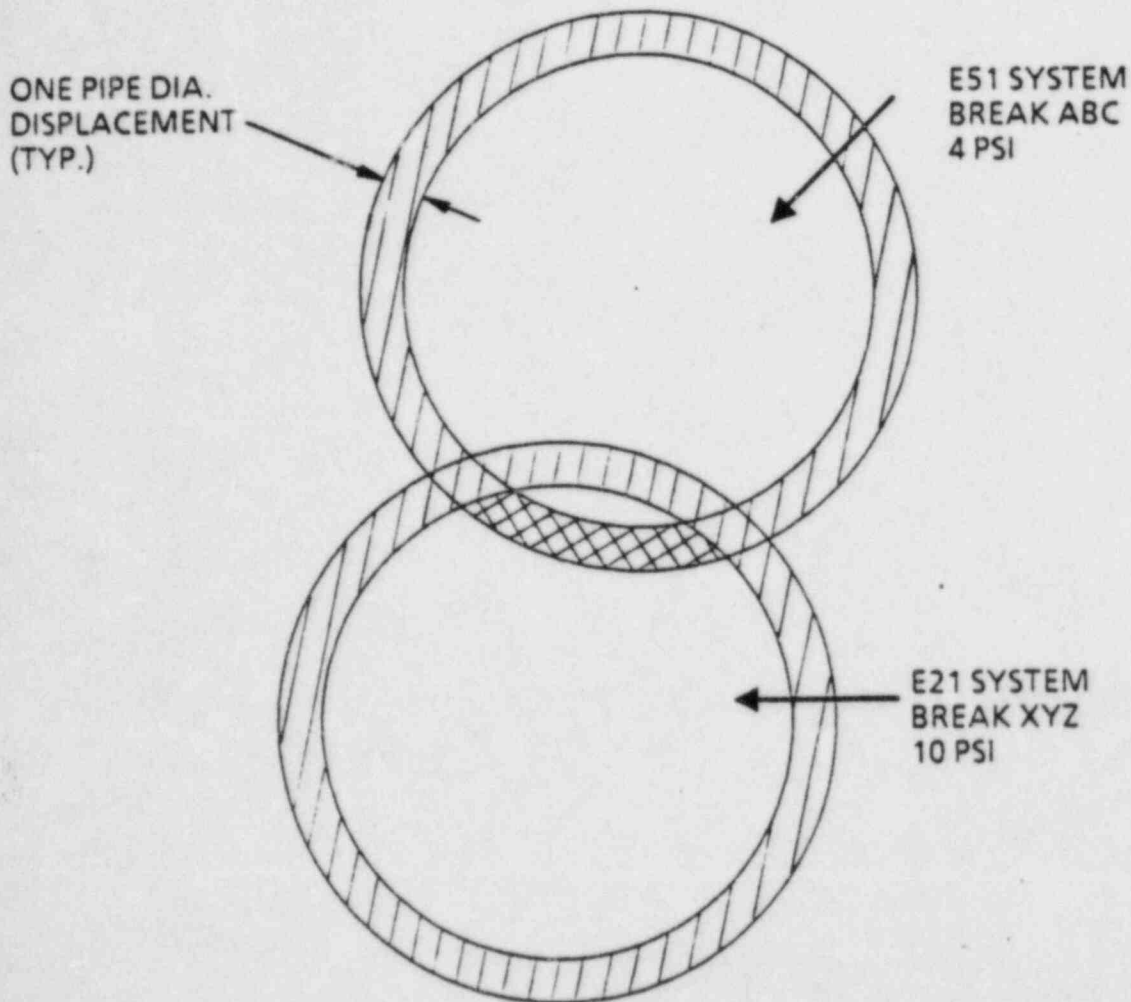
D2.4-5 (Deficiency) Deviation From a Technical Approach With
Respect to Jet Impingement Envelopes

JET IMPINGEMENT INCREASE ENVELOPE DUE TO PIPING DISPLACEMENT (AS CURRENTLY EXISTS ON DRAWINGS).

However, in response to this item, all the Jet Study drawings will be reviewed to identify any safety-related targets located in discontinued band zones not previously identified. This corrective action will be completed by February 1, 1985. For the reasons stated above, it is not expected that any new targets will be identified.
