LICENSEE EVENT REPORT (LER)

FACILITY NAME (1) Sequoyah, Unit 1										DOCKET NUMBER (2) 0 5 0 0 0 3 2 7										PAGE (3) 1 OF 0 7									
---------------------------------------	--	--	--	--	--	--	--	--	--	--------------------------------------	--	--	--	--	--	--	--	--	--	----------------------	--	--	--	--	--	--	--	--	--

Thimble Tube Ejection, Revision 1

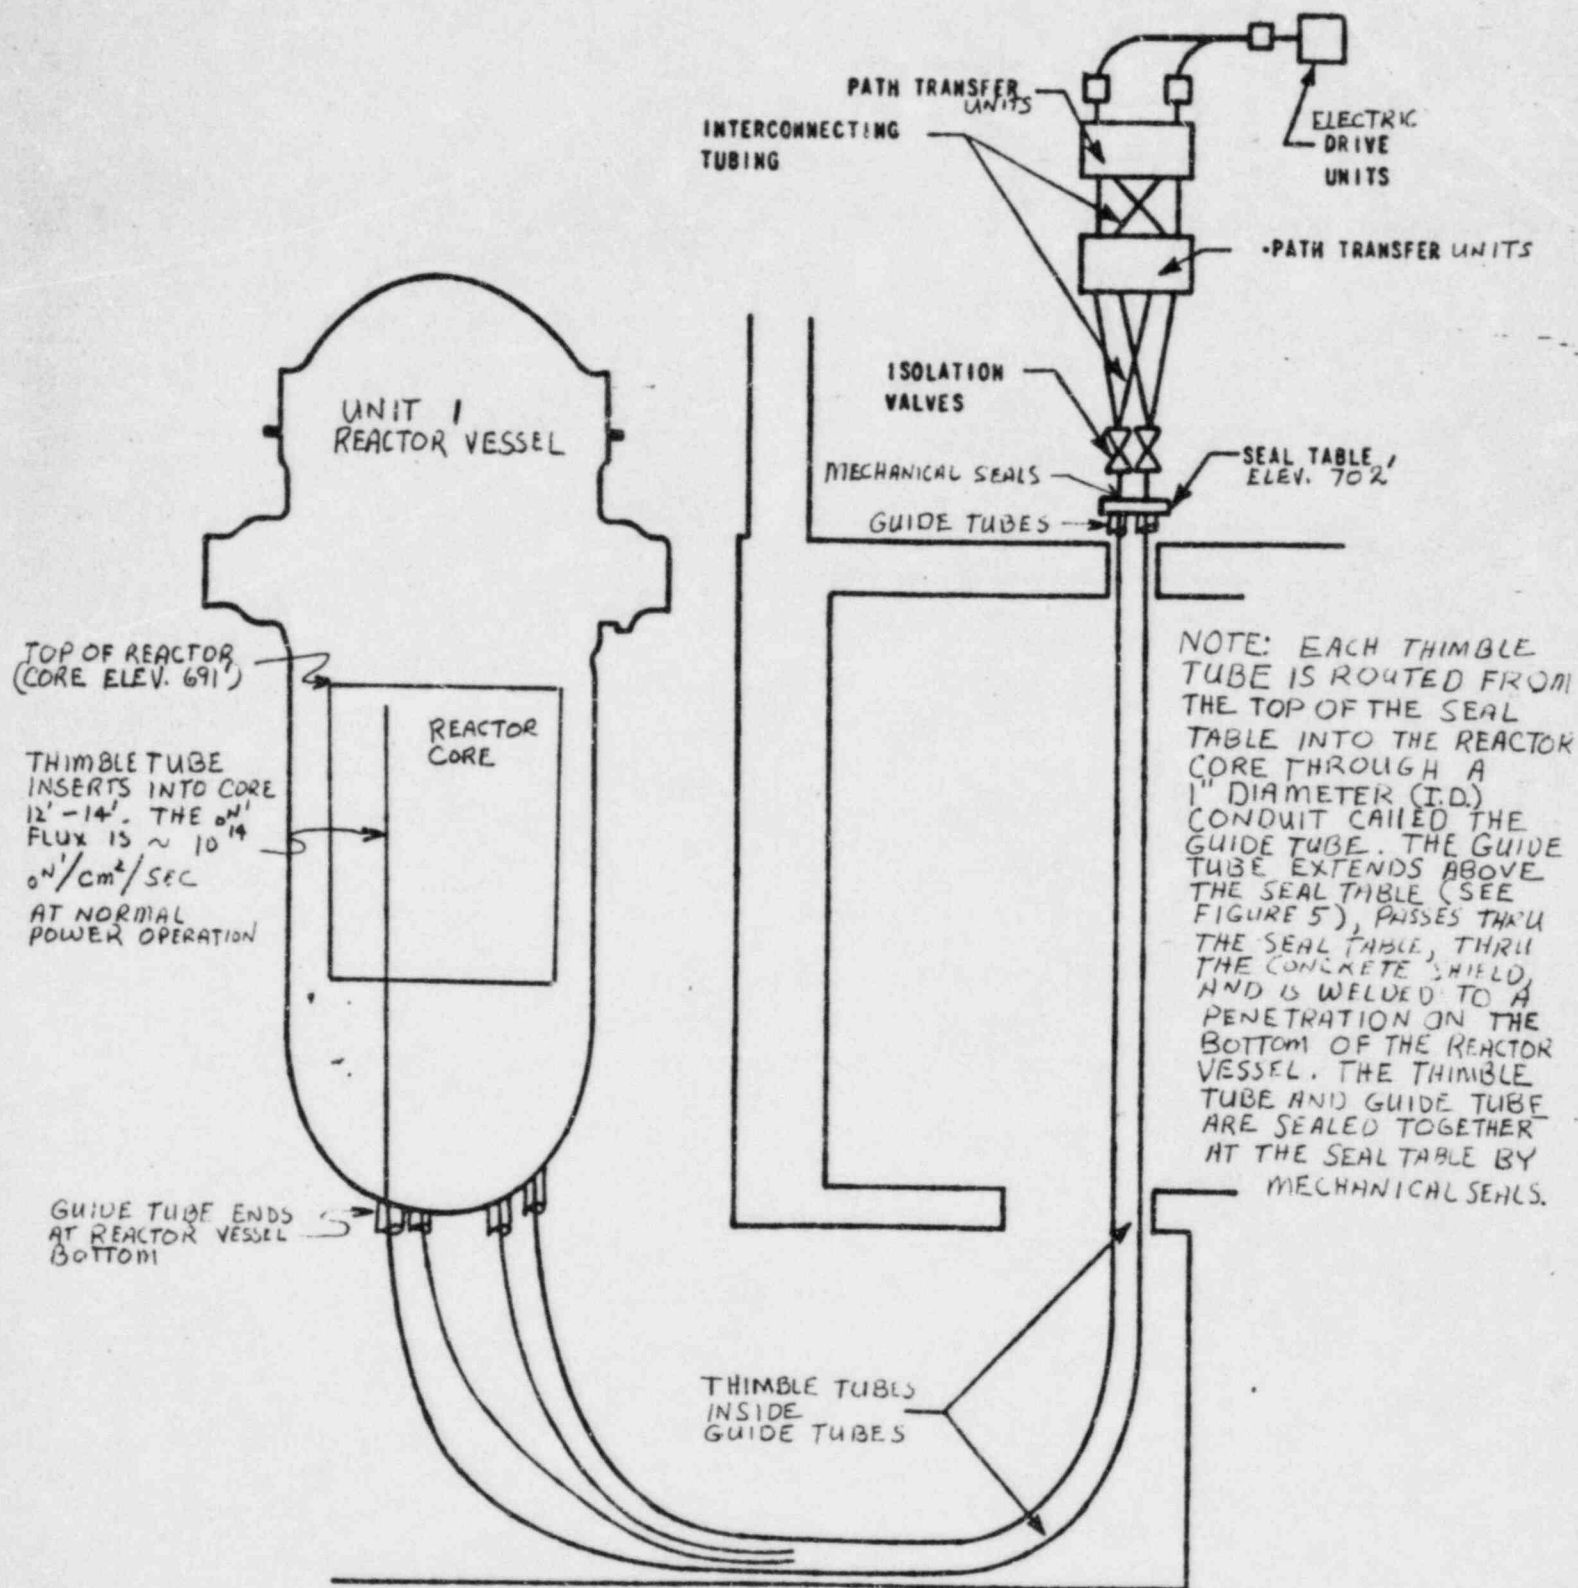
FIGURE 1 INCORE DETECTOR SYSTEM

NOTE: THIMBLE TUBE EJECTION
OCCURRED FROM D-12 (31) LOCATION

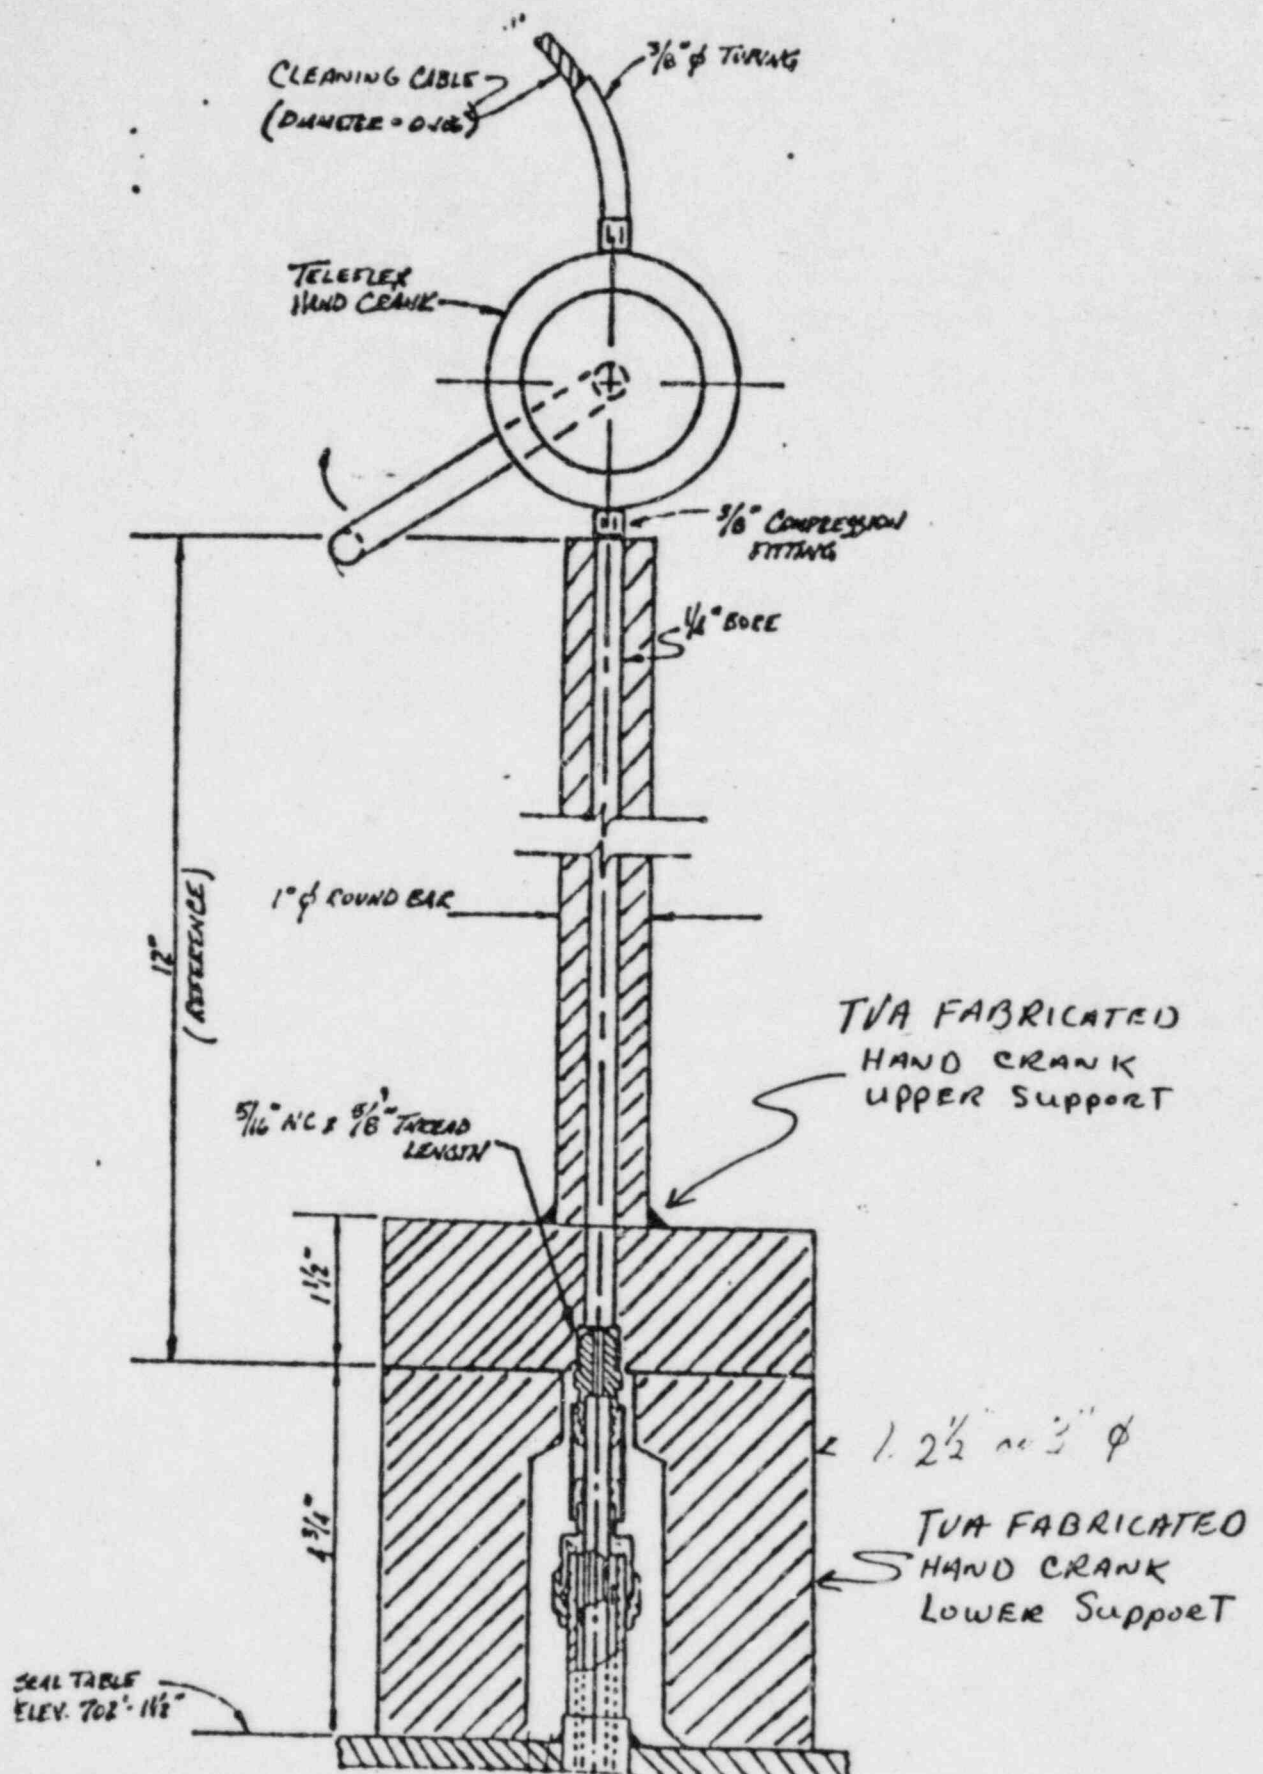
FIGURE 12 A

6. Cleaning fixture imposed unusual forces on the assembly. This appears to be the most probable cause of the failure from the tests performed on the mock-up. Three fittings were failed by a person pushing on the handle of the cleaning fixture mock-up. The failed mock-up tubes were similar in appearance to the actual failed tube and fitting. Strain gauges were installed on the mock-up tube and a measured force was applied to the mock-up handle. A plot was made using applied force versus strain. Tube strains of approximately 1000 strain units were noted just due to installation of the cleaning tool. Evaluation of the plot showed some slippage at 30 lbs. applied force. Some leakage appeared at 140 lbs. force and separation occurred at 250 lbs. force.

The cleaning tool base support was modified and a temporary base was constructed and used without a technical evaluation of the effect on the mechanical seals. No testing was performed before use. Use of the tool and its support was determined during post-accident testing to impose forces of considerable magnitude on the mechanical seals and those forces were found to cause strain sufficient that the thimble tube separated from the mechanical seal.

DRYBRUSHING CLEANING TOOL (TELEFLEX SUPPLIED HAND CRANK) AND TVA
 FABRICATED HAND CRANK UPPER AND LOWER SUPPORT PIECES IN USE WHEN THE
 THIMBLE TUBE WAS EJECTED

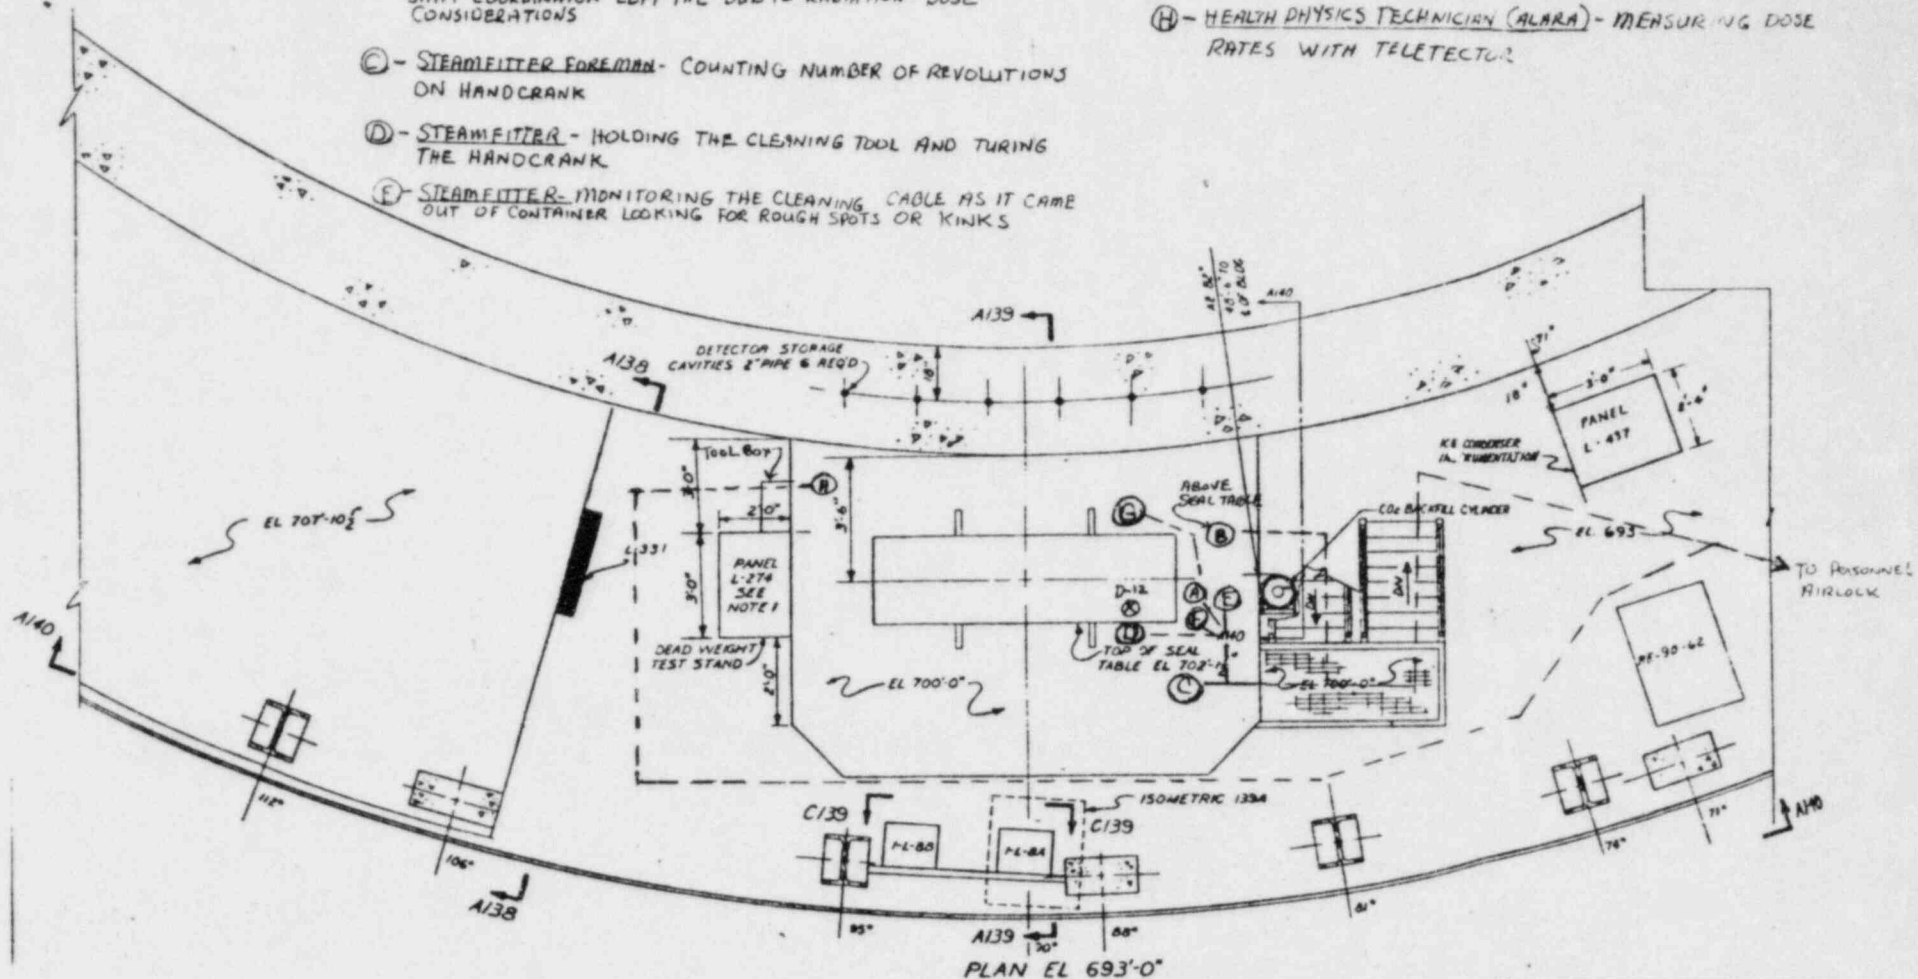
FIGURE 13A

LOCATION OF WORKERS WHEN THE INCIDENT OCCURRED AND EGRESS ROUTES OUT OF THE INSTRUMENT ROOM

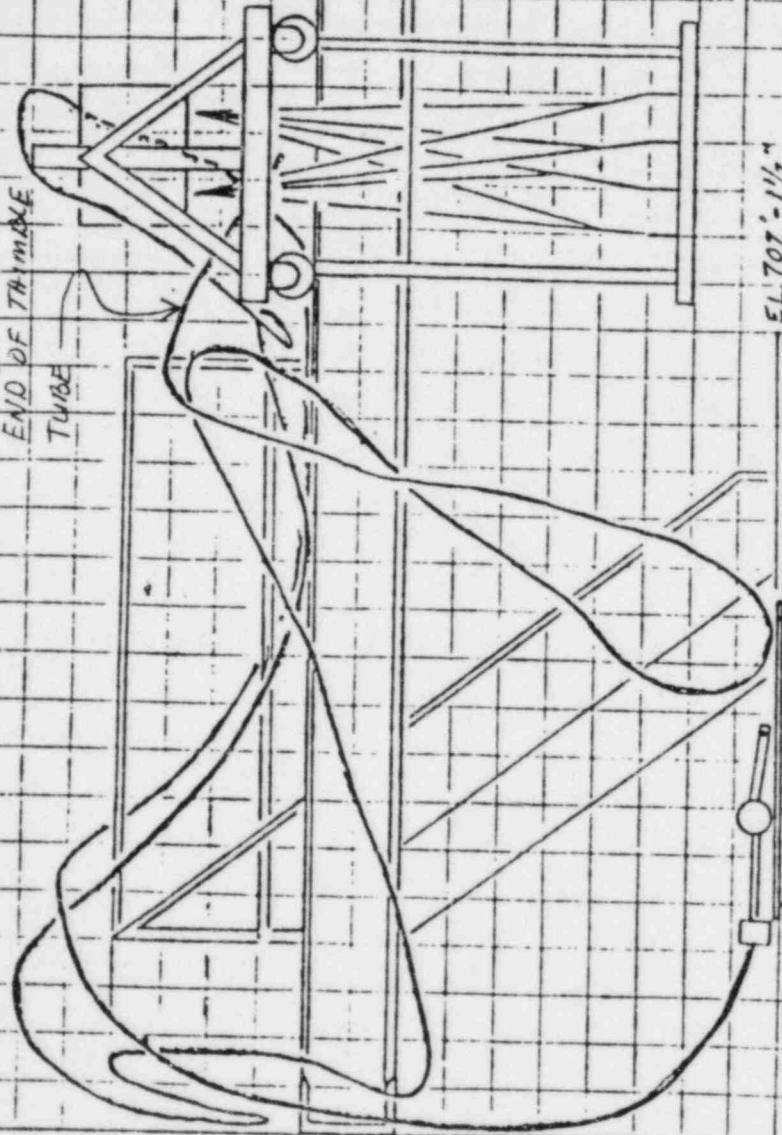
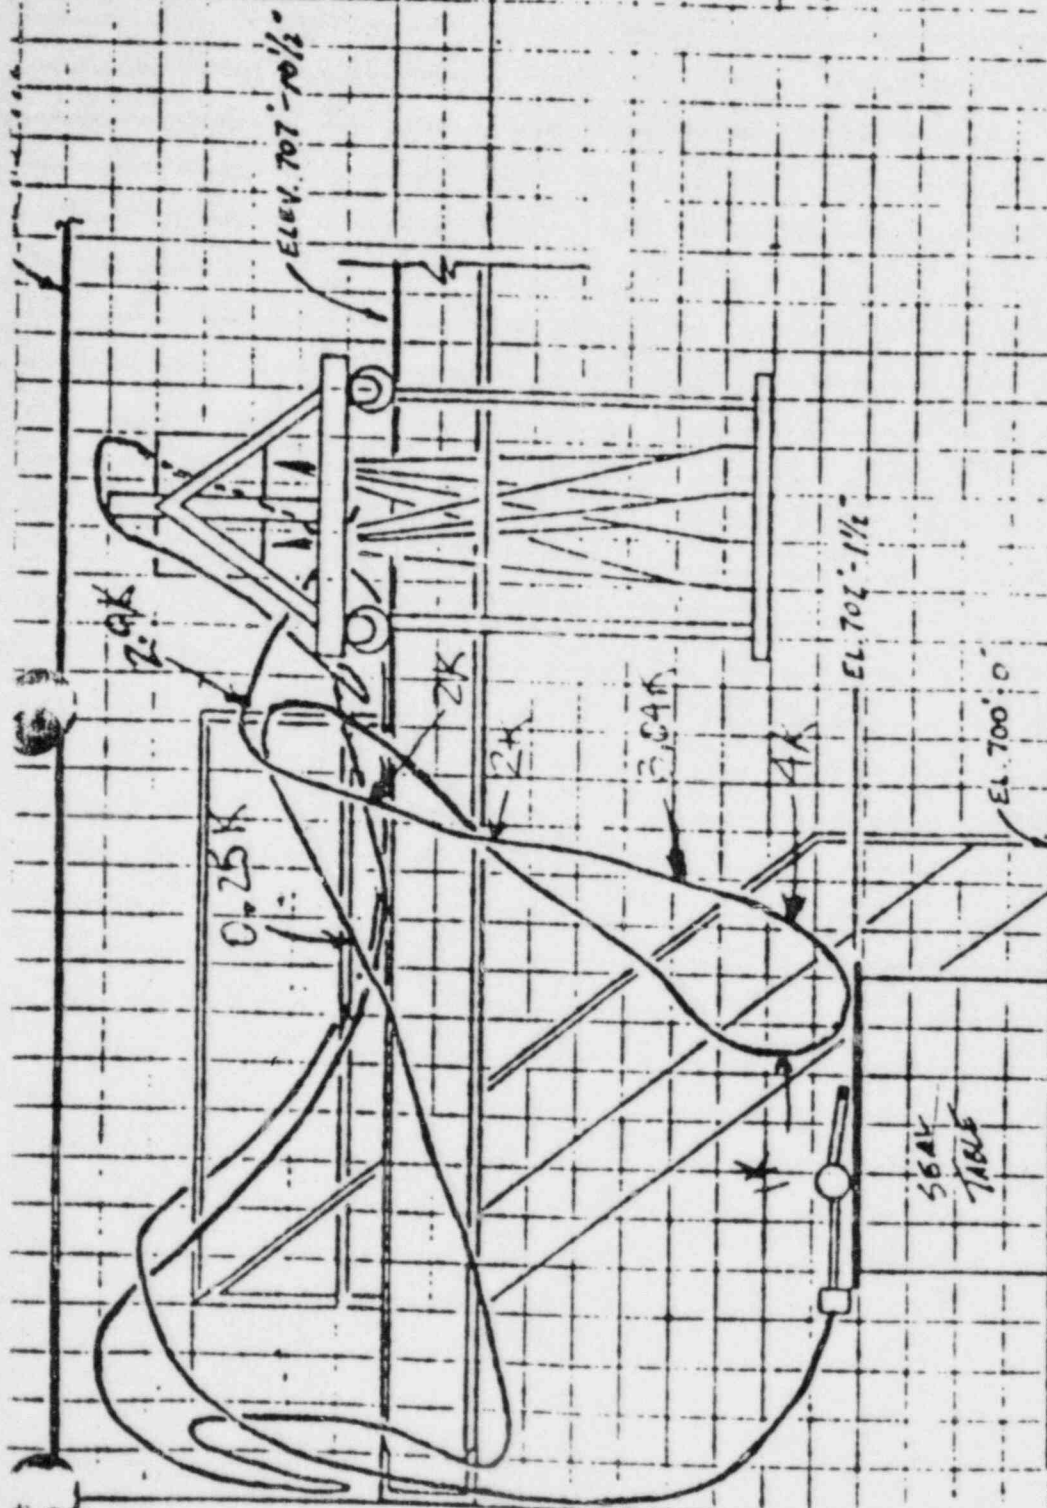
FIGURE 15

At approximately 0900 CST, four personnel entered the seal table area to observe the general condition of the area. Personnel reported the thimble tube to be completely ejected from the guide tube and twisted throughout the room. A small, steady stream of water was flowing from the guide tube at the seal table as a result of the pressure from the nitrogen blanket in the pressurizer. Radiation surveys indicated levels of 2-3 rem at the entrance to the seal table area, 200-300 rem at the end of the tube closest to the seal table, and greater than 1000 rem in the center of the ejected tube.

REPRODUCED DRAWING OF EJECTA THIMBLE TUBE
