Northern States Power Company

MONTICELLO NUCLEAR GENERATING PLANT
Docket No. 50-263 License No. DPR-22
LER 96-002

Emergency Diesel Generator Operability Concerns Due to
Missing Fastener in Voltage Regulator

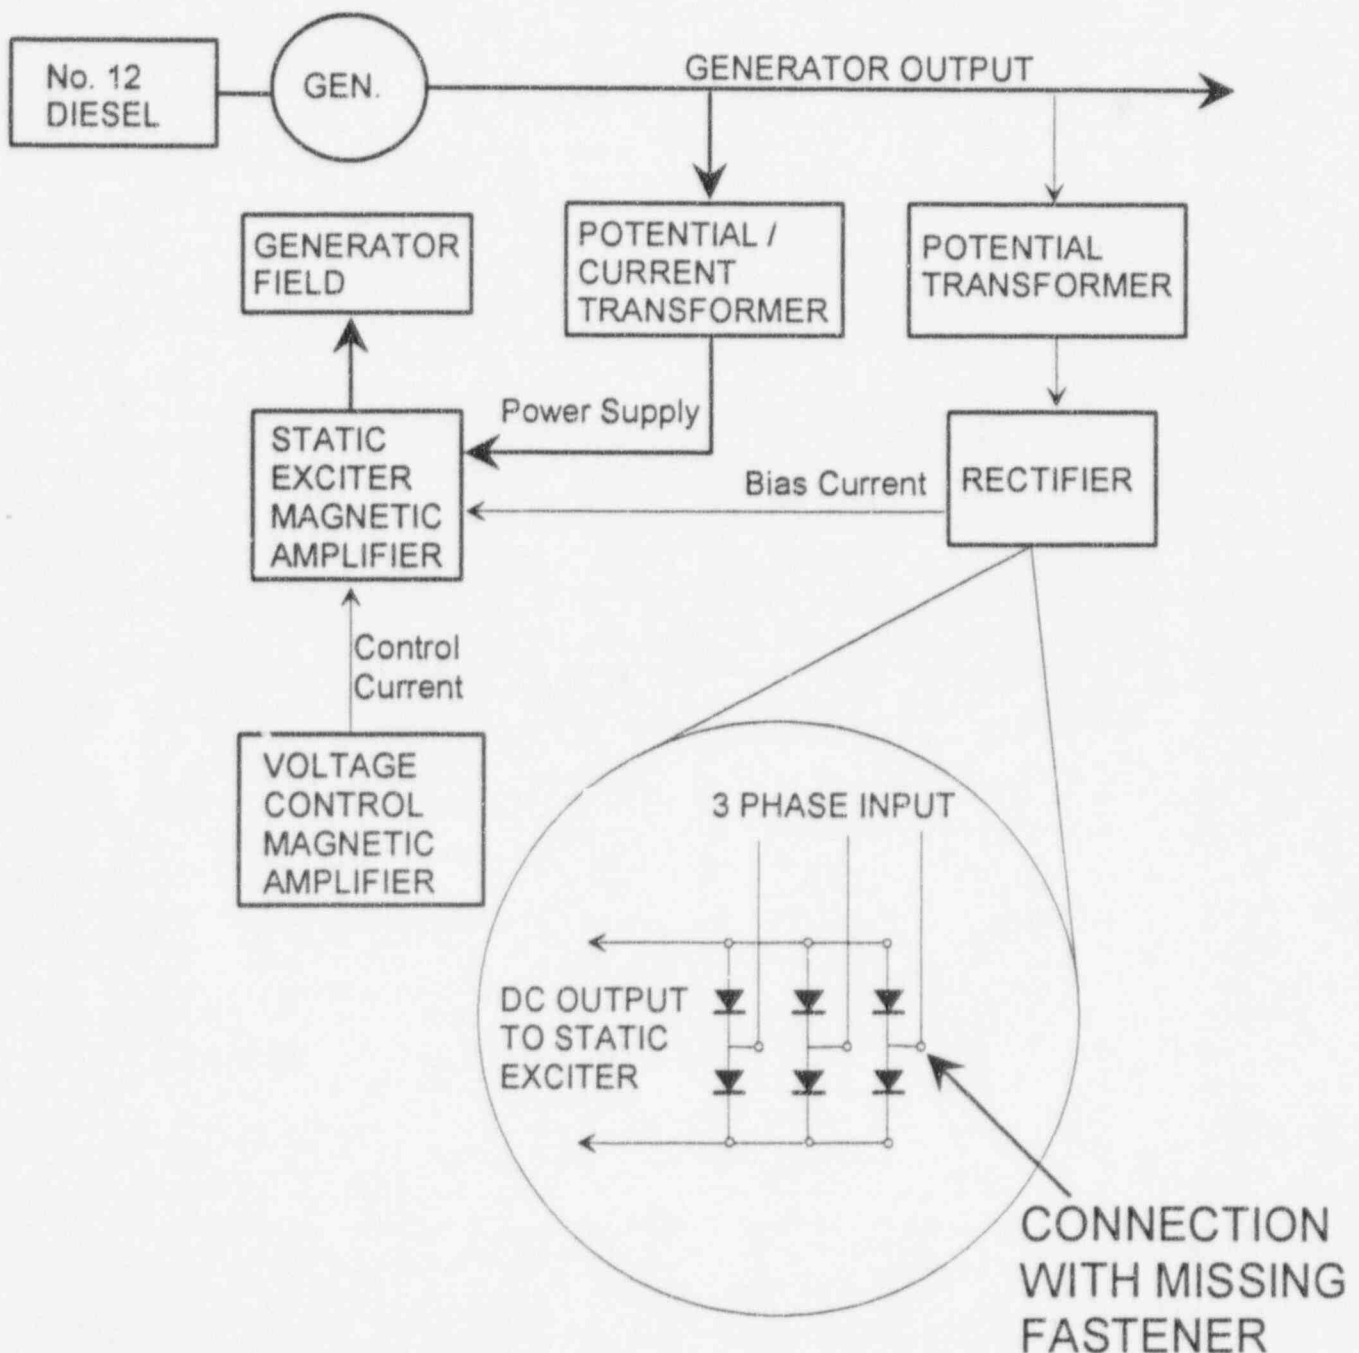
EMERGENCY DIESEL GENERATOR VOLTAGE CONTROL (SIMPLIFIED)

While at 83% power on March 8, 1996, system engineers found a wire in the No. 12 Emergency Diesel Generator (EIS System Code: EK) voltage regulator (EIS Component Code: EC) not properly secured. The wire provides the electrical connection between a potential transformer and a rectifier in the voltage regulator (see attached figure). The wire was promptly secured and the emergency diesel generator (No. 12) was successfully tested. The unaffected redundant emergency diesel generator (No. 11) was also successfully tested.

The wire had a lug on it and the rectifier terminal connection is a metal tab with a hole for the bolt to penetrate. No bolt or nut was present at the connection. The wire was found with the lug in contact with the rectifier terminal and held against the terminal by spring tension in the wire. However, continuous contact between the lug and the terminal during a seismic event could not be assured.
