**Subject:** LaSalle County Nuclear Power Station Unit 1  
L1R07 Core Shroud Inspection Results  
NRC Docket No. 50-373

## Response to Generic Letter 94-03

**ATTACHMENT 1**  
**SHROUD SKETCHES**

WELD H4 EXAMINATION SUMMARY SHEET

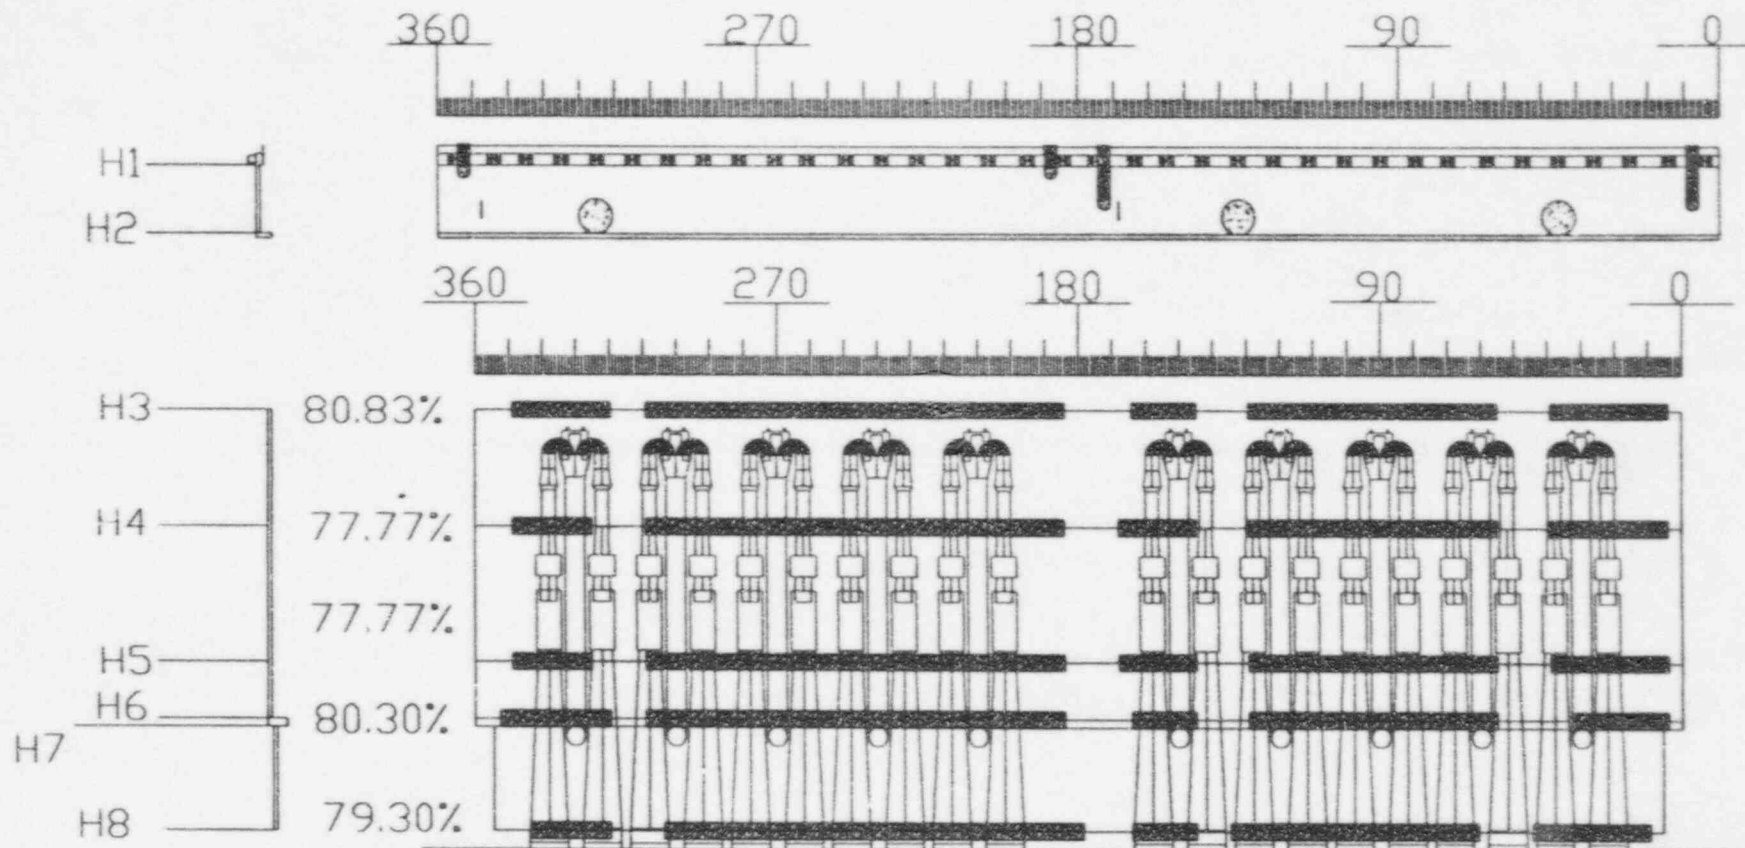
EFFECTIVE COVERAGE FOR  
H3, H4, H5, H6 & H8

Weld H3 - 526.7" examined representing 80.83% of the total weld length.

Weld H4 - 506.8" examined representing 77.77% of the total weld length.

Weld H5 - 506.8" examined representing 77.77% of the total weld length.

Weld H6 - 523.3" examined representing 80.30% of the total weld length.

Weld H8 - 499.6" examined representing 79.30% of the total weld length.

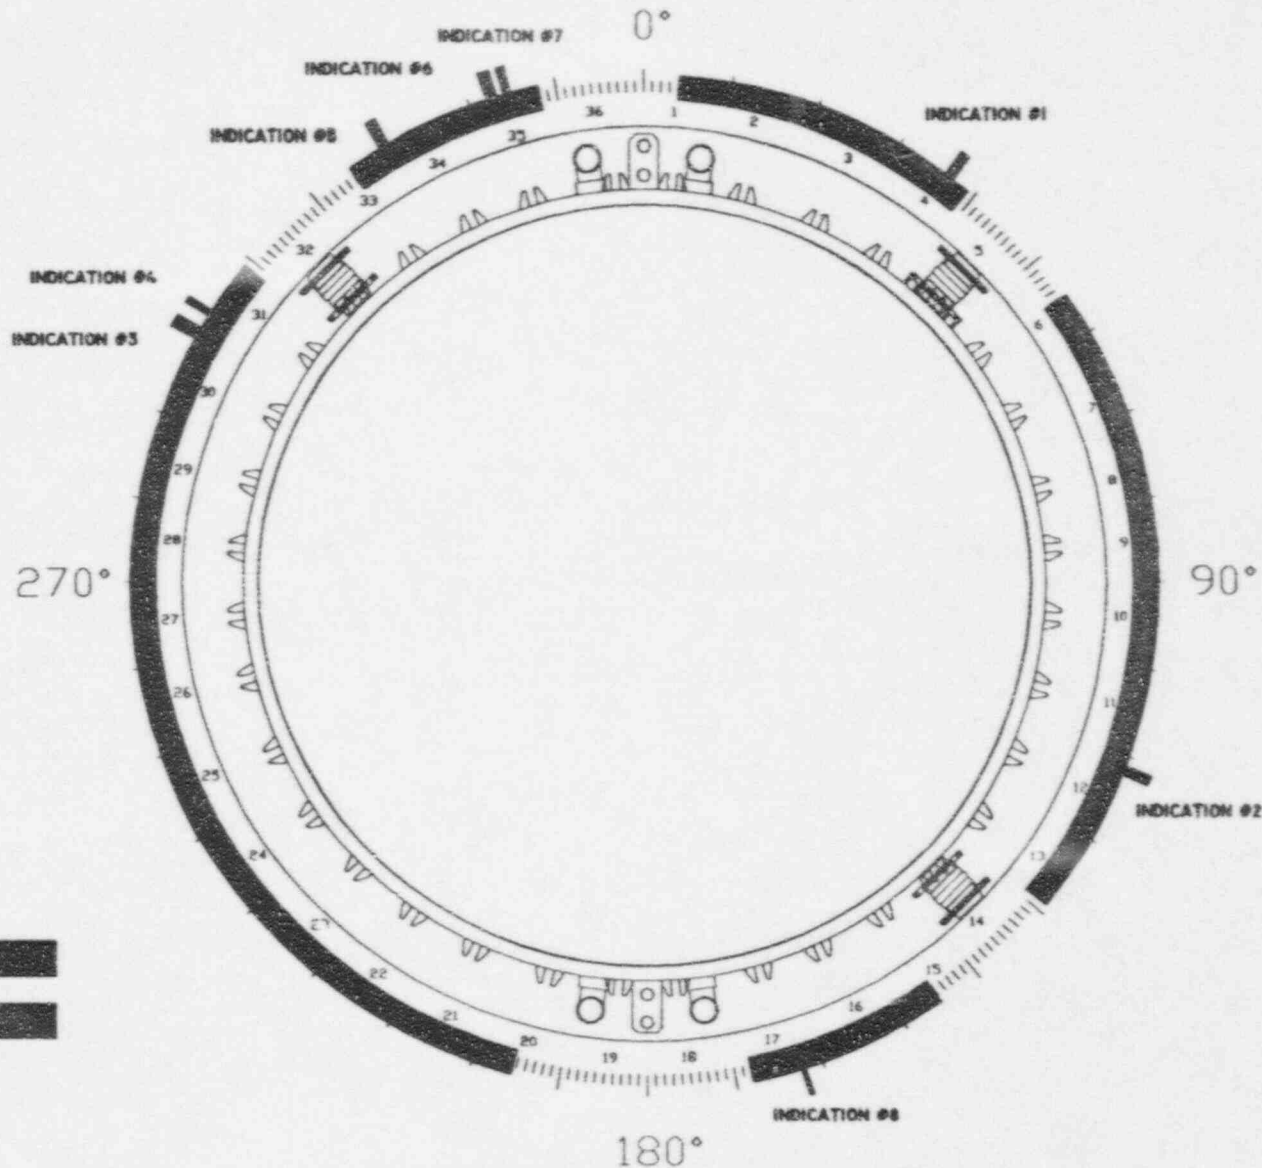
# LASALLE UNIT I SHROUD INSPECTION H4 WELD FLAW & COVERAGE MAP

Eight indications were detected by the 60 degree Refracted Longitudinal and/or the OD Creeping Waves during examination of the H4 circumferential weld. The total combined length of the eight indications is 15.2", representing 3% of the examined

length. The longest of the individual indications is 2.72" long. The depth of the indications does not exceed .60". Ultrasonic data shows that three of the eight indications are OD connected, none of the eight are ID connected. Visual examination of one indication confirmed that it was open to the OD of the Shroud. Attachment 2 (Examination Summary Sheet, Report No. RS-02) provides a detailed summary of the H4 weld examination and the locations and sizes of all of the indications.

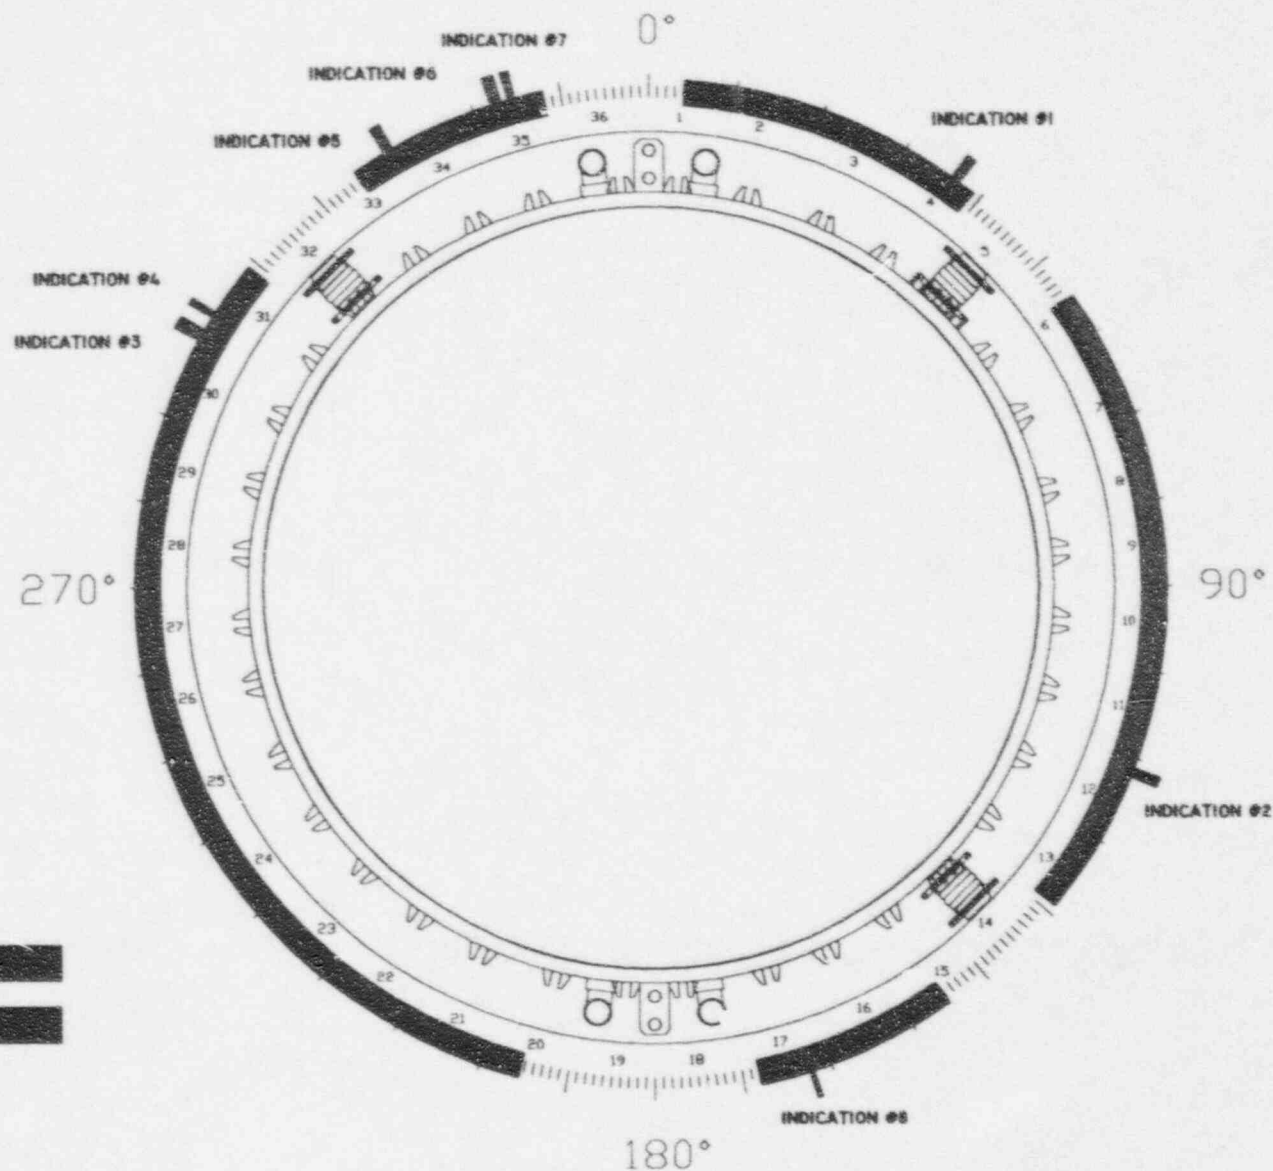
# LASALLE UNIT I SHROUD INSPECTION H4 WELD FLAW & COVERAGE MAP

Indication Number	Distance from Vessel 'O'	Lug Set	Total Length	Flaw Depth	Distance from weld	Side of Weld	Surface Connection	Search Unit
1	35.79°- 36.89°	4	1.1°	*	2.8°	Lower	OD	60°/ODCR
2	110.47°-111.57°	12	1.1°	*	.50°	Lower	**	60°/ODCR
3	298.58°-300.08°	31	1.5°	*	1.1°	Lower	OD	60°/ODCR
4	302.06°-302.86°	31	.8°	*	.90°	Lower	OD	60°/ODCF
5	328.38°-329.58°	34	1.2°	*	.60°	Lower	**	60°/ODCh
6	341.76°- 343.06°	35	1.3°	*	.40°	Lower	**	60°
7	343.95°-344.85°	35	.9°	*	.50°	Lower	**	60°/ODCR
8	161.96°-162.46°	17	.5°	*	.80°	Lower	**	60°/ODCR

Total flaw length is 8.4° or 15.2". The conversion factor for linear units is 1.81" per degree.

Total effective exam area was 284° or 506.8°. This represents 77.77% of the weld length. Effective coverage is the area interrogated by all three beam angles. 100% of all accessible areas were examined. Access was limited due to the proximity of Guide Pins, Core Spray downcomers and LPCI bellows. This examination was performed from the lower shroud shell side only, due to Jet Pump riser brace interference.

Effective Exam Area: 4.1° to 39.1°, 55.1° to 129.1°, 145.1° to 168.1°, 184.1° to 309.1° and 325.1° to 348.1°

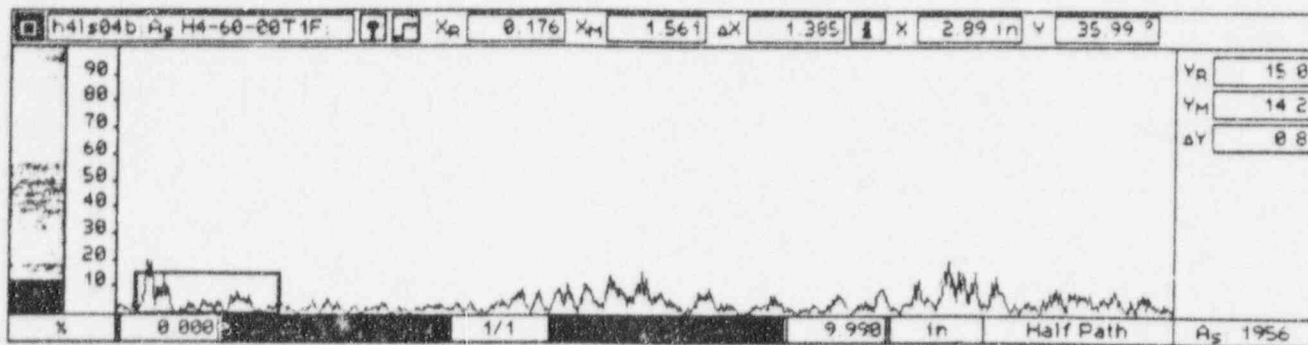
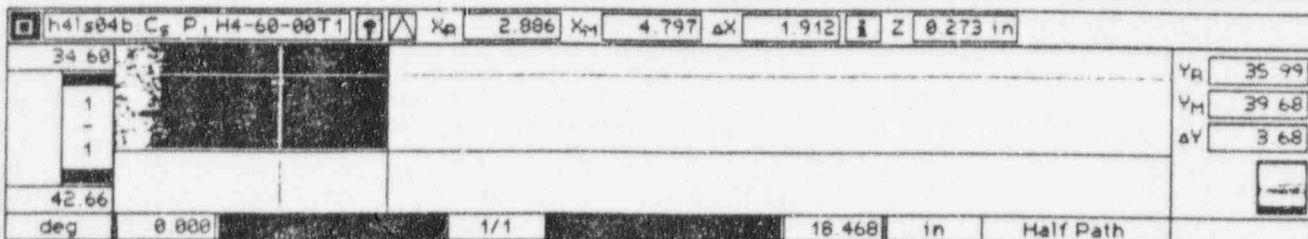
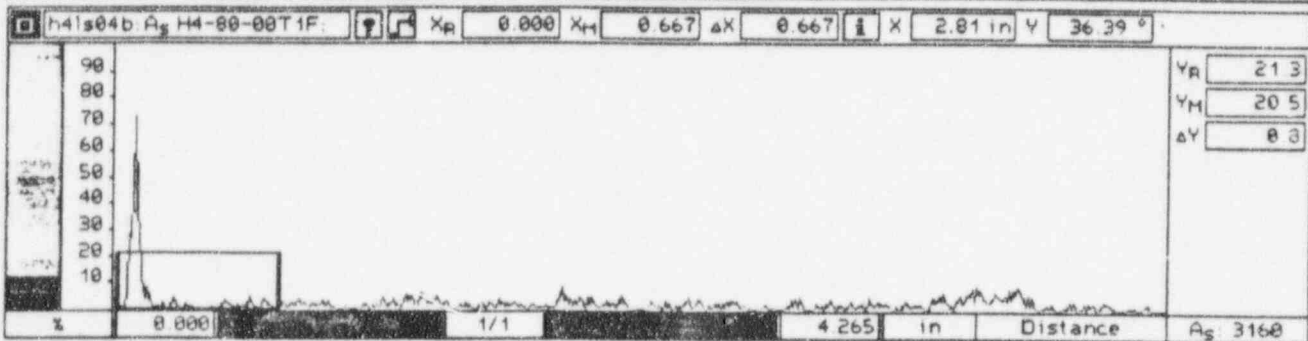
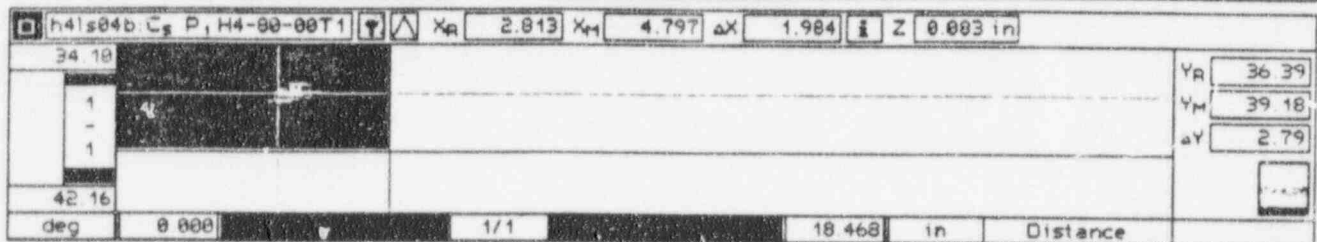
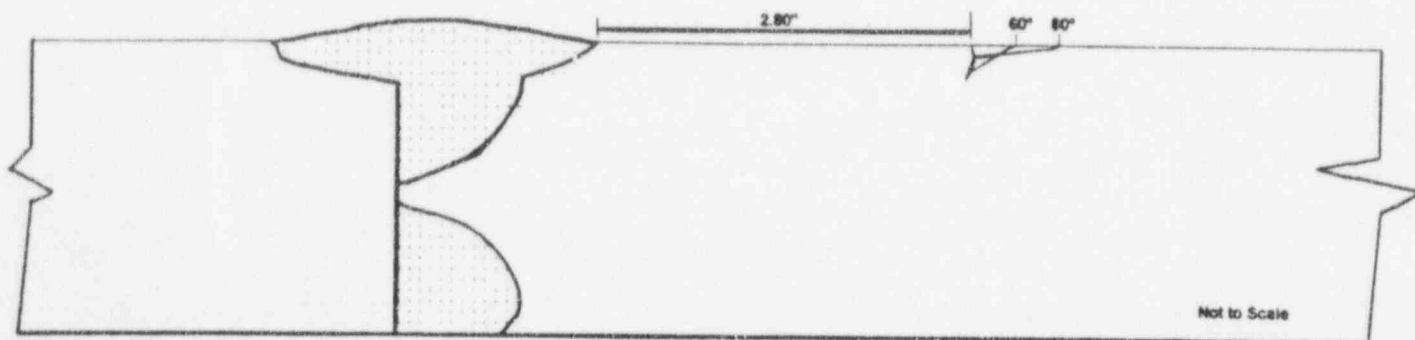
SITE: LASALLE UNIT: 1 PROJECT NO.: L1R07 SUMMARY NO.: RS-02  
WELD NO.: H-4 SEARCH UNIT: 60° & 80° INDICATION NO.: 1 PAGE: 4 OF: 21

Indication # 1, 3 and 4 are OD connected flaws as confirmed by UT. Indication # 1 was also confirmed by visual.

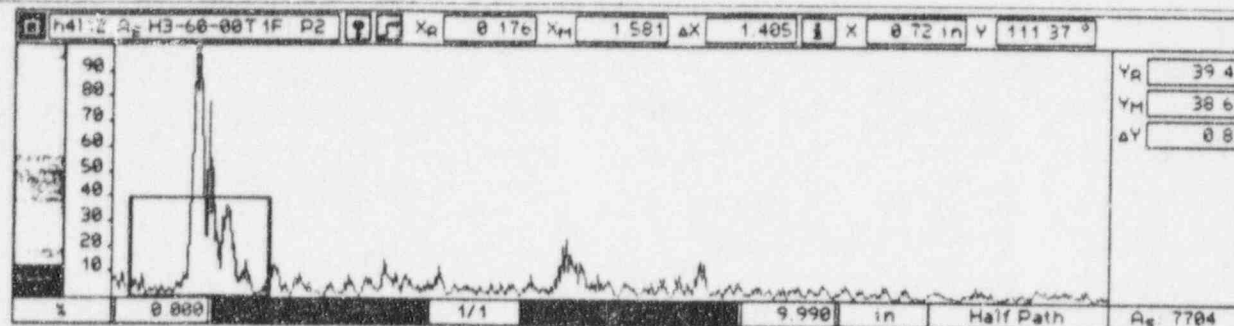
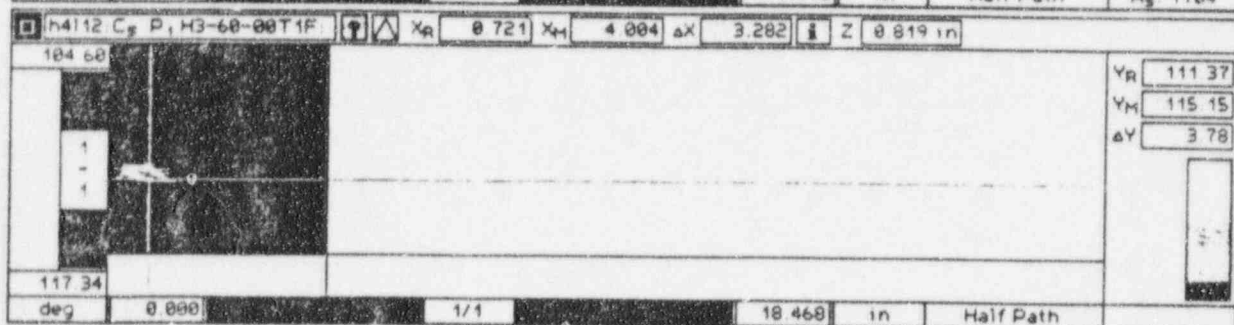
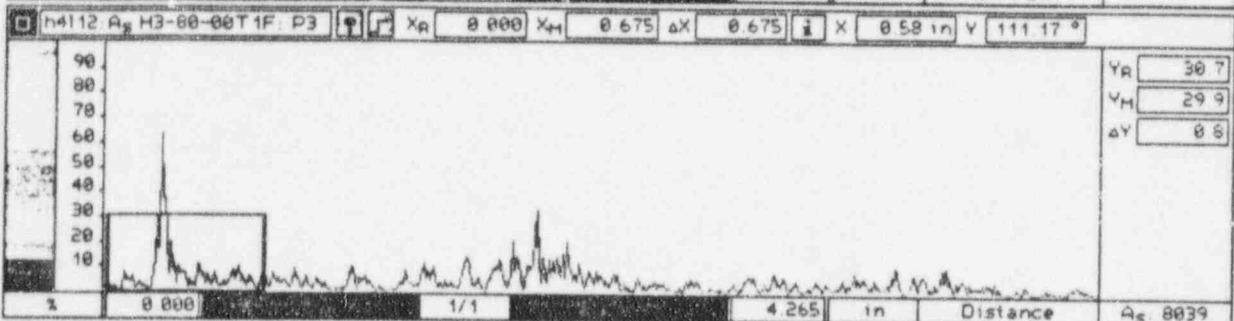
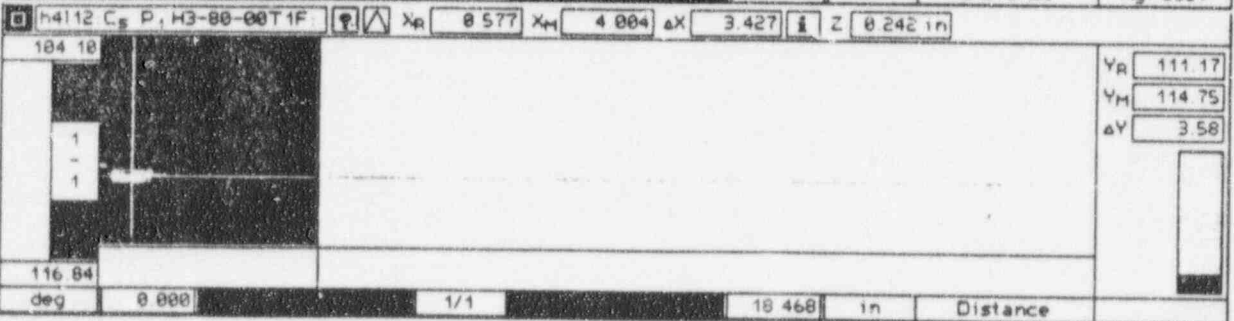
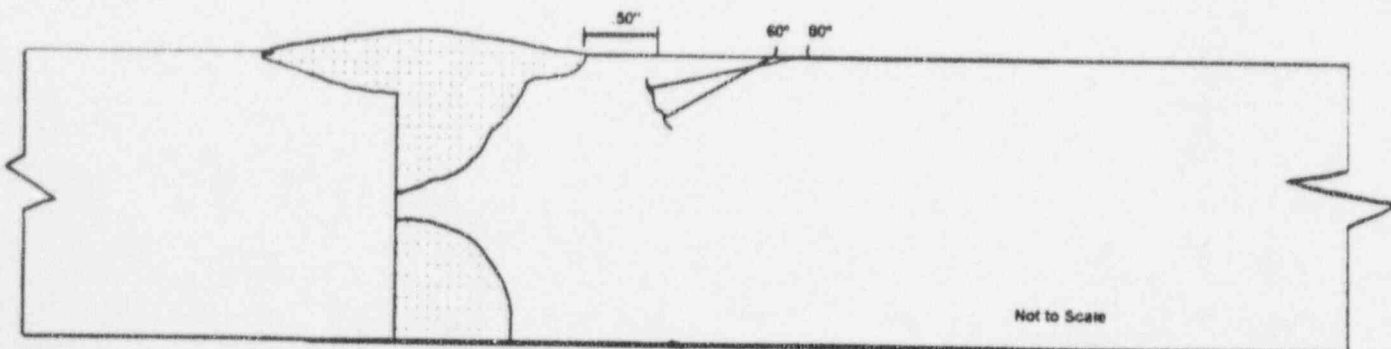
SITE: LASALLE UNIT: 1 PROJECT NO.: L1R07 SUMMARY NO.: RS-02  
WELD NO.: H-4 SEARCH UNIT: 60° & 80° INDICATION NO.: 2 PAGE: 5 OF: 21

Indication # 2 a visual examination was performed and could detect no abnormal condition.

Indications # 2, 4, 5, 6, 7 and 8, the weld crown geometry prevents the search units from scanning over the indication, therefore OD confirmation could not be determined.
