Northeast  
Utilities System

Docket No. 50-423  
B15669

Millstone Nuclear Power Station Unit 3

Reactor Coolant System Pressure Boundary Leak from a Valve Bonnet Stem Leak-Off Pipe

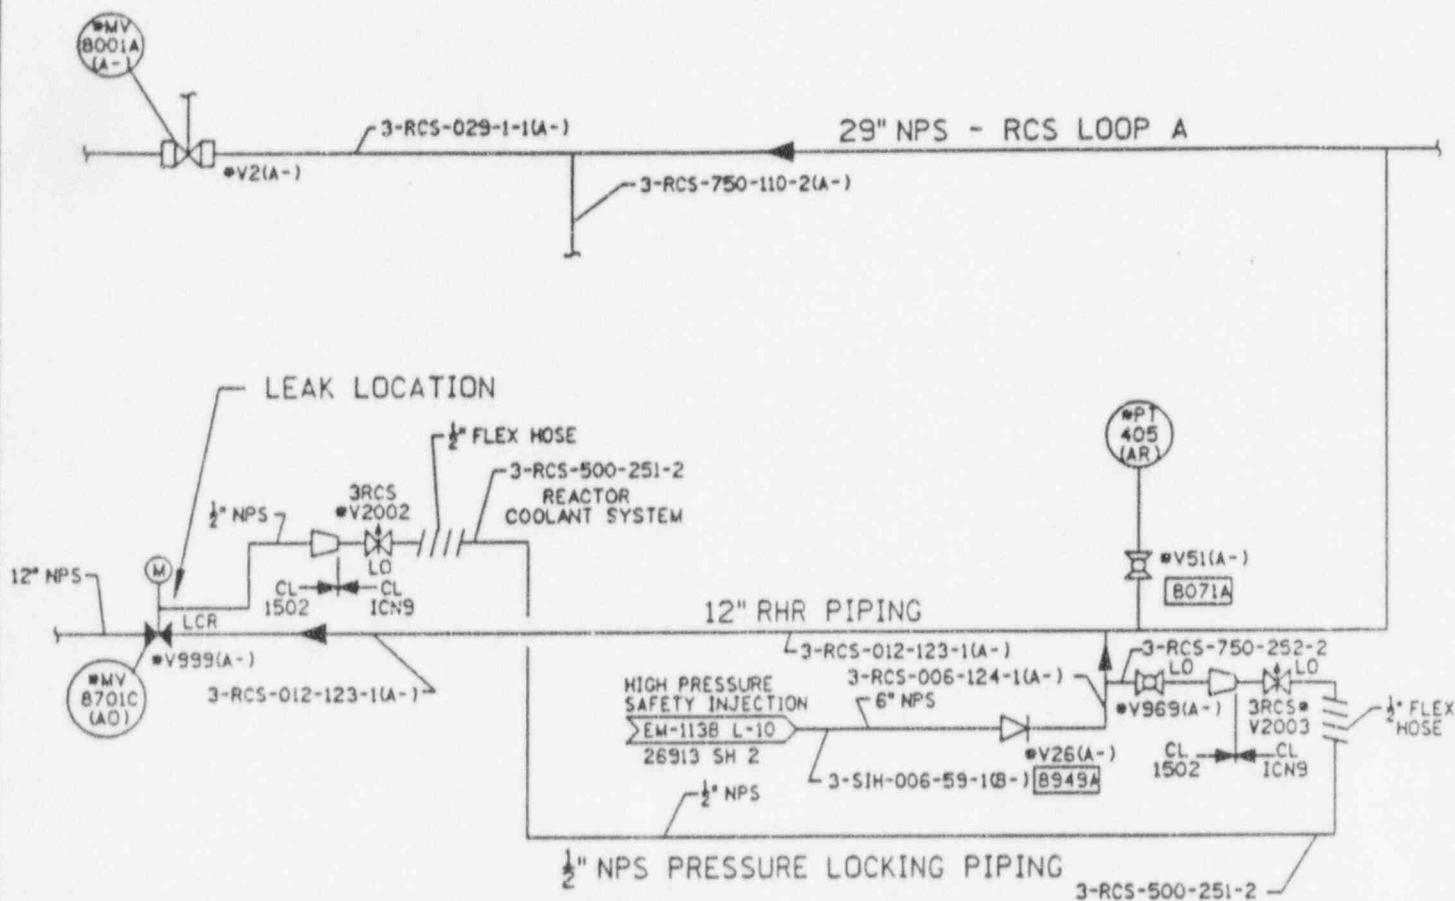
SKETCH 2

3RHS\*MV8701C PRESSURE LOCKING / THERMAL BINDING PIPING

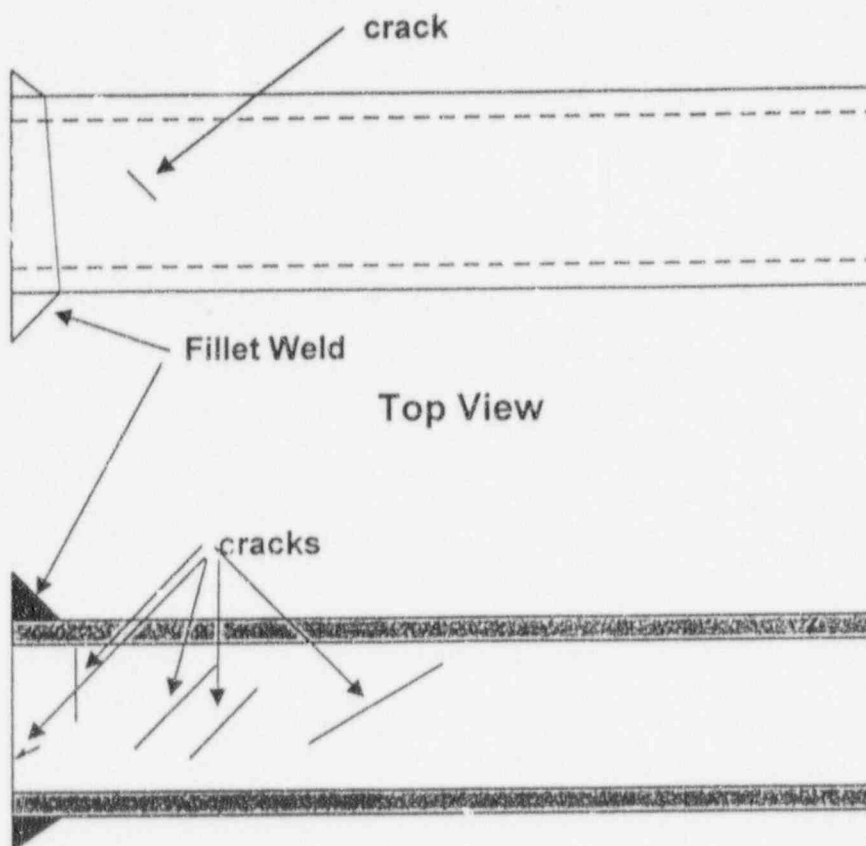
**SKETCH 3**  
Locations of Linear Indications

An initial inspection indicated a crack near the toe of the fillet weld between the pipe and the valve body. The leaking section of pipe was removed for further evaluation which resulted in the discovery of six linear indications at a 45-degree angle to the pipe. (See Sketch 3 for inspection results). None of the indications were in the weld material, all were located in the pipe.

Initial inspection indicated a small crack in the pipe near the toe of the fillet weld between the pipe and the valve body. A further examination of the removed section of piping revealed six linear indications in the pipe, and none in the weld. Five of the indications were at a 45-degree angle to the pipe. The most likely cause of the indications is from mechanically induced tensile overload consisting of a bending or twisting motion. The failures were not the result of a fatigue mechanism, material incompatibilities, the welding process, or service related conditions. The attached Sketch 3 shows the locations of the linear indications.

The location and configuration of the linear indications are consistent with mechanically induced tensile overload consisting of a bending or twisting motion. It cannot be determined exactly when or how the leak-off pipe was mishandled. This condition may have been present since construction/startup. The problem then manifested itself after the pressure locking / thermal binding modification. During this modification, packing which normally isolates the leak-off piping from system pressure, was removed. This allows the upper bonnet area to vent to avoid the pressure locking / thermal binding. This would also be the first time that this pipe saw system pressures.

The failed pipe and valve bonnet weld were removed. A new pipe was installed and welded into the valve bonnet. The fit-up, visual, and liquid penetrant examinations of the weld were satisfactory. A visual examination of the weld was conducted at normal operating pressure and there was no leakage.

The now modified configuration is less susceptible to future tensile overloads. The longer piping configuration is readily visible and would distribute any loads over a longer length from the original six-inch pipe nipple. Additionally, flexible hose and pipe supports added as a result of the modification assist in protecting the pipe from future recurrences.
