Crystal River Unit 3

Subject: Licensee Event Report (LER) 96-009-00

Failure to Re-attach Instrument Tubing to Seismic Supports After Modification Leads to Operation Outside Design Basis

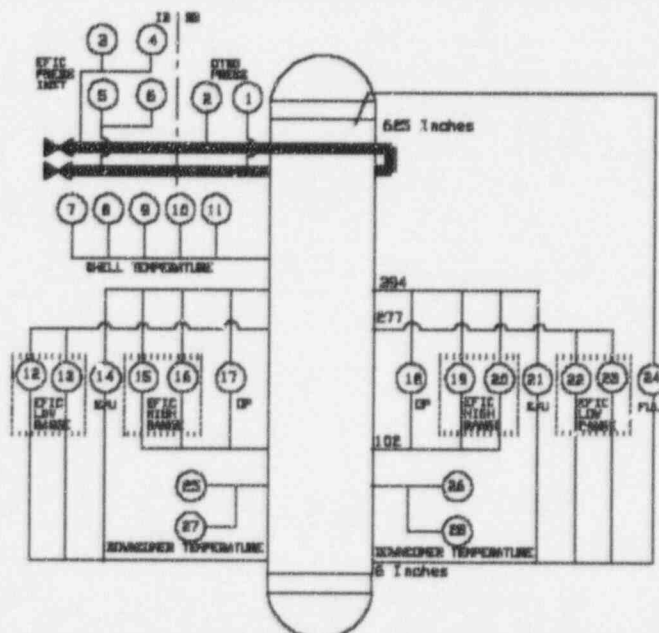
OTSG INSTRUMENTATION LAYOUT

SP-1B-LT4 is one of four transmitters required to provide signals for Steam Generator Startup level monitoring and selectable control signals to the Integrated Control [JA] System (ICS). SP-1B-LT3 is one of four transmitters required to

provide signals for Steam Generator Operating Range level monitoring and control signals to the ICS for feedwater control. Full range non-Class 1E level measurement is provided for indication of each steam generator level but does not provide safety related protective actuation functions. Loss of these instruments during a seismic event would have no impact on the ability to mitigate a design basis accident.

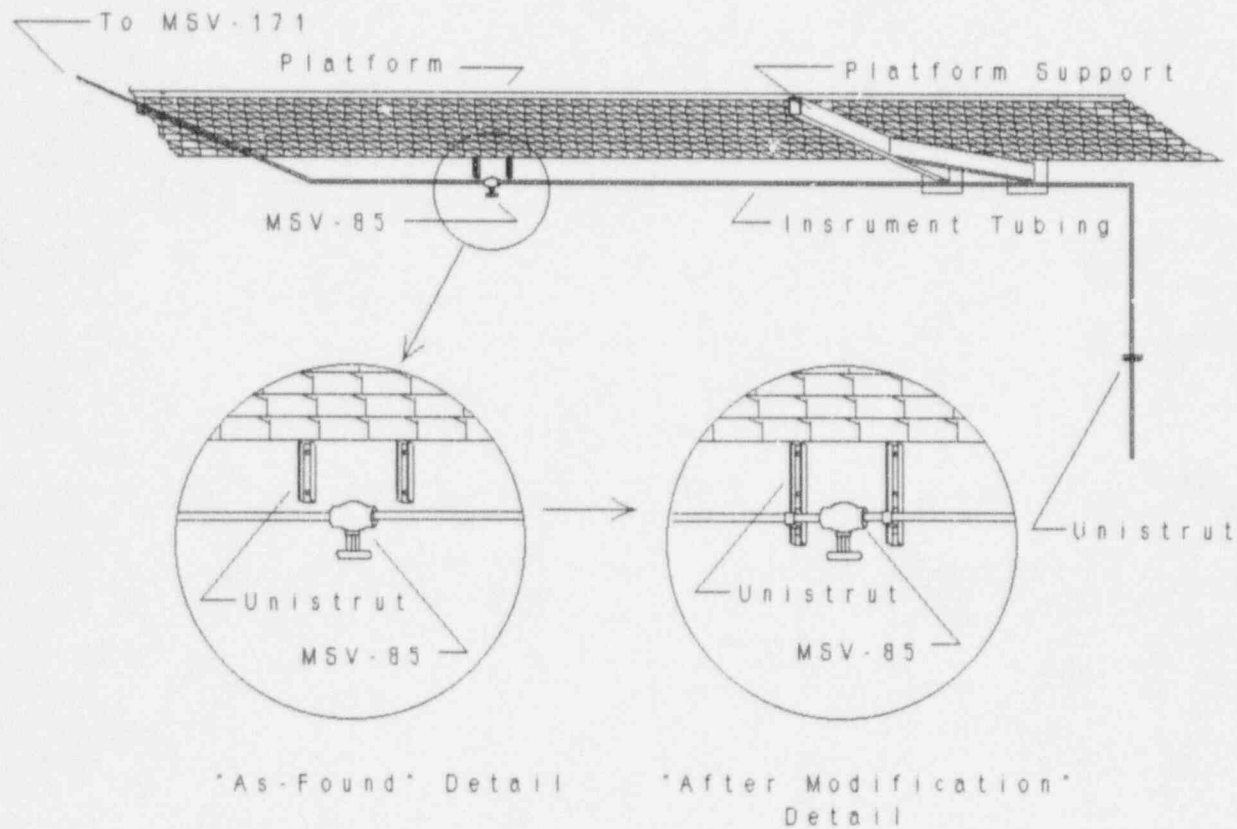
Figure 2

On March 27, 1996, Florida Power Corporation's (FPC) Crystal River Unit 3 (CR-3) was in MODE 6 (REFUELING). A question had been raised regarding the seismic adequacy of instrument tubing in the Reactor Building [NH] (RB) via a Precursor Card by a work supervisor who was performing an unrelated activity. The instrument tubing is located between Main Steam (MS) Instrument Block Valves [SB, ISV] MSV-171 and MSV-85 below a work platform at elevation 135 feet in the RB inside the "D-ring". The Once Through Steam Generators [AB, SG] (OTSG) are surrounded by shielded cubicles called "D-rings" because of their shape. Engineering personnel investigating the condition confirmed that a section of 1/2-inch instrument tubing downstream of MSV-171 had been removed from its seismic supports leading to an unsupported length of approximately 17 feet. CR-3's seismic support criteria for instrument tubing requires the maximum seismic support spacing for 1/2-inch stainless steel tubing to be 80 inches (6 feet, 8 inches). The instrument tubing provides the upper tap for safety related Emergency Feedwater Initiation and Control [JB] (EFIC) high range level transmitters [JB, LT] associated with Channels "B" and "D" for the "B" OTSG. The EFIC High Range level transmitters affected by this event are identified as SP-022-LT and SP-024-LT on Figure 1. Additionally, the instrument tubing serves the same purpose for the "B" OTSG non-Class 1E Startup Level transmitter [SJ, LT] and Operating Range Transmitter. The transmitters in this category affected by this event are identified as SP-1B-LT4 and SP-1B-LT3 on Figure 1. The tubing had been removed from its seismic supports in 1992 to allow installation of a crossover work platform between Reactor Coolant (RC) Pumps [AB, P] RCP-1C and RCP-1D. The investigating engineer determined the design of the work platform did not provide sufficient clearance to allow the tubing to be re-attached to its previous points.

EFIC System components essential to safe shutdown are designed as Seismic Category I in order to maintain system functional integrity during an earthquake. Shortly after the reporting of this event, engineering personnel evaluated the as-found condition of the unsupported section of tubing and noted it was stressed above code (Power Piping Code USAS B31.1) allowables due to deadweight. The evaluation determined that under seismic loading, the tubing would have been stressed above the ultimate tensile capacity of the tubing material, ASTM A213, TP304. As a result, it was concluded that the affected section of tubing would not have been capable of performing its design function during a design basis seismic event. As a minimum, the tubing would have crimped and resulted in inaccurate instrument reading. It is also possible this section of tubing would have ruptured, causing a breach in the secondary side of the OTSG pressure boundary. Although the analysis conservatively indicated the section of tubing was at yield stress under normal loading, no permanent deformation of the tubing was noted on field observation of the as-found condition. It is reasonable to conclude that a more rigorous analysis would demonstrate the tubing did not yield. It is Engineering's conclusion that no permanent damage or degradation was experienced by this section of tubing as a result of this event.

The cause of this event was personnel error/inattention to detail. The crossover platform between RCP-1C and RCP-1D was one of several work platforms installed in the Reactor Building (RB) in 1992 (Refuel 8R). The platforms were installed for required maintenance and access to valves located throughout the RB for inspection and line-up. A review of the work package reveals there are no instructions that address the need to detach instrument tubing. Consequently, there are no instructions that address the need to re-attach the tubing which was removed from its supports. There is no record of anyone notifying field engineering personnel that supports for this tubing were not long enough to mount the clamp that supported the tubing. The original supports were 8 inches long and needed to be at least 11 inches long to provide sufficient clearance around a structural member associated with the work platform. See Figure 2. The tubing would have required bending in order to re-attach to the original supports.

UNSUPPORTED INSTRUMENT TUBING

1. A modification was installed to modify the original instrument tubing supports on both side of MSV-85 to facilitate re-attaching the instrument tubing, thereby returning the instrumentation to full qualification.
2. A memorandum has been issued to Maintenance Department supervision including a copy of this LER as an attachment. Maintenance supervision will be requested to convey the information to responsible department personnel as a "lessons learned".
3. Discussions have been held using this LER as a basis, with Project Managers who are responsible for closing out modification packages. These discussions served to raise the sensitivity of the Project Managers to this issue and promoted a questioning attitude with respect to those modifications that may not require an independent walkdown of the work activity.
