Crystal River Unit 3

Subject: Revised Response to a Notice of Deviation

FLORIDA POWER CORPORATION
NRC INSPECTION REPORT NO. 50-302/95-16
REPLY TO A NOTICE OF DEVIATION

DEVIATION 50-302/95-16-05

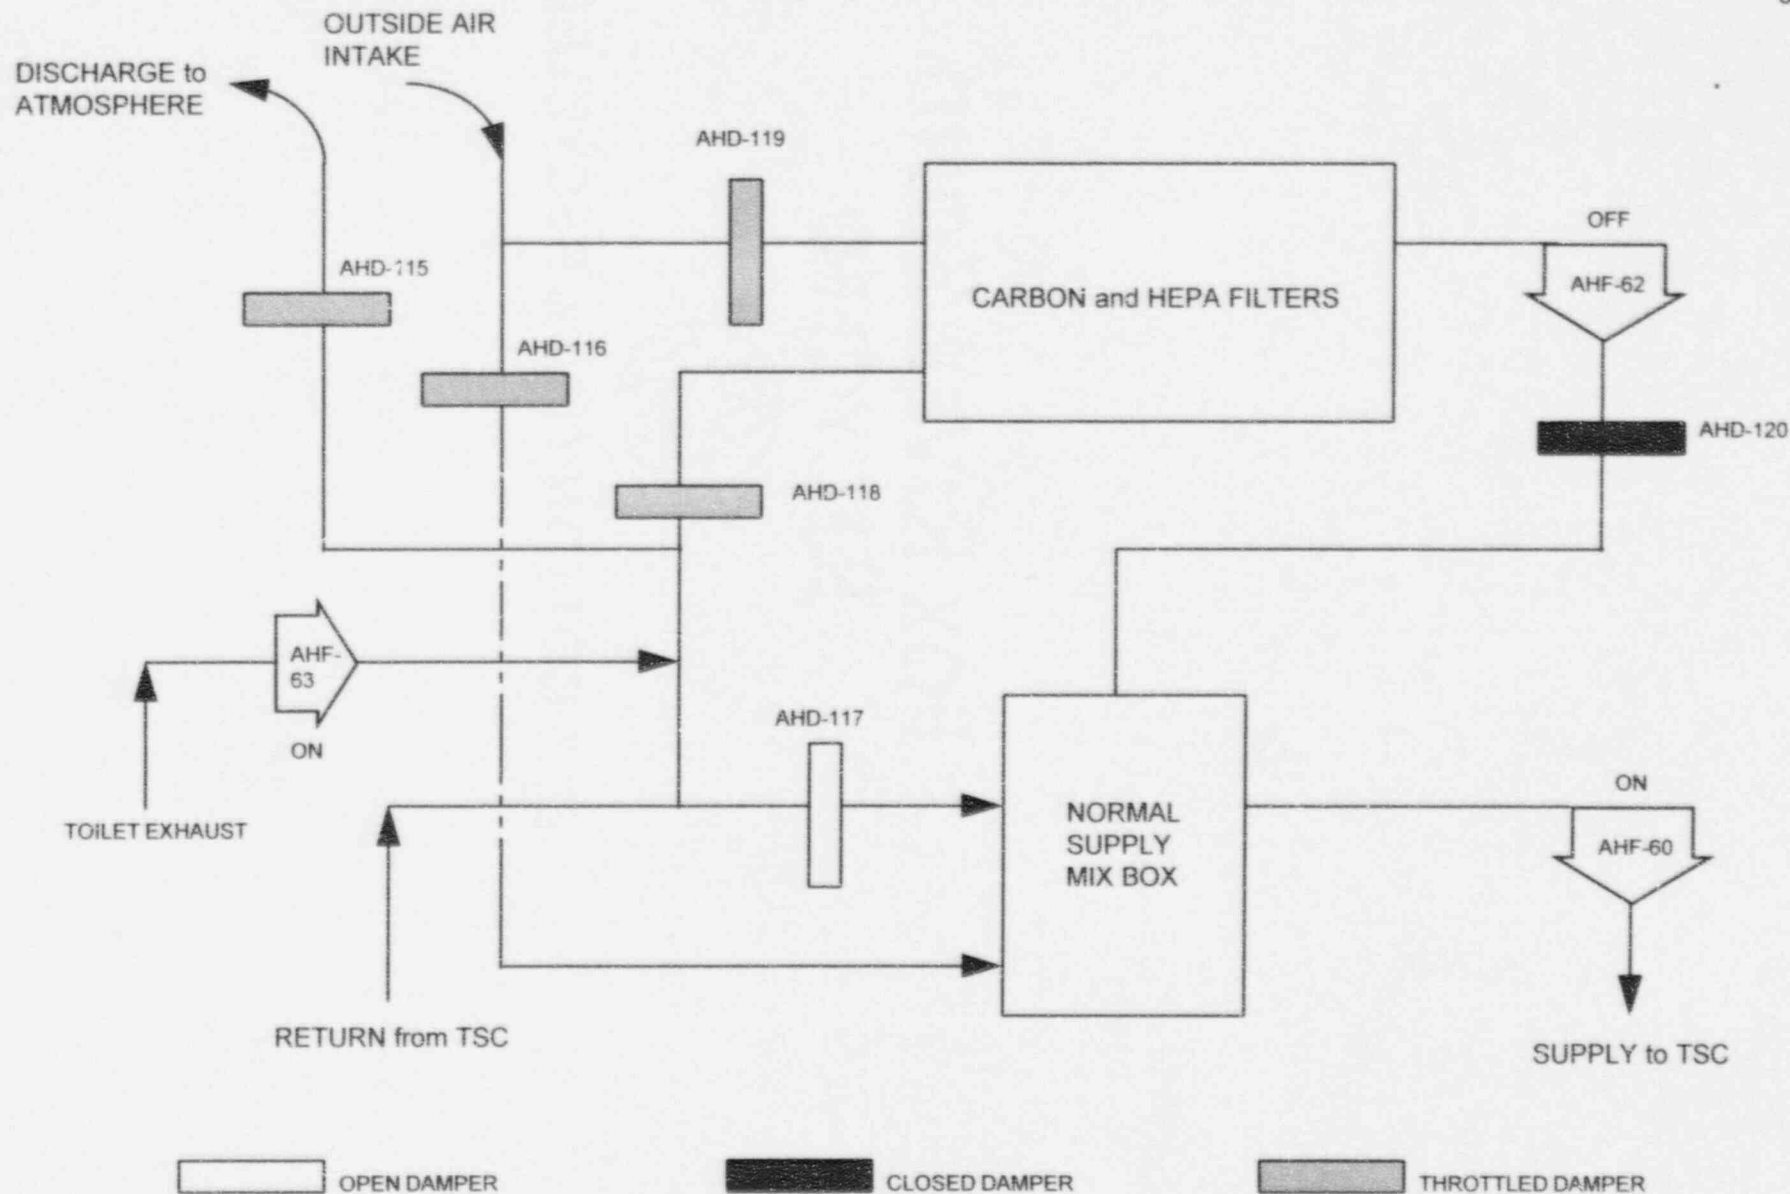
1. Fan performance substantially exceeded design flow requirements. This required throttling of system dampers to a point where slight changes had significant affects on system flows.
2. Motorized dampers were used to balance system flows. In conjunction with the excessive fan performance, repeatability of damper position when the system was cycled could have affected flows.
3. System operation relies on a positive building pressure to prevent in leakage and assumes zero leakage past the normal make-up damper (AHD-116) and relief air damper (AHD-115). These were found to be leaking. See Figures 1 and 2 for flow diagrams of the original TSC Ventilation system.

Figure 1
Original TSC Ventilation System - Normal Operation

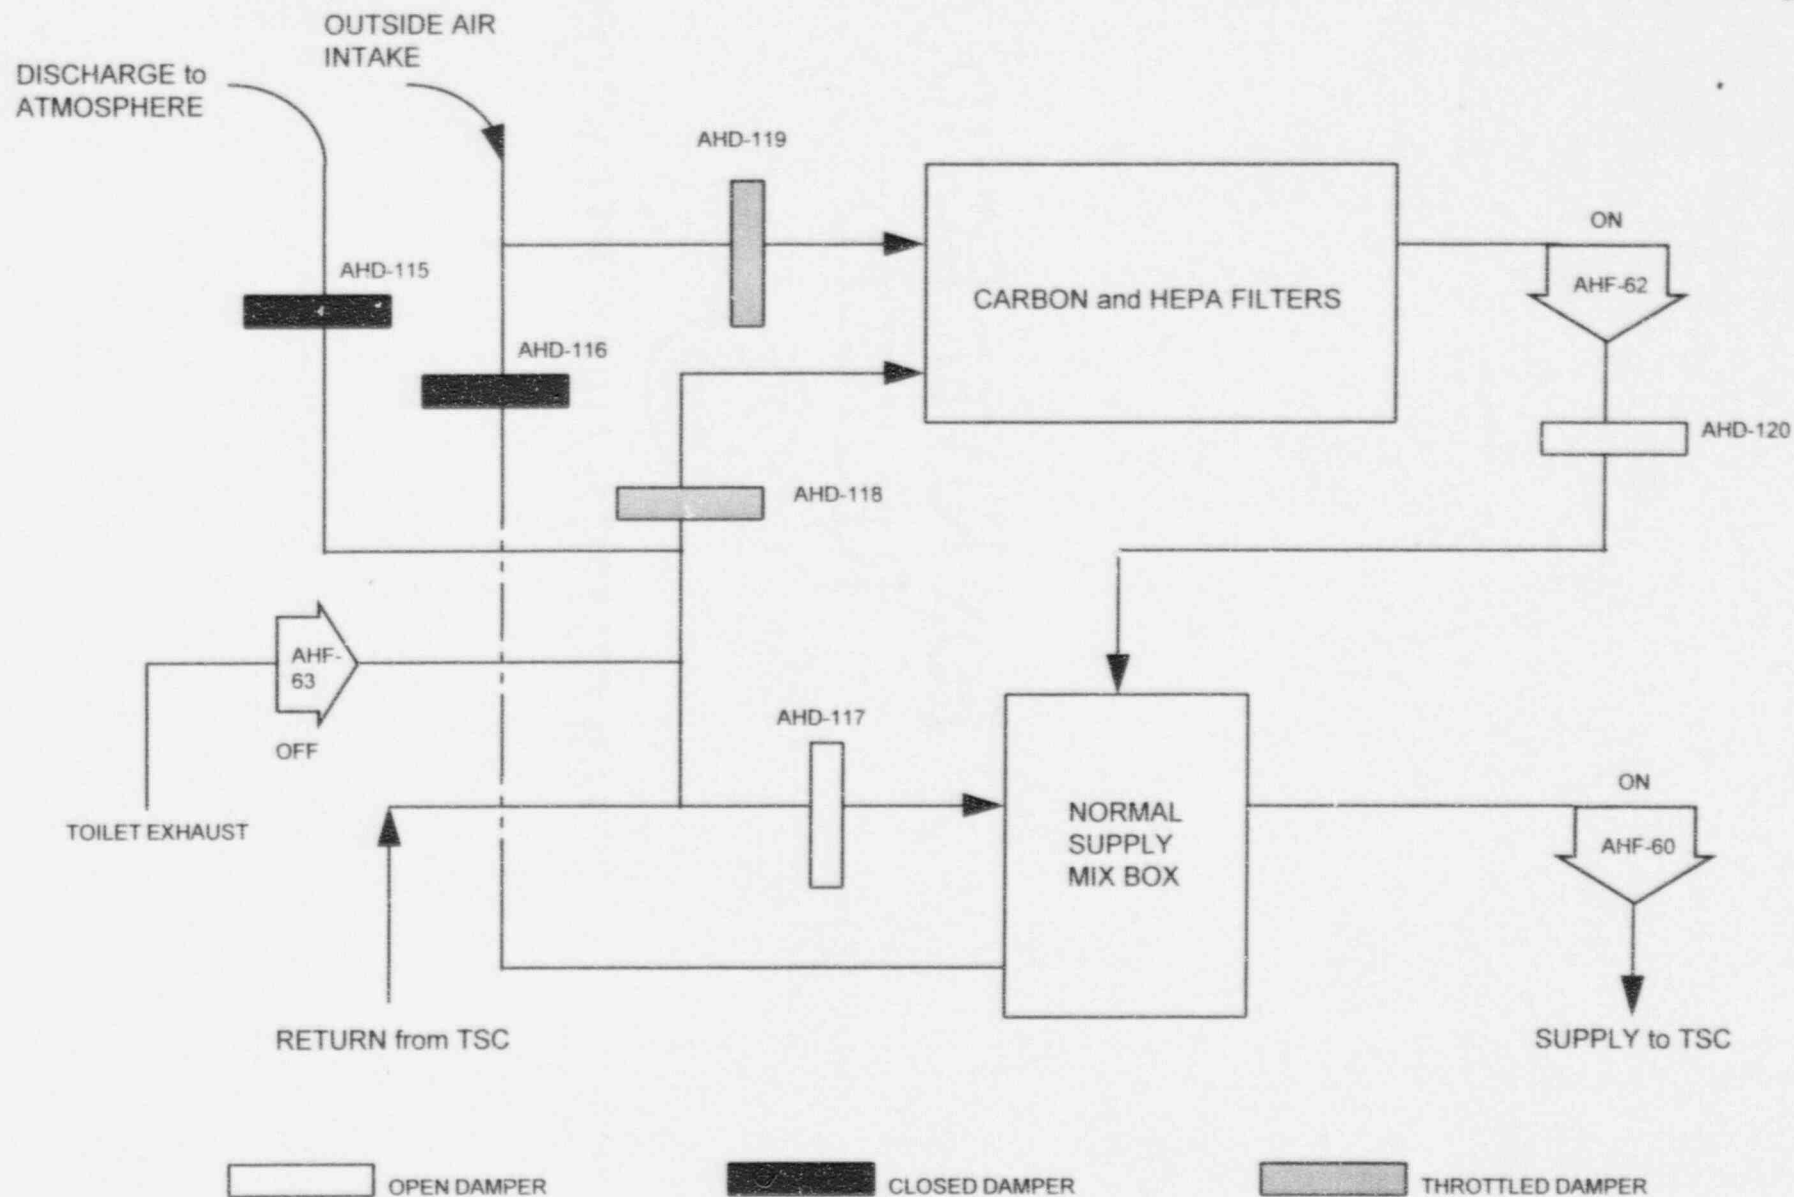
Figure 2
Original TSC Ventilation System - Emergency Operation

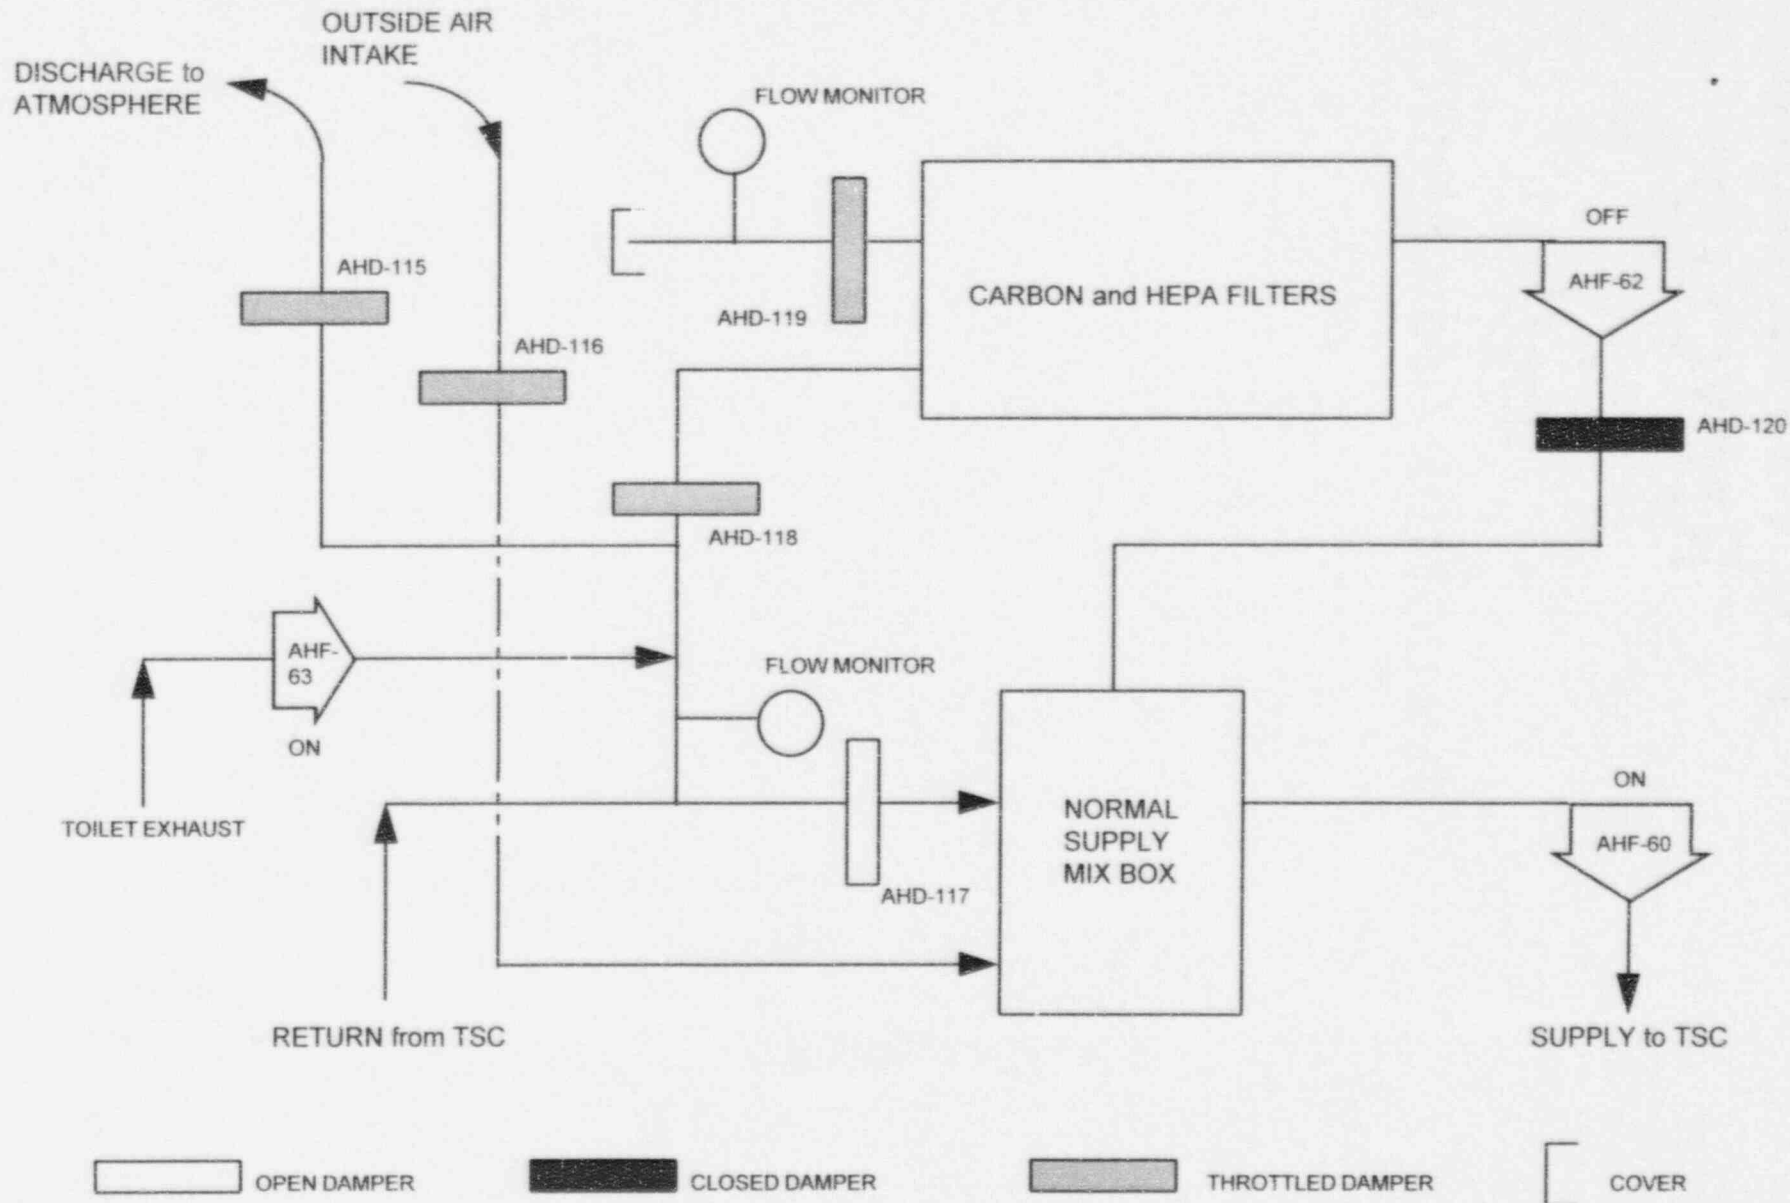
Figure 3

Modified TSC Ventilation System - Normal Operation

1. Fan speed has been reduced to facilitate balancing. Power has been removed from motorized balance dampers and they have been set to fixed positions.
2. Modifications were made to eliminate system leakage and to improve flow measurement capability and repeatability. See Figures 3 and 4 for flow diagrams of the modified TSC Ventilation system. The modifications are as follows:

The system has been modified to eliminate leakage through AHD-115 and AHD-116. This was accomplished by providing positive closure at the inlet paths using custom fit metal covers. These will be installed when the emergency filters are placed in service.

Potential wind affects on make-up air flow measurement were eliminated by relocating the intake into the equipment room.

Improved flow measurement was provided by reducing the size of the make-up and recirculation air duct, thereby increasing the measured air velocity.

Air flow monitors were installed with local indicators which display outside make-up air flow and return air flow.

All insulation on the suction side of the fans was removed, duct joints were inspected and sealed, and the insulation was replaced.

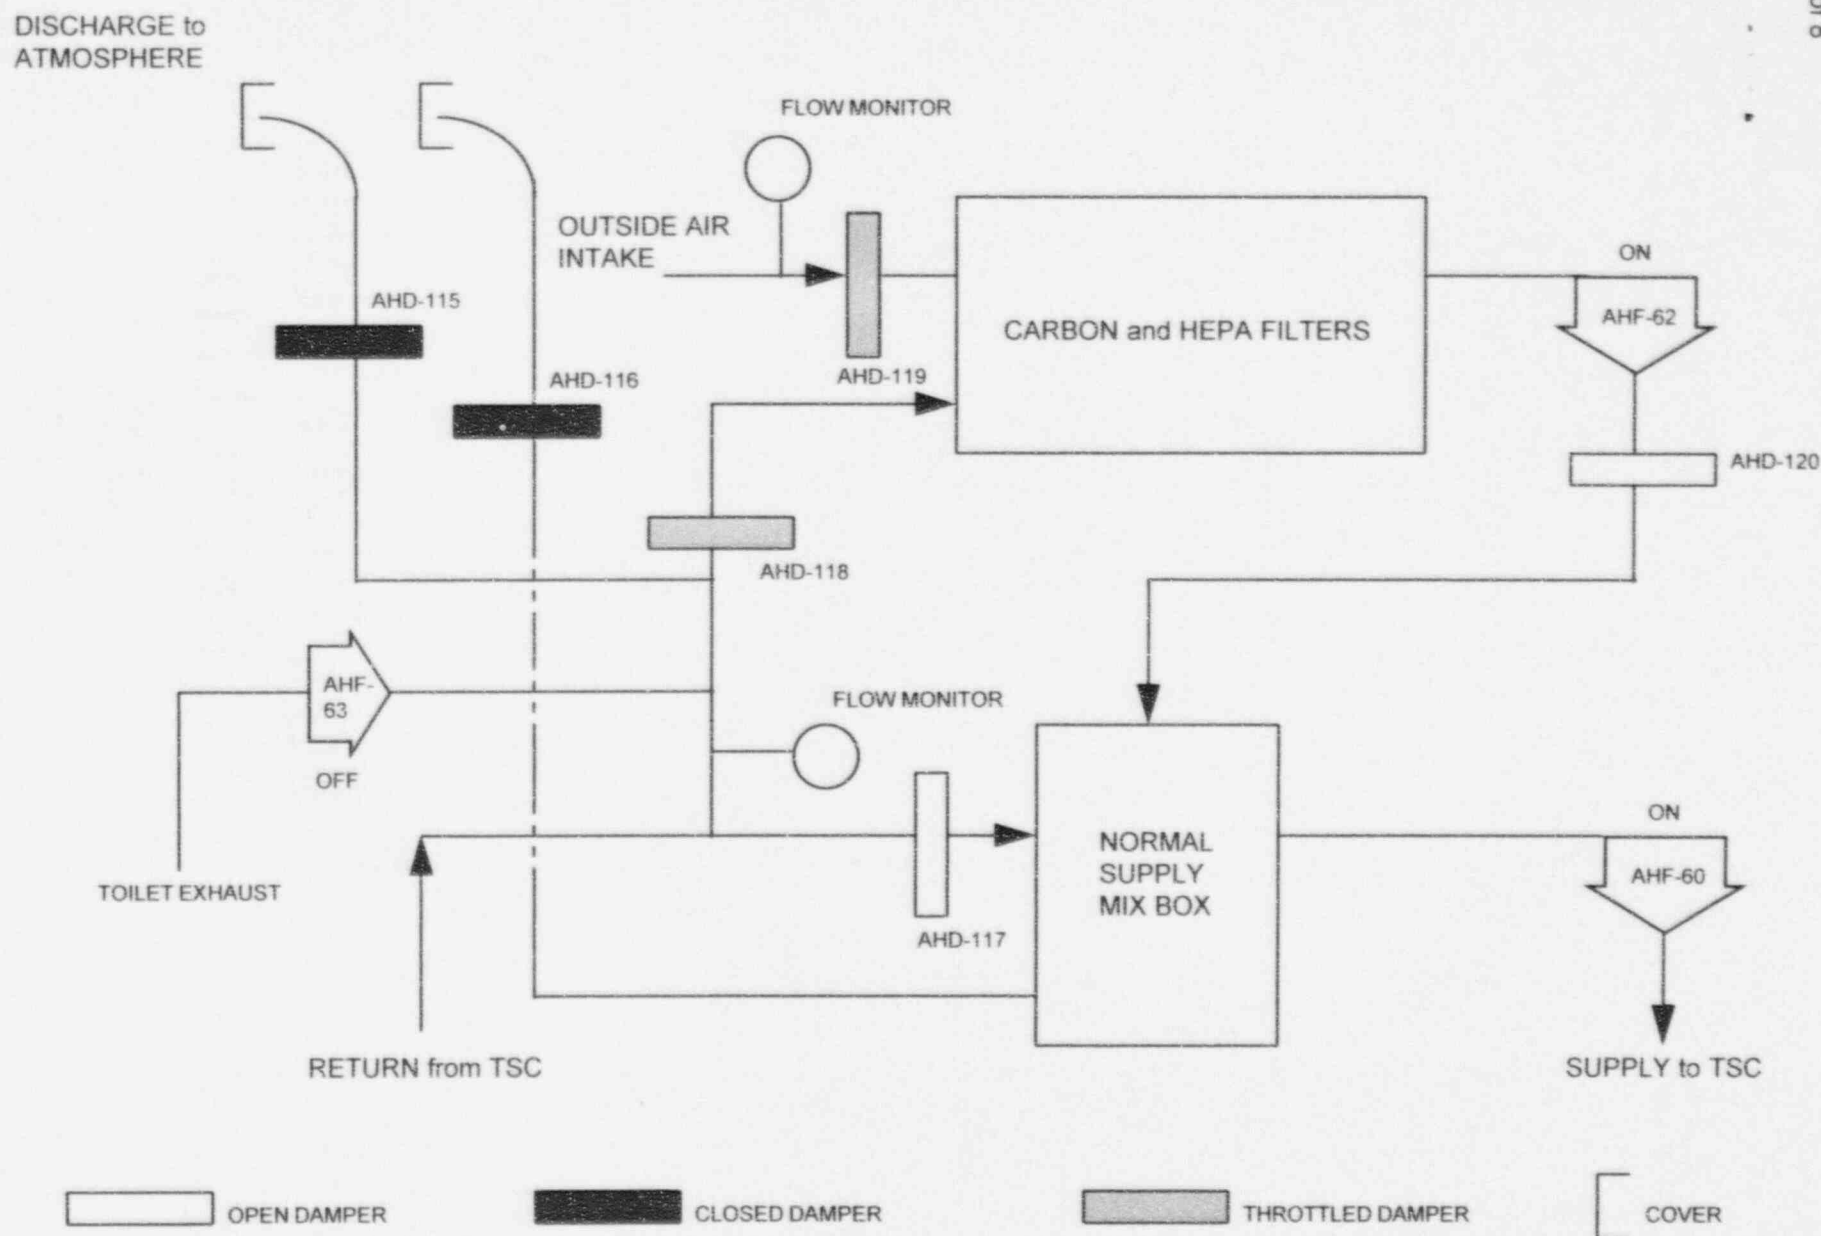
Figure 4

Modified TSC Ventilation System - Emergency Operation
