INVESTIGATION OF ENGINE BEARING DISTRESS  
IN FAIRBANKS-MORSE EMERGENCY DIESEL GENERATORS  
AT ENRICO FERMI II POWER PLANT  
PHASE I: INSPECTION AND PRELIMINARY CONCLUSIONS

Failure Analysis Associates  
Palo Alto, California

Detroit Edison Company

February 1985

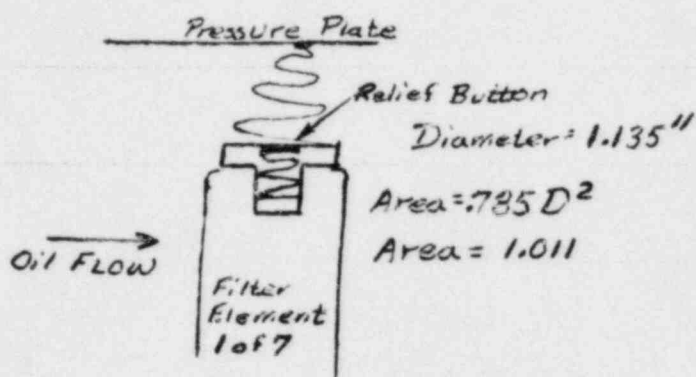
<u>EDG #11</u>	
<u>Force</u>	<u>Relief Pressure (PSI)</u>
25.5	25.2
25.5	25.2
26.0	25.7
25.0	24.7
24.5	24.2
27.0	26.7
29.5	29.2

<u>EDG #12</u>	
<u>Force</u>	<u>Relief Pressure (PSI)</u>
23.5	23.2
25.0	24.7
27.5	27.2
27.5	27.2
22.4	22.2
21.3	21.1
23.5	23.2

Comments: Metal Particles / Shavings found wedged between disc and seating surface of valves (indicative of opening during flows).  
Manufacturer Setpoint - 20 PSI

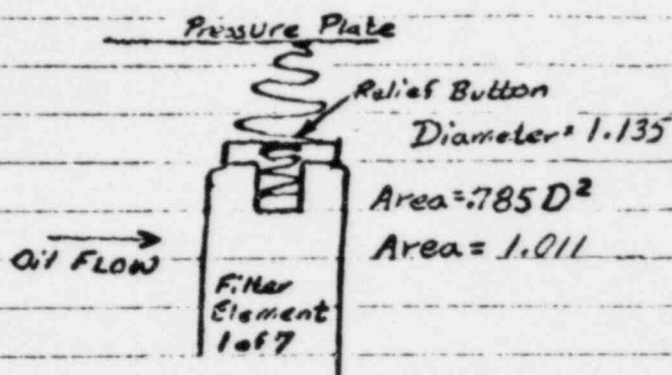
EDG # 14		EDG # 13	
		Force	Relief Pressure (PSI)	Force	Relief Pressure (PSI)
1	25		24.7	1. 20	27.7
2	23		22.8	2. 25.5	25.2
3	25		24.7	3. 26	25.7
4	28		27.7	4. 26.5	26.2
5	28		27.7	5. 29	28.7
6	25.5		25.2	6. 22	21.8
7	29		28.7	7. 27	26.7

Comments: Upon reassembly of EDG #14 filters the distance between pressure plate and filter was 2.5 inches on three filter assemblies.
