LICENSEE EVENT REPORT (LER)

FACILITY NAME (1) Fort St. Vrain, Unit No. 1										DOCKET NUMBER (2) 0 5 0 0 0 2 1 6 7 1										PAGE (3) 1 OF 1																													
TITLE (4) During SR 5.1.2c-X, Only 1/2 Of Total RSD Material Was Discharged From CRD#21																																																	
EVENT DATE (5) MONTH DAY YEAR 1 1 0 5 8 4 8 4										LER NUMBER (6) SEQUENTIAL NUMBER REVISION NUMBER 0 1 2 0 1 0 2 2 8 8 5										REPORT DATE (7) MONTH DAY YEAR 0 5 2 8 8 5										OTHER FACILITIES INVOLVED (8) FACILITY NAMES DOCKET NUMBER(S) N/A 0 5 0 0 0 1 1																			
OPERATING MODE (9) N										THIS REPORT IS SUBMITTED PURSUANT TO THE REQUIREMENTS OF 10 CFR 50.73 (Check one or more of the following) (11)																																							
POWER LEVEL (10) 0 0 0										20.402(b) 20.406(a)(1)(i) 20.406(a)(1)(ii) 20.406(a)(1)(iii) 20.406(a)(1)(iv) 20.406(a)(1)(v)										20.406(a) 20.36(a)(1) 20.36(a)(2) 20.73(a)(2)(i) 20.73(a)(2)(ii) 20.73(a)(2)(iii)										20.73(a)(2)(iv) 20.73(a)(2)(v) 20.73(a)(2)(vi)(A) 20.73(a)(2)(vi)(B) 20.73(a)(2)(vi)										73.71(b) 73.71(c) OTHER (Specify in Abstract Below and in Text, NRC Form 306A)

SUBJECT: Licensee Eve

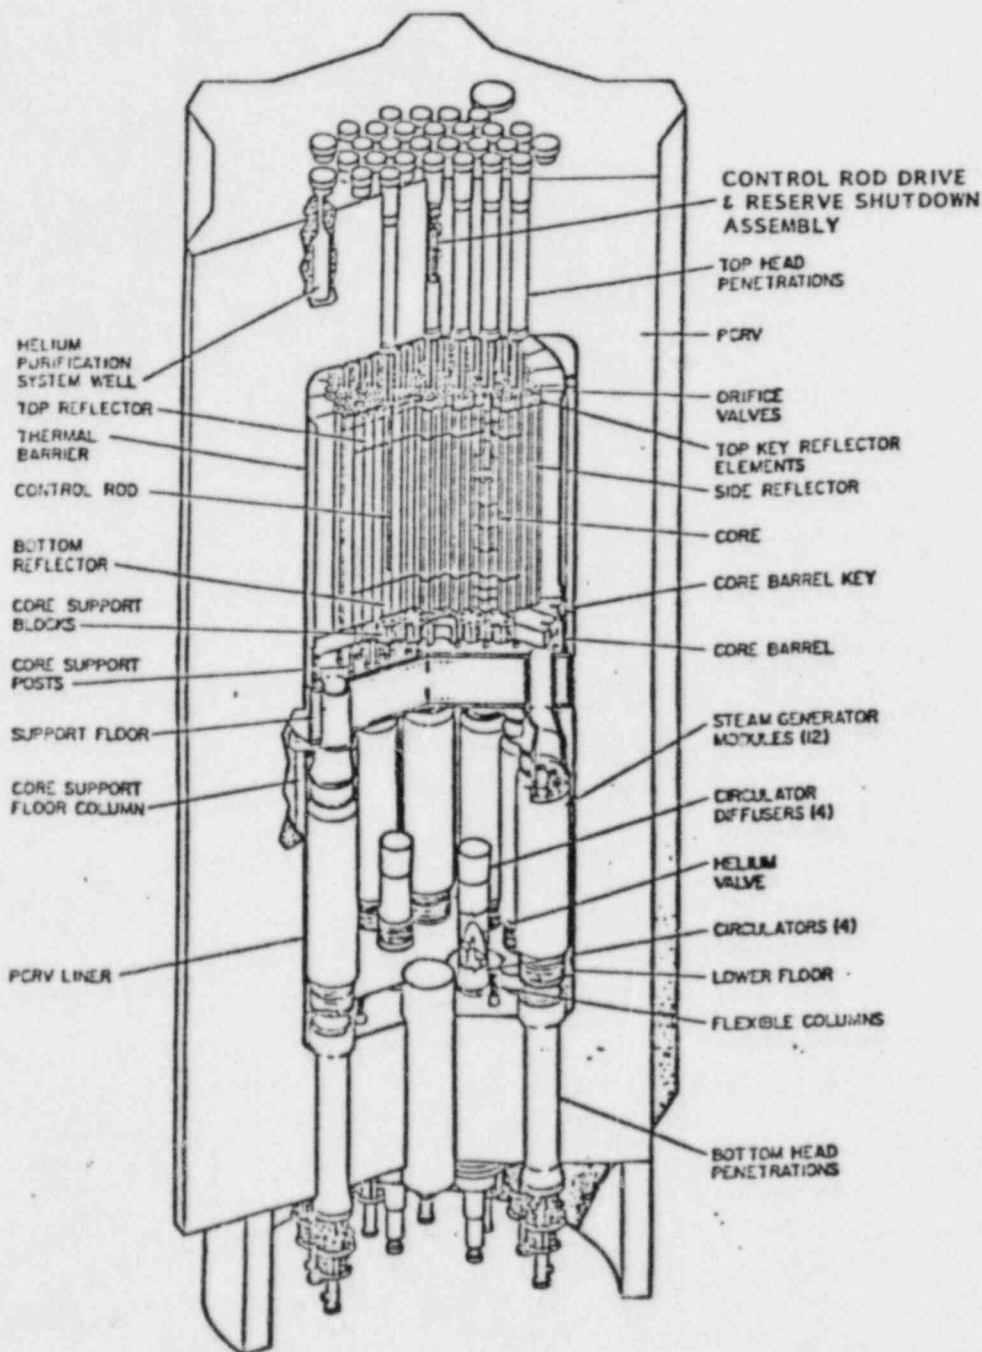
Figure. 1. Reactor Arrangement

A steel guide tube extends from the underside of the hopper to the top control reflector block of the associated core region. The guide tube engages the top reflector block, forming a clear passageway for the reserve shutdown material to fall from the hopper, through the guide tube, and into the core (see Figures 1, 2, and 3).
