Subject: Clinton Power Station - Unit 1  
Licensee Event Report No. 96-004-00

Enclosed is Licensee Event Report No. 96-004-00: Inadequate Job Preparation for a Preventive Maintenance Task on a Switchyard Breaker Causes Main Steam Line Isolation Valve Closure and Reactor Scram. This report is being submitted in accordance with the requirements of 10CFR50.73.

Clinton Power Station

TITLE (4)  
Inadequate Job Preparation for a Preventive Maintenance Task on a Switchyard Breaker Causes Main Steam Line Isolation Valve  
Closure and Reactor Scram

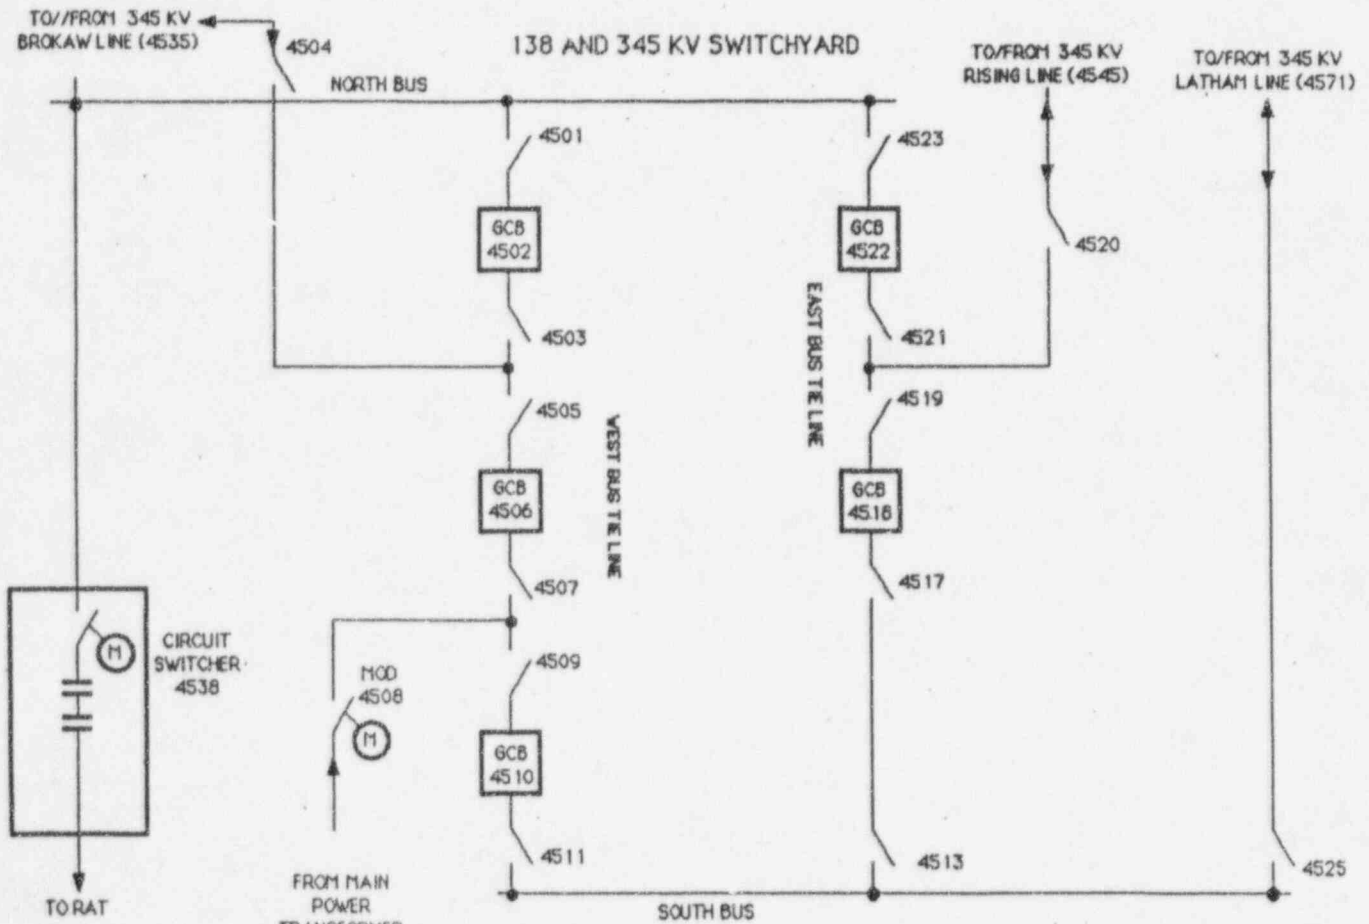
Figure 1  
Clinton Power Station  
Switchyard Schematic

GCB 4522 is in one of the two electrical supply paths that connect the plant's north bus to the south bus. The north bus supplies power to the reserve auxiliary transformer (RAT) [XRFM]. The RAT is the normal offsite power supply to the plant's safety-related power buses [BU]. The RAT also provides offsite power to the balance of plant electrical buses when the unit is not on-line. A one line diagram of the CPS switchyard [FK] is provided as Figure 1 of this report.

At about 1331 hours, utility electrical maintenance personnel moved the "C" phase pole of GCB 4522 so that the breaker contacts could be visually inspected. The protective relaying for GCB 4522 is designed so that if there is low insulating gas pressure or low hydraulic pressure in GCB 4522 and all three poles in the breaker are not in the same position (pole disagreement), a protective relaying scheme is actuated. When the "C" phase pole was closed, the conditions necessary to actuate the protective relaying scheme were met since the insulating gas, and hydraulic pressure were removed earlier from GCB 4522 and all three poles were not in the same position (pole disagreement). The protective relaying scheme for GCB 4522 sent a signal for GCB's 4502, 4518, and a breaker at the Rising substation, which is outside the CPS switchyard, to trip. The tripping of GCB 4502, in conjunction with GCB 4522 being out of service, caused the RAT to lose power. The electrical maintenance personnel in the switchyard heard GCB 4502 trip. They left the "C" phase pole closed and went to the relay house to help determine what caused GCB 4502 to trip. They did not believe at that time that the work that they were performing on GCB 4522 could have caused breaker 4502 to trip and interrupt power to the RAT. The loss of power to the RAT

The design of the breaker failure logic for GCB 4522, which caused the interruption of power to the RAT, is significantly different than the other GCB's in the Clinton Power Station (CPS) switchyard. One difference is that the breaker failure logic for the other GCB's in the switchyard require current to be flowing through the breaker to cause it to actuate. GCB 4522 does not require current flow through the GCB for the trip to occur when the breaker has low insulating gas pressure, or low hydraulic pressure and one of the three poles is not in the same position (pole disagreement).

After this event the breaker failure relay logic for GCB 4522 was isolated to prevent any impact from this logic on the plant during the preventive maintenance task. A system impact matrix was added to preventive maintenance task PEMS004 to ensure that all of the potential impacts for performing this task have been identified.
