Subject: Docket Nos. 50-361 and 50-362  
Voluntary Report  
Licensee Event Report No. 2-96-004  
San Onofre Nuclear Generating Station, Units 2 and 3

LICENSEE EVENT REPORT (LER)																
Facility Name (1) SAN ONOFRE NUCLEAR GENERATING STATION, UNITS 2 AND 3										Docket Number (2) 0 5 0 0 0 3 6 1			Page (3) 1 of 0 5			
Title (4) Auxiliary Feedwater System Turbine Driven Pump Relatch																
EVENT DATE (5)			LER NUMBER (6)				REPORT DATE (7)			OTHER FACILITIES INVOLVED (8)						
Month	Day	Year	Year	///	Sequential Number	///	Revision Number	Month	Day	Year	Facility Names		Docket Number(s)			
0	4	1	1	9	6	9	6	0	5	1	SONGS UNIT 3		0 5 0 0 0 3 6 2			
OPERATING MODE (9) 1			THIS REPORT IS SUBMITTED PURSUANT TO THE REQUIREMENTS OF 10CFR (Check one or more of the following) (11)													
POWER LEVEL (10) 0 9 9 //////////////////// //////////////////// //////////////////// //////////////////// ////////////////////			<input type="checkbox"/> 20.402(b)				<input type="checkbox"/> 20.40(c)				<input type="checkbox"/> 50.73(a)(2)(iv)				<input type="checkbox"/> 73.71(b)

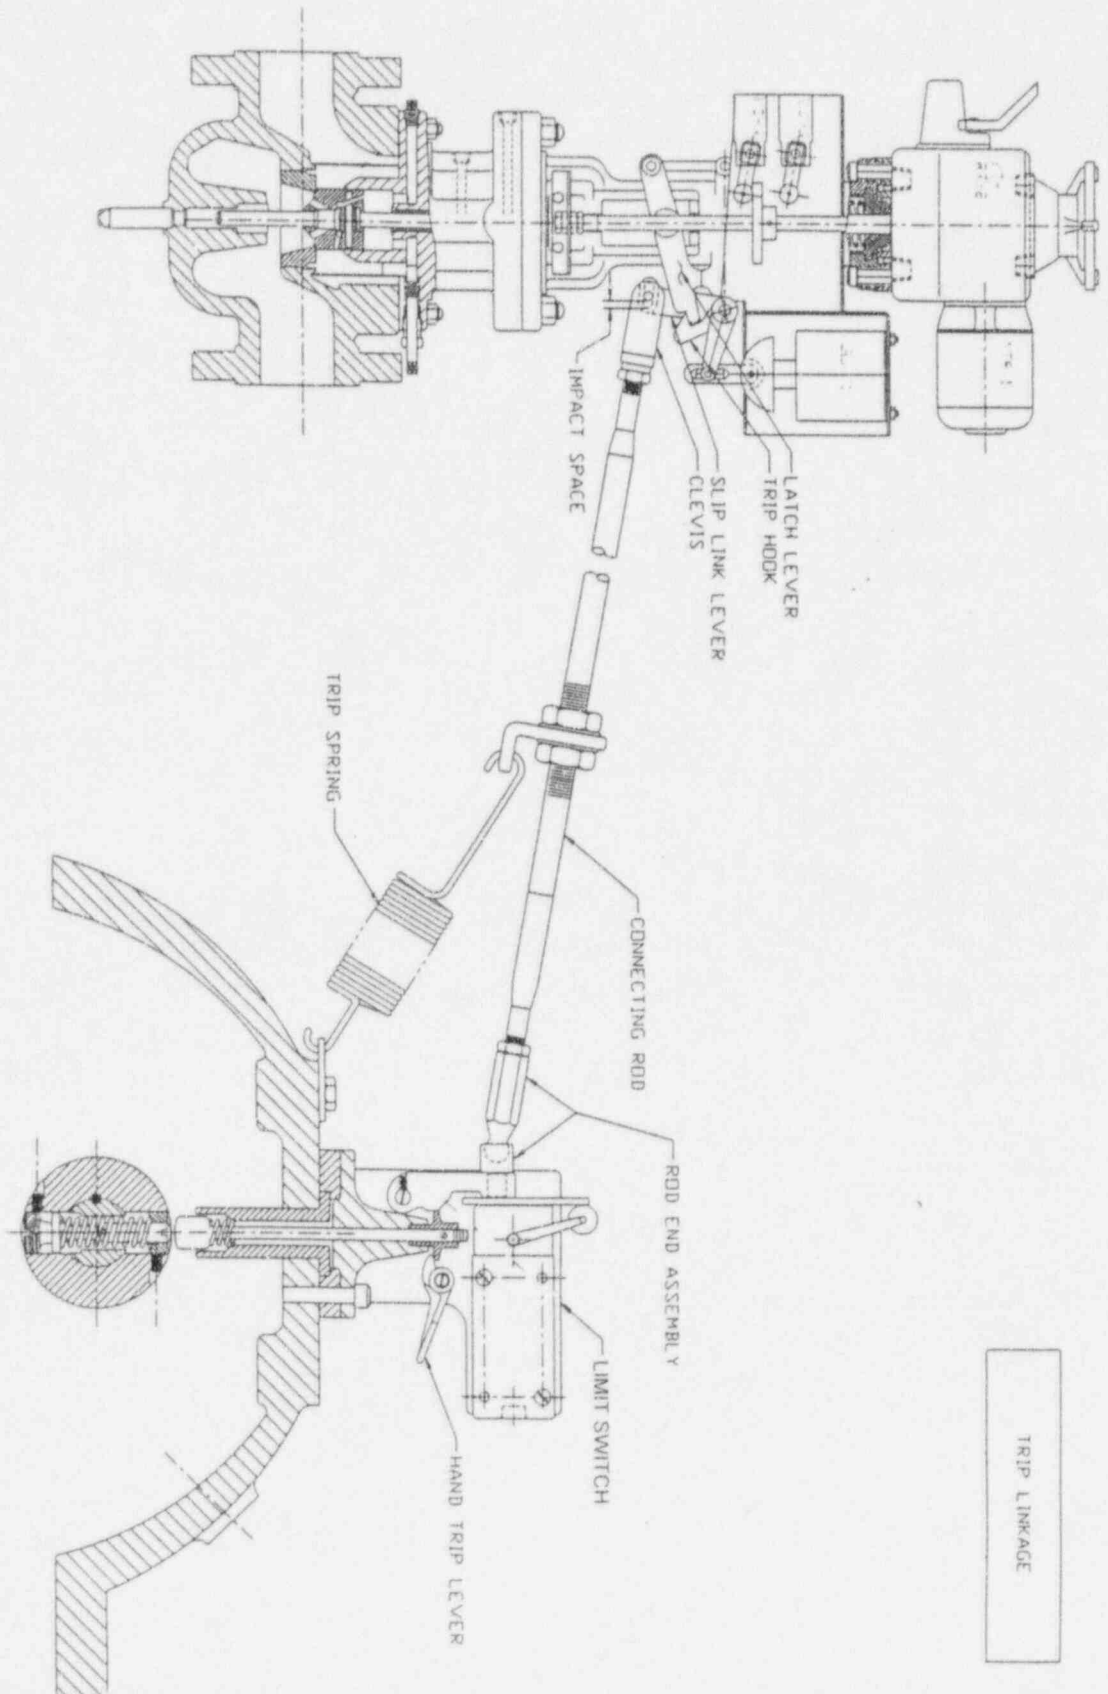
FIGURE 1

Valve HV-4716 also functions as part of the mechanical overspeed trip system for the steam turbine for Pump P-140. The mechanical overspeed trip system protects the turbine from a possible overspeed event by automatically closing Turbine Stop Valve HV-4716 when the turbine reaches a shaft speed of 3927 +/- 100 rpm. The overspeed protection mechanism functions as follows: The shaft of the Terry turbine K-007 is hollow and contains a pre-calibrated spring-loaded trip weight. If shaft rotation exceeds 3927 +/- 100 rpm, centrifugal acceleration forces the weight outward from the shaft. When the trip weight contacts and raises the trip plunger, the overspeed trip linkage is released and retracted by the emergency trip spring. A coil spring on the sliding nut of HV-4716 then forces the sliding nut and valve stem down, thereby closing the valve. This terminates steam flow to the turbine (see attached figure 1).

If an EFAS signal is present at the time an operator attempts to reset the trip linkage, the EFAS signal may cause the valve stem to begin to reposition before the trip linkage can be reset. The resulting automatic movement of the valve stem might prevent successful relatching of the trip mechanism and thereby prevent restarting the TDAFW pump. (Note: It typically takes less than one second to reset the trip linkage, and it may be possible to reset the linkage before the actuator begins moving).

Edison has revised appropriate procedures to instruct control room operators to depress the EFAS override and close handswitch(s) prior to allowing a plant equipment operator to reset the overspeed trip mechanism. This will prevent the motor actuator for HV-4716 from moving the valve stem when the overspeed trip limit linkage is moved away from the limit switch. This action will ensure the latching mechanism can be reset.
