Northern States Power Company

MONTICELLO NUCLEAR GENERATING PLANT
Docket No. 50-263 License No. DPR-22

LER 96-004
Inboard Main Steam Isolation Valve Leakage
Greater Than allowed by Technical Specifications

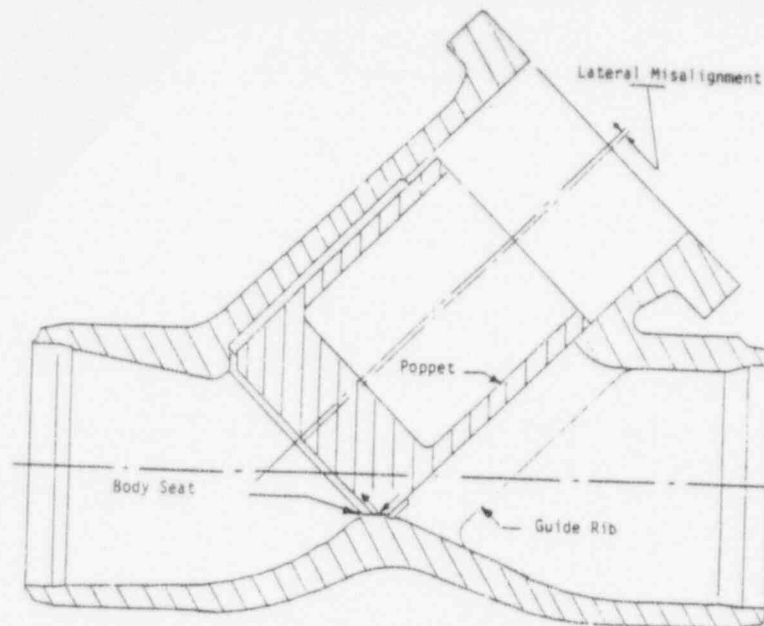
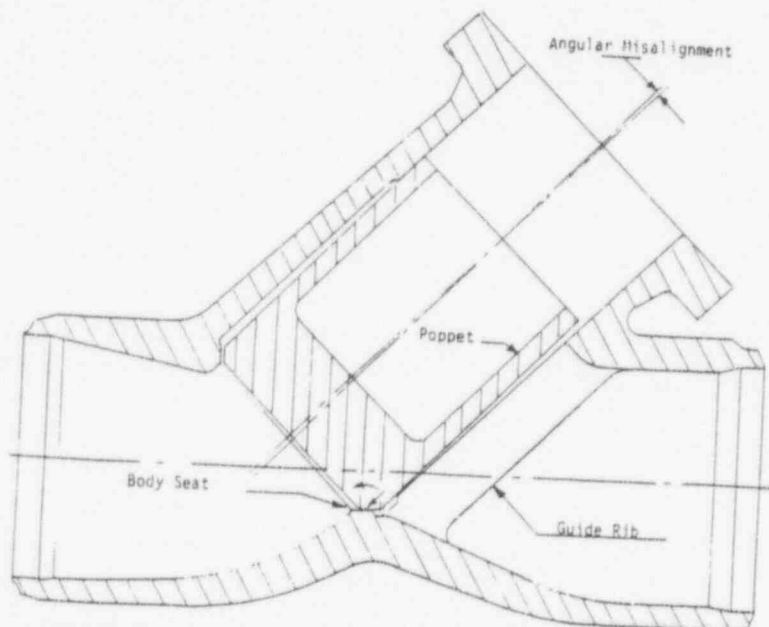
Figure 1 Poppet Tipping

The excessive inboard Main Steam Isolation Valve leakages were the result of failures of each valve's poppet and/or pilot to seat properly. It is believed that these failures were caused by poppet tipping during valve closure (see Figure 1). Poppet tipping results from two features of the original valve design: 1) the poppet and the stem are not solidly connected and 2) the poppet sits at a 45° angle.

Since the poppet sits at a 45° angle, all diametrical clearances exist on the upper surface of the poppet. This causes the poppet to be non-concentric with the valve seat. As a result when the valve is closed, the lower poppet seat will contact the valve body seat first. If the poppet does not slide on the lower body seat, then the poppet may tip due to the poppet not being rigidly connected to the stem. This can cause angular misalignment and incomplete contact between the poppet seat and the valve body seat resulting in excessive leakage. When the poppet is tipped, excessive leakage can also occur through the pilot since the poppet pilot seat and the stem pilot seat are mis-aligned and not in complete contact.

Bevel Seat Seating Movements

Bevel Seat Misalignment Movements

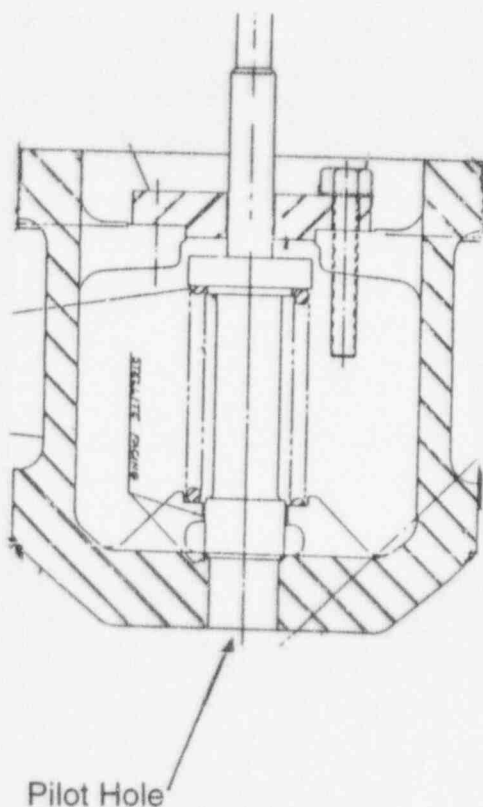
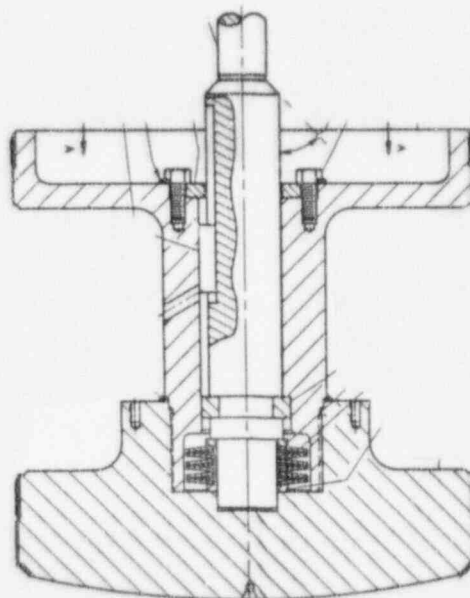
Figure 2

Main Steam Isolation Valve Poppets

Original Design

New Design
(With no pilot opening in the poppet bottom)

1. The valve poppets and stems were replaced with the following design enhancements (see Figure 2):

The poppet is solidly connected to the valve stem to eliminate tipping.

The elimination of the spring between the poppet and the stem, i.e., solid connection between the two, will increase the initial force and momentum which drives the poppet into the seat. This will improve poppet seating.

The new poppets and stems also have no pilot thereby eliminating one potential leakage path.

The new poppets are equipped with anti-rotation hardware which will prevent poppet spinning and the resulting wear and damage.
