SUBJECT: Calvert Cliffs Nuclear Power Plant  
Unit Nos. 1 and 2; Docket Nos. 50-317 and 50-318;  
License Nos. DPR 53 and DPR 69  
Licensee Event Report 96-003  
Discovery of Holes in the Containment Sump Screen to Facilitate Field Run  
Tubing

## LICENSEE EVENT REPORT (LER)

TITLE (4)
Discovery of Holes in Containment Sump Screen to Facilitate Field Run Tubing

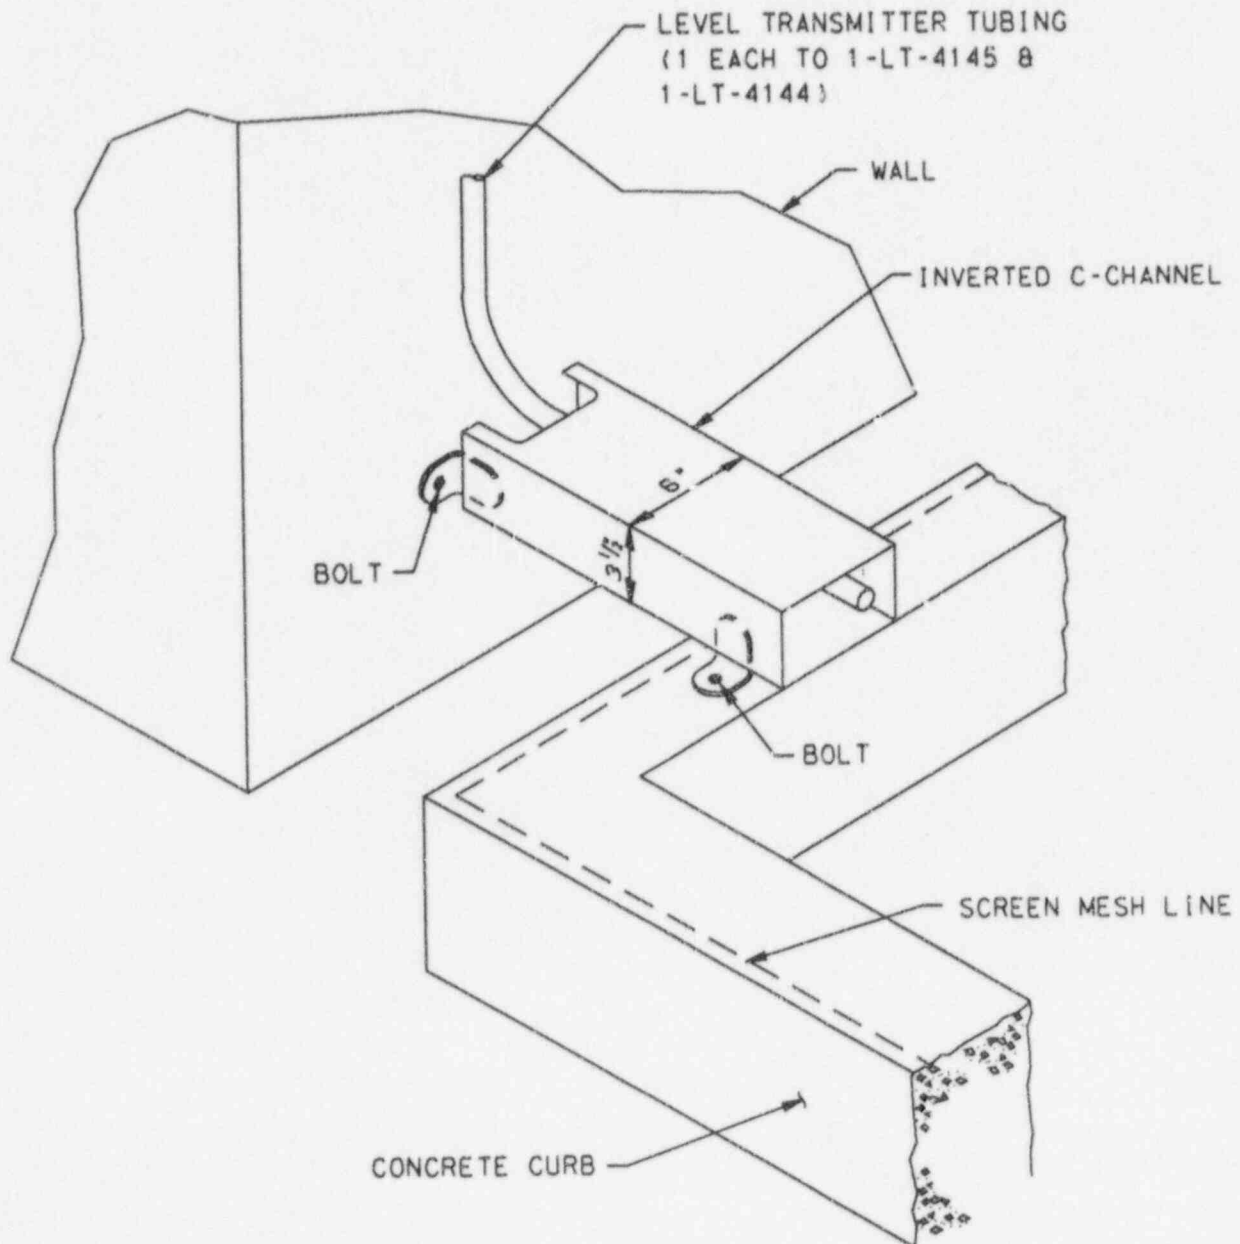
FIGURE 1

The 3-inch by 6-inch holes were most likely field-installed during initial plant construction to route level transmitter tubing through the screen. The holes were not shown on plant drawings. It is unlikely that the holes would have ever been observed other than by a deliberate inspection due to their difficult to access location and poor lighting in the area. The holes have been repaired. A requirement will be added to the sump visual inspection procedure to inspect for holes in the Containment Sump Screens during future refueling outages.

During the next refueling outage for Unit 1 (spring 1996), a visual inspection of its containment sump screen was performed. The inspection found two 3-inch by 6-inch holes through the screen. An inverted 3-inch by 6-inch C-channel ran through each opening to protect the instrument tubing to level transmitters 1-LT-4145 and 1-LT-4144 (see Figure 1). The holes were located at the bottom of the screen on top of the 1-foot curb surrounding the sump area. In addition, a small hole was discovered in each of the four corners of

The holes in the sump screens for the tubing runs were most likely installed during original plant construction. They were part of a field installation that was not shown on plant drawings.

The location of the holes was between the screen and a wall with approximately one and one-half feet of space between the screen and the wall. This space is also a high radiation area and crawling or sliding between the screen and the wall constitutes a personal contamination hazard. Casual observations of the side of the sump screen with the holes could only be done from the opposite side of the sump. Due to poor lighting conditions inside the sump screen and the presence of the opposite screen, it is unlikely that the holes would have ever been observed other than by a deliberate inspection.

TYPICAL DETAIL OF A 3-INCH BY 6-INCH HOLE THROUGH  
CALVERT CLIFFS UNIT 1 CONTAINMENT SUMP SCREEN

A minor modification was completed that welded plates over the openings in the Unit 2 screens and returned the sump screens to a fully qualified status. This minor modification was completed prior to the end of the Unit 2 refueling outage. A similar visual inspection was scheduled for Unit 1 during its next refueling outage in the spring of 1996.

Due to the size of the 3-inch by 6-inch openings, the System Engineer who discovered them had a concern that these holes could possibly allow debris to pass into the sump and present a safety injection header isolation valve clogging hazard, a Containment Spray Nozzle clogging hazard, or possibly damage the HPSI, LPSI or Containment Spray Pumps. An issue report was generated and a revision to the minor modification that repaired the holes in the Unit 2 sump screen was issued to repair the Unit 1 sump screen.

- B. The holes discovered in the Containment Sump Screens for both Units have been repaired.
- C. We will add steps to our Containment Sump visual inspection procedures to inspect for holes in the sump screen during future refueling outages. These changes will be completed prior to the next refueling outage (next use) for each Unit. The change will include the addition of an information statement to sensitize personnel performing the surveillance that holes in the sump screen constitute a condition not in accordance with the Updated Final Safety Analysis Report.
