Commonwealth Edison Company
Byron Generating Station
4450 North German Church Road
Byron, IL 61010-9794
Tel 815-234-5441

This report is number 96-001 Supplement 1; Docket No. 50-454.

Enclosure: Licensee Event Report No. 96-001 Supplement 1

FACILITY NAME (1)	DOCKET	LER NUMBER (6)			PAGE (3)
		YEAR	SEQUENTIAL NUMBER	REVISION NUMBER	
BYRON NUCLEAR POWER STATION	05000454	96	-- 001	-- 01	2 OF 8

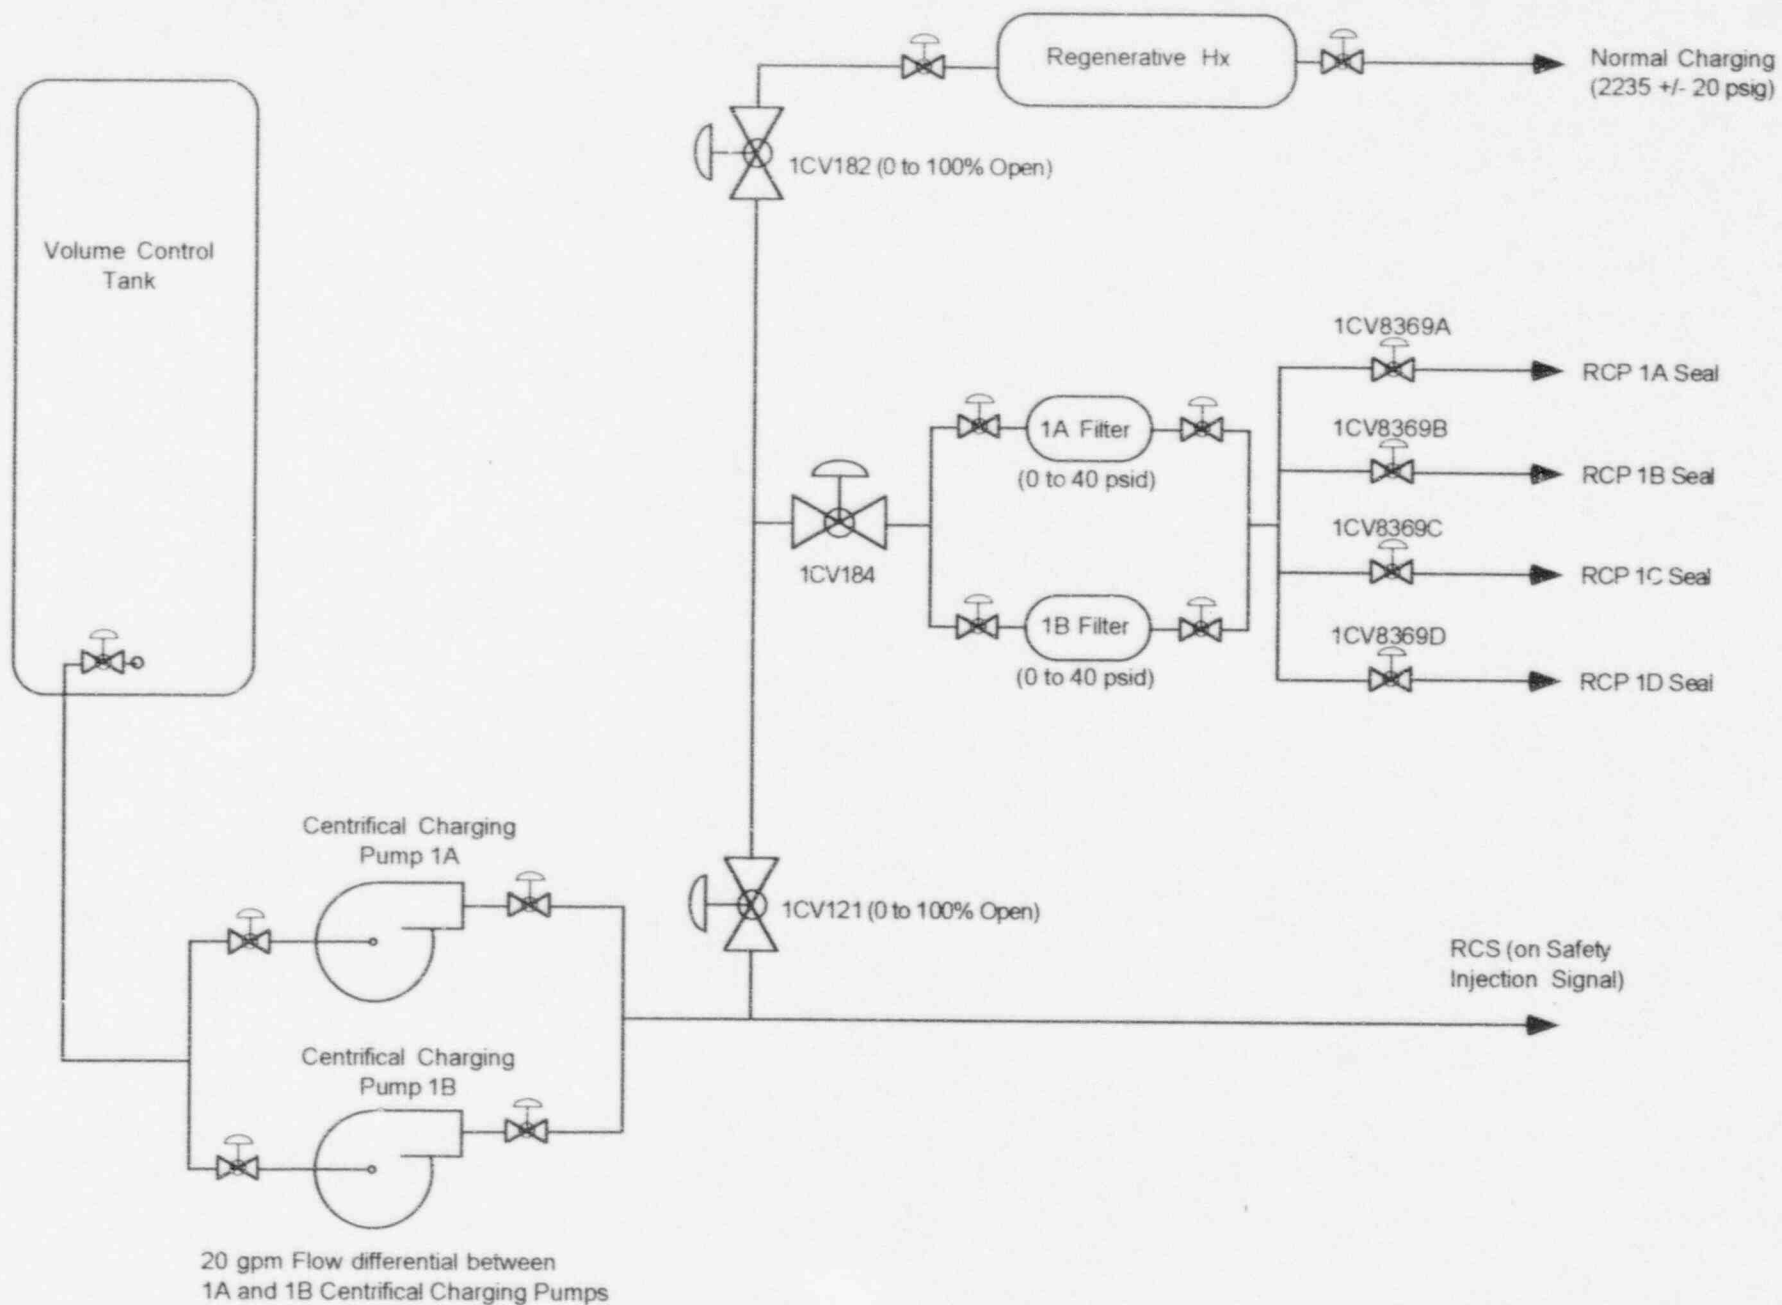
Attachment A: Seal Injection Parameters

Actual Controlled Leakage rate during the first event was determined to be 43.2 gpm. Actual Controlled Leakage rate during the second event was determined to be 41.9 gpm. Both of these controlled leakage values exceeded the Technical Specification limit of 40 gpm. In support of Byron Station's Technical Specification conversion to Improved Technical Specifications (ITS), Engineering has performed calculations involving Seal Injection flowrates with respect to the minimum allowable charging flow during various accident scenarios. As part of the ITS submittal, the Controlled Leakage Limiting Condition for Operation has been changed from a set 40 gpm to a variable flow related to the difference between charging header and RCS pressures. Using this relationship, it has been found that during the time that Controlled Leakage was greater than 40 gpm, the ITS allowable Controlled Leakage would have been 47.9 gpm (RCS pressure approx. 2255 psig, Charging Header pressure approx. 2395 psig). Since the proposed ITS limits satisfy all accident analysis assumptions, it can be concluded that had this event occurred during any analyzed accident condition, there would have been no safety consequences impacting plant or public safety.
