Houston Lighting & Power South Texas Project Electric Generating Station P. O. Box 289 Wadsworth, Texas 77483

May 31, 1996
ST-HL-AE-5377
File No.: G09.16
10CFR50.55a

South Texas Project
Units 1 & 2
Docket Nos. STN 50-498 & STN 50-499
Request for Relief from ASME Boiler and Pressure Vessel Code,
Section XI Requirements (Relief Request RR-ENG-14)

**REQUEST FOR RELIEF FROM ASME BOILER AND
PRESSURE VESSEL CODE, SECTION XI REQUIREMENTS
(RELIEF REQUEST RR-ENG-14)**

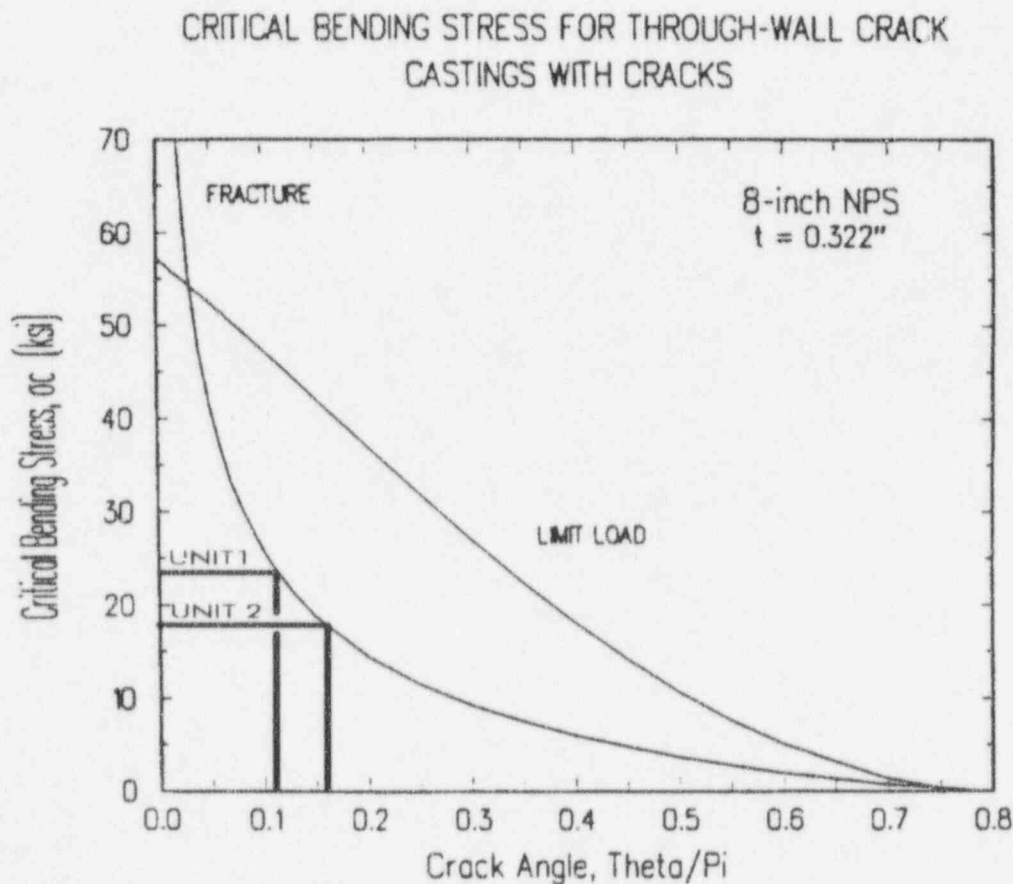
The critical bending stress for through-wall cracks in casting has been completed by Aptech in Calculation AES-C-1964-1 (Reference 2) and includes both limit load and linear elastic fracture mechanics. The following figure depicts the crack angle θ/π compared to the critical bending stress σ_c .

Critical Bending Stress for 8-Inch Nominal Pipe Size Castings With Cracks.

As shown above, linear elastic fracture mechanics provides the more limiting analysis for the crack angle to be analyzed; therefore, only the detailed linear elastic fracture mechanics were analyzed in South Texas Project Calculation CC06401 (Reference 6). In addition, since the Unit 1 flaw is bounding, and the same design stress values apply to both flaws, the presented results will only be for Unit 1.

The results of South Texas Project Calculation CC06401 (Reference 6) show that the Critical Bending Stress for fracture, σ_b^c equals 17.26 ksi. This is in agreement with the figure "Critical Bending Stress for 8" Nominal Pipe Size Casting with Cracks" shown on the previous page.
