NRC Inspection Report (IR) Nos. 50-315/97-24, 50-315/99-10

Event Description: Lack of a procedure for manually backwashing the emergency service water pump discharge strainers

Date of Event: December 1997 and May 1999

Plant: Donald C. Cook Nuclear Plant, Units 1 and 2

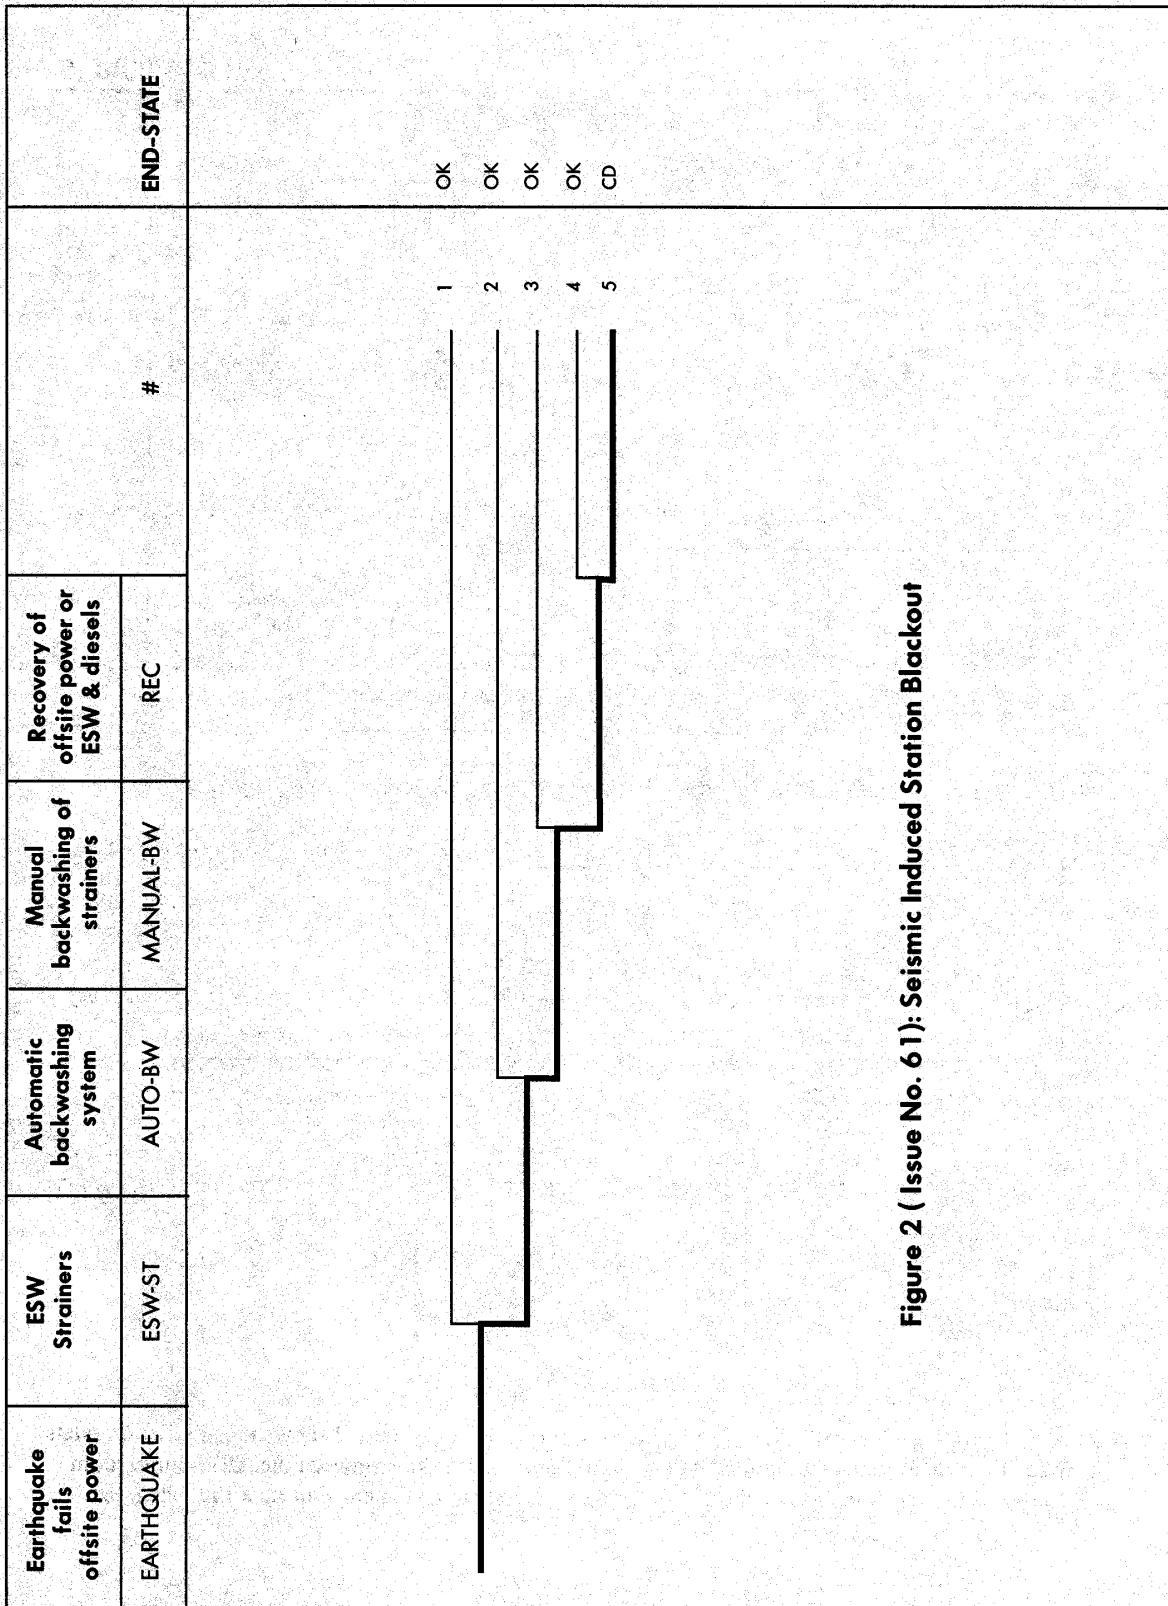
**Figure 2.** Seismic-induced station blackout event tree.

The estimated increase in the core damage frequency (Δ CDF) associated with this issue is the sum of frequencies of Sequences 1 and 2 above which is 3.2×10^{-5} /year. It is dominated by Sequence 2. This

sequence is highlighted in Figure 2. In Sequence 2, core damage results due to an earthquake which fails offsite power and ESW due to the degraded automatic backwash capability that is not seismically qualified. The manual backwash capability was not credited due to lack of a procedure to perform that function.
