Commonwealth Edison Company
Byron Generating Station
4450 North German Church Road
Byron, IL 61010-9794
Tel 815-234-5441

Enclosure: Licensee Event Report No. 95-005S1

LICENSEE EVENT REPORT (LER)
TEXT CONTINUATION

BYRON NUCLEAR POWER STATION	05000454	YEAR	SEQUENTIAL	REVISION	5 OF 11
		95 --	005 --	01

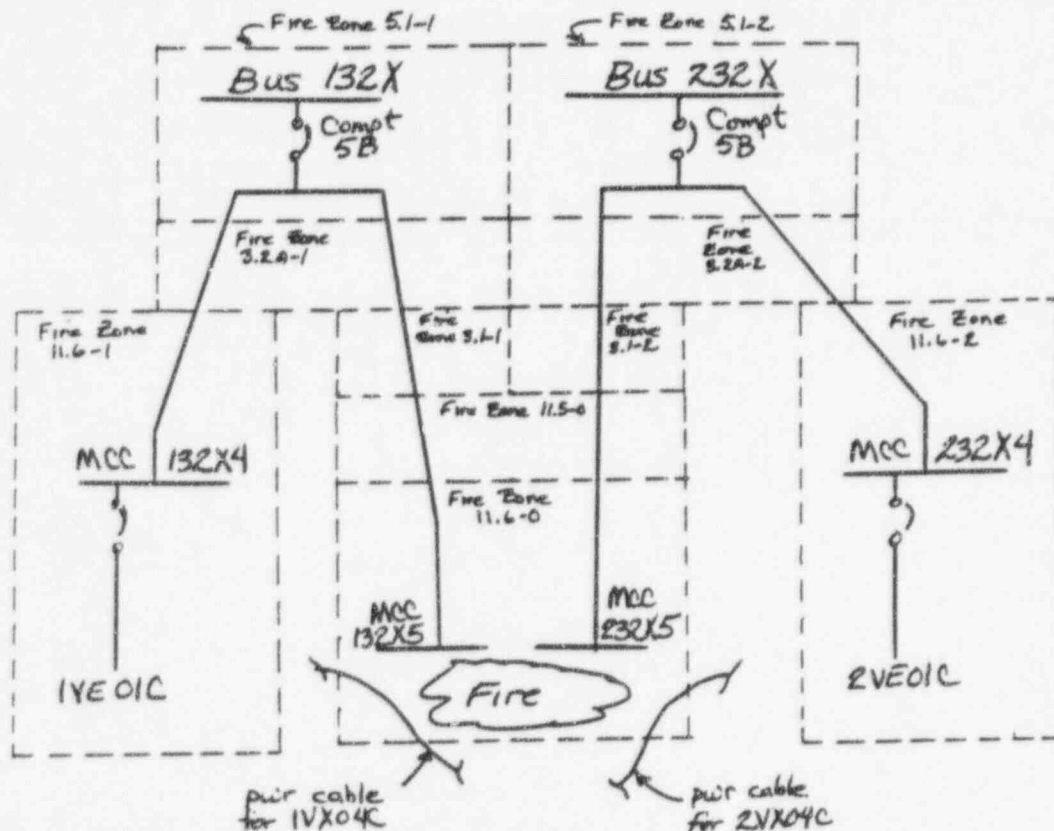
Figure 1: Configuration of Fire Zone 11.6-0

The FPR Safe Shutdown Analysis for Fire Zone 11.6-0 failed to recognize the loss of electric power to the Division 12 and 22 MEER Supply Fans. Although the power cables for these fans are not routed through Fire Zone 11.6-0, they are powered from Motor Control Centers (MCCs) which are affected by a fire in zone 11.6-0. The MCCs supplying power to the Division 12 and 22 MEER Supply Fans are powered from two 480 volt breakers that also power MCCs located in zone 11.6-0. The MCCs located in fire zone 11.6-0 can be damaged by a fire in this zone. A fire induced fault on these MCCs will cause the 480 volt breakers to open which will also de-energize the MEER Supply Fans. See Figure 1 in Attachment A for a diagram of the above configuration.

The cause of the events reported on 10/12/95 and 10/13/95 was a failure of the team of analysts preparing the original Byron Safe Shutdown Analysis to recognize the interconnection between MCCs powered from a single 480 volt Bus breaker. Consequently, the Safe Shutdown Analysis for Fire Zones 11.4-0 and 11.6-0 did not consider the potential loss of some MCCs located outside of the fire zone. The team of analysts considered the equipment and cables located in the fire zone that could be directly affected by a fire. An assumption was implicitly made and the analyses was performed as if the power and control for each component formed an independent circuit and that a failure of cables for one component would not have any impact on any other safe shutdown components. This assumption is based on breaker coordination studies that demonstrate that fire induced faults on a cable will not cause an upstream supply breaker to open before the specific load fuse or breaker for the circuit in question opens. This assumption would not apply if two MCCs are fed from a single bus breaker.

Problem: Appendix R Fire in Zone 11.6-0 (Elev. 426', AB) may cause failure of:

- 1). Power cable for 1VX04C (U-1 Div 11 MEER Supply Fan)
- 2). Power cable for 2VX04C (U-2 Div 21 MEER Supply Fan)
- 3). Fault MCC 132X5 which causes Bus 132 Compt 5B breaker to open when sensing fault current.

Therefore MCC 132X4 de-energized resulting in:

- (a) Loss of 1VE01C (U-1 Div 12 MEER Supply Fan)
- 4). Fault MCC 232X5 which causes Bus 232 Compt 5B Breaker to open when sensing fault current.

Therefore MCC 232X4 de-energized resulting in:

- (a) Loss of 2VE01C (U-2 Div 22 MEER Supply Fan)

Which means for a fire in Zone 11.6-0;

Both redundant MEER Supply Fans are lost on both units.

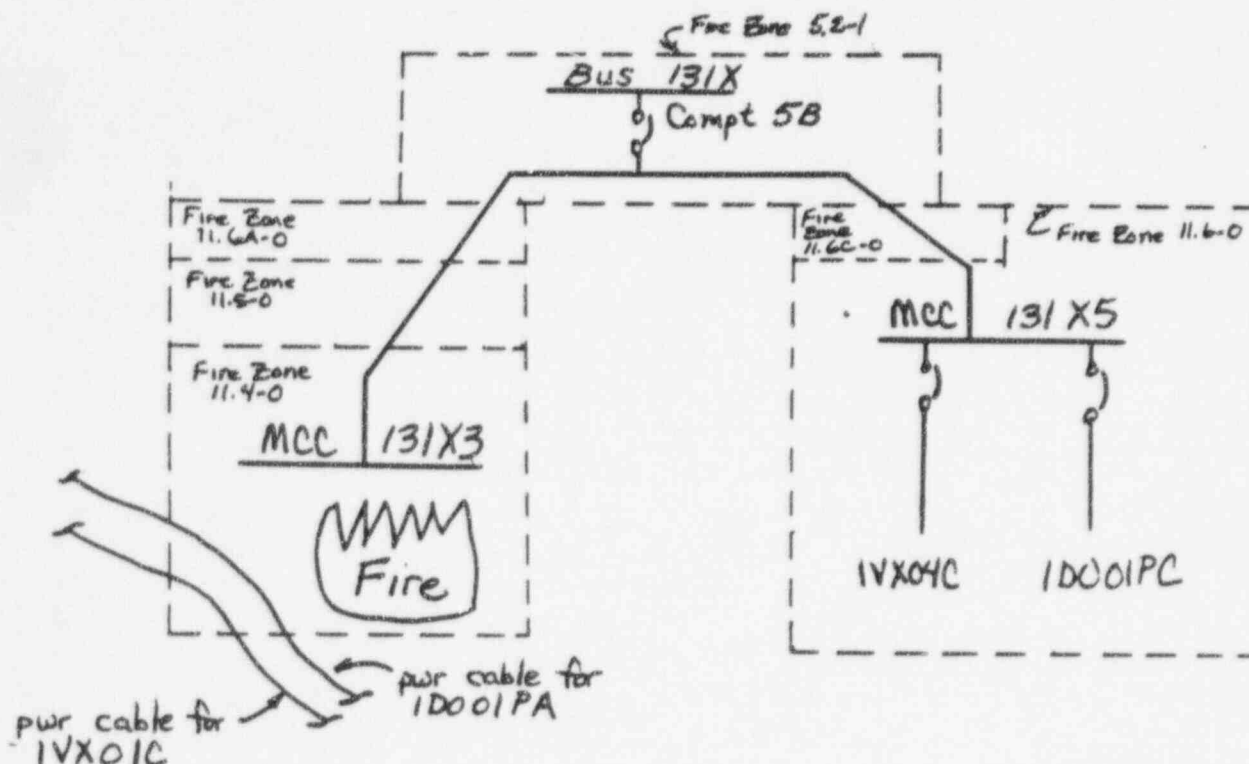
Figure 2: Configuration of Fire Zone 11.4-0

Unit 1 FPR Sections 2.4.2.43 and A5.8.17 state that Division 11 equipment is relied upon for a fire in Fire Zone 11.4-0. The power cable for Diesel Oil Transfer Pump (1DO01PA, Division 11) is routed in this zone and can be damaged by a fire. Redundant pump (1DO01PC, Division 11), its power cable, and MCC power source are located outside of zone 11.4-0. The MCC power source receives power from a common 480 volt bus breaker which also powers an MCC located in Fire Zone 11.4-0. The MCC located in zone 11.4-0 can be damaged by a fire in this zone. Therefore, a fire-induced failure on this MCC will cause the common supply breaker to open and de-energize the MCC supplying power to pump 1DO01PC. With both Diesel Oil Transfer pumps not available, the 1A Emergency Diesel Generator is not available. Additionally, the Division 11 ESF Switchgear Room Supply Fan (1VX04C) is powered by the MCC for pump 1DO01PC. Similarly, fan 1VX04C may not be available for a fire in zone 11.4-0. See Figure 2 in Attachment A for a diagram of the above configuration.

Problem: Appendix R Fire in Zone 11.4-0 (Elev. 383', AB) may cause failure of:

- 1). Pwr cable for 1VX01C (Div 12 ESF Swgr Supply Fan)
- 2). Pwr cable for 1DO01PA (A Diesel Oil pp for 1A D/G)
- 3). Fault MCC 131X3 which causes Bus 131 Compt 5B breaker to open when sensing fault current.

Therefore MCC 131X5 de-energized resulting in:

- (a) Loss of 1VX04C (Div 11 ESF Swgr Supply Fan)
- (b) Loss of 1DO01PC (A Diesel Oil pump for 1A D/G)

Which means for a fire in Zone 11.4-0, which the FPR Safe Shutdown Analysis states that Division 11 will be protected from fire:

- 1). Both DO pumps for the 1A D/G are lost
- 2). Div 11 ESF Swgr Room Supply Fan 1VX04C is lost
