South Texas Project
Unit 2
Docket No. STN 50-499
Licensee Event Report 92-007
Regarding an Unplanned Engineered Safety Feature Actuation of an
Isolation Valve for the Above Seat Drain Line

Unplanned ESF Actuation of an Isolation Valve for the
Above Seat Drain Line

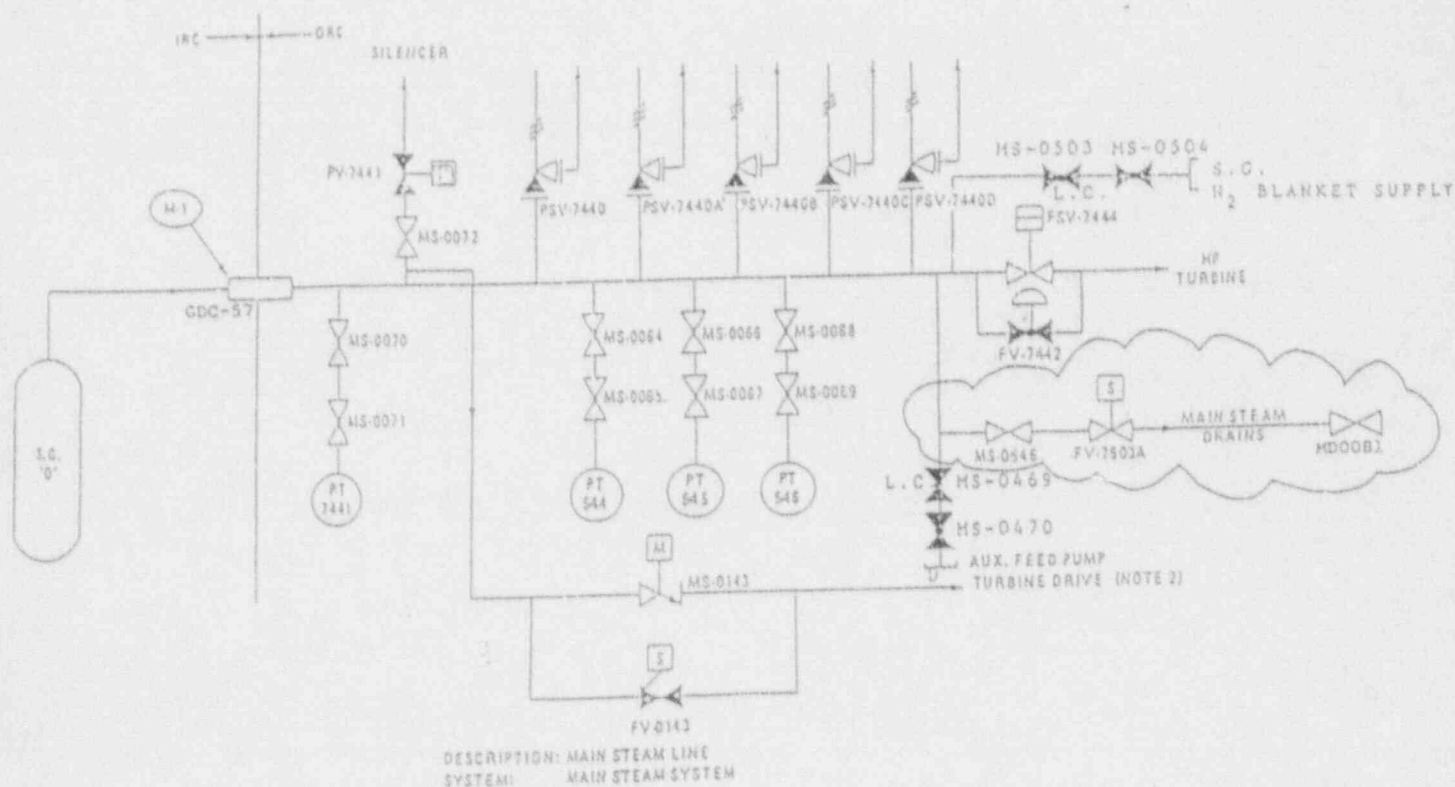
On August 31, 1992, a Unit 2 Equipment Clearance Order (ECO) was written for Unit 2 to close the Main Steam drain isolation valve (MS0546), a normally locked open valve and the isolation valve for the above seat drain line on Main Steam line "D" (MS7903A) to isolate a leak on a down stream valve. MS0546 was manually closed and the Control Room handswitch for MS7903A was placed in the "CLOSE" position. MS7903A is a normally energized open Solenoid Operated Valve (SOV) and automatically closes on a Containment Isolation signal. (See Figure)
