Northern States Power Company

MONTICELLO NUCLEAR GENERATING PLANT
Docket No. 50-263 License No. DPR-22

LER 96-006

Reactor Scram Due to Loss of Stator Water Cooling Flow

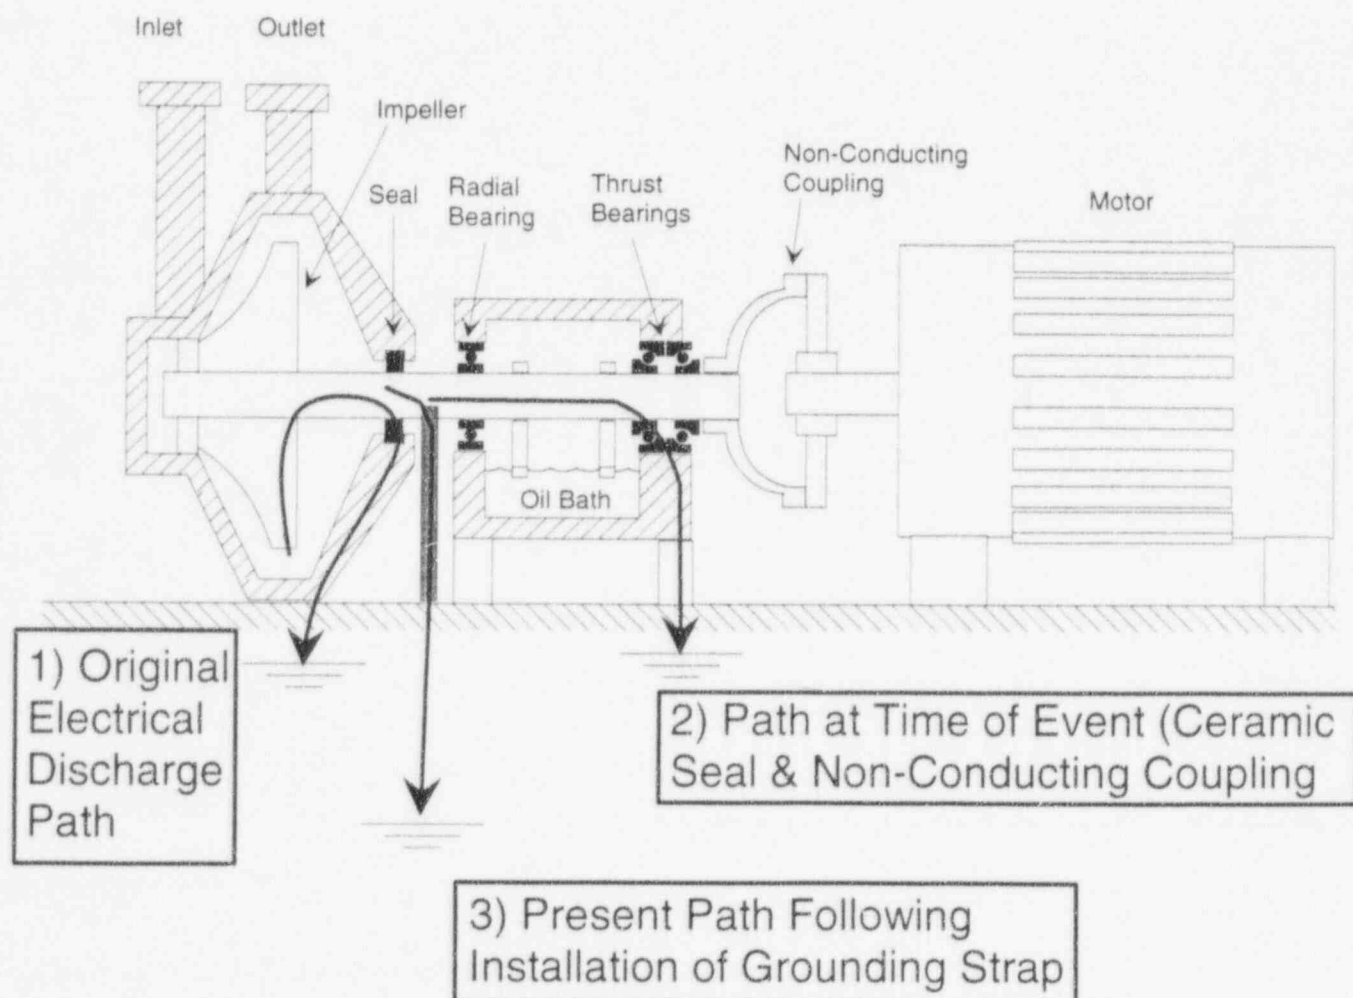
Figure 1 - Simplified Stator Water Cooling Pump Assembly Showing Potential Electric Discharge Paths

The root cause of the stator water cooling pump failures was originally believed to be low oil bath level. Subsequent, increased, monitoring of the stator water cooling pump performance, identified that low oil level may not have been the root cause. An investigation team has identified that electrical discharge in the bearing may have been the cause of the failures. The electrical discharge in the bearing may have led to the degrading of the lubricating oil and/or physical damage to the bearing race. This degradation led to fatigue cracking in the bearing race and subsequent failure of the bearing.

During the recent refueling outage (April 1996), new stator water cooling pumps (pumps, bearing assembly, and coupling) were installed. This unit was designed and supplied to Monticello by General Electric Corp. This was believed this to be a standard configuration utilized in the industry. Since these failed prematurely, the investigation considered what had changed from the design of the previous pumps. Two differences may have been responsible for the electrical discharge in the thrust bearing, a ceramic pump seal and a non-conducting coupling (see Figure 1). Static electricity is generated by the pump impeller in the pump casing.

The conductivity of the stator water is very low, so the electrical charge is not transmitted to ground through the water to the pump casing. In the past, the charge is believed to have been harmlessly transmitted to ground through a metallic seal. With the new ceramic pump seal and non-conducting coupling, the path of least resistance was the thrust bearings. The stator water cooling pumps are lubricated with a light non-conducting turbine oil (Mobil DTE-797). The small distances between the bearing race and the ball bearings allowed the charge to travel through the non-conducting oil. The transmission through the thrust bearing causes oil degradation and small arc strikes in the bearing race.

A grounding strap/brush was installed on both stator water cooling pumps to eliminate any voltage difference between the pump shaft and ground.
