REFERENCE: Docket No. 50-186
University of Missouri-Columbia Research Reactor
Renewed Facility Operating License No. R-103

SUBJECT: Written communication as required by University of Missouri Research Reactor
Technical Specification 6.6.c(3) regarding a deviation from Technical Specification
3.2.f.8

Licensee Event Report No. 20-02 – April 9, 2020
University of Missouri Research Reactor

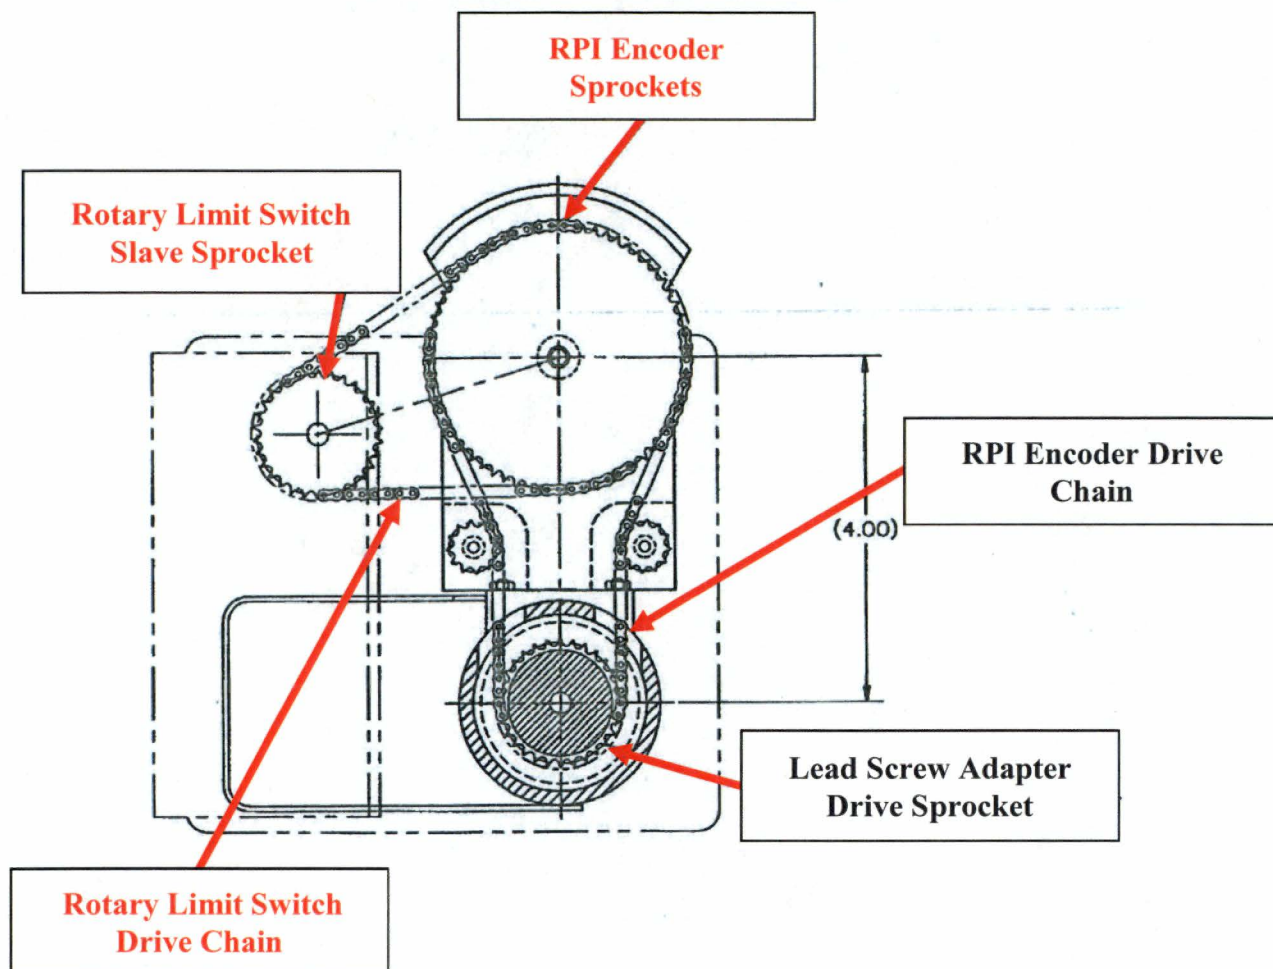
Regulating Blade Drive Assembly Diagram

Initial investigation revealed that the upper RPI encoder sprocket, which drives the rotary limit switch slave sprocket, was not moving when its drive shaft was rotating. The regulating blade drive mechanism was removed and taken to the Instrumentation Support Shop for further inspection and troubleshooting. Examination revealed that the two (2) setscrews that couple the upper RPI encoder sprocket to the RPI encoder drive shaft were not tightened onto the two (2) flat areas of the encoder drive shaft. The as-found positions of the setscrews indicated the setscrews were tightened against the rounded portion of the RPI encoder drive shaft, not the flat areas, during recovery from LER 20-01 the previous day. Eventually, the rotary shaft drive force must have overcome the setscrews' friction and allowed slippage between the sprocket setscrews and the rounded portion of the shaft.

After replacing the RPI encoder drive shaft, all regulating blade drive setscrews had thread lock applied and were checked tight. In addition, both regulating blade drive mechanism chains were aligned and the chains' tensions evaluated to be normal and satisfactory.
