October 30, 1992
MP-92-1160

LICENSEE EVENT REPORT (LER)

FACILITY NAME (1) Millstone Nuclear Power Station Unit 2

Combined Leakage Rate Exceeded

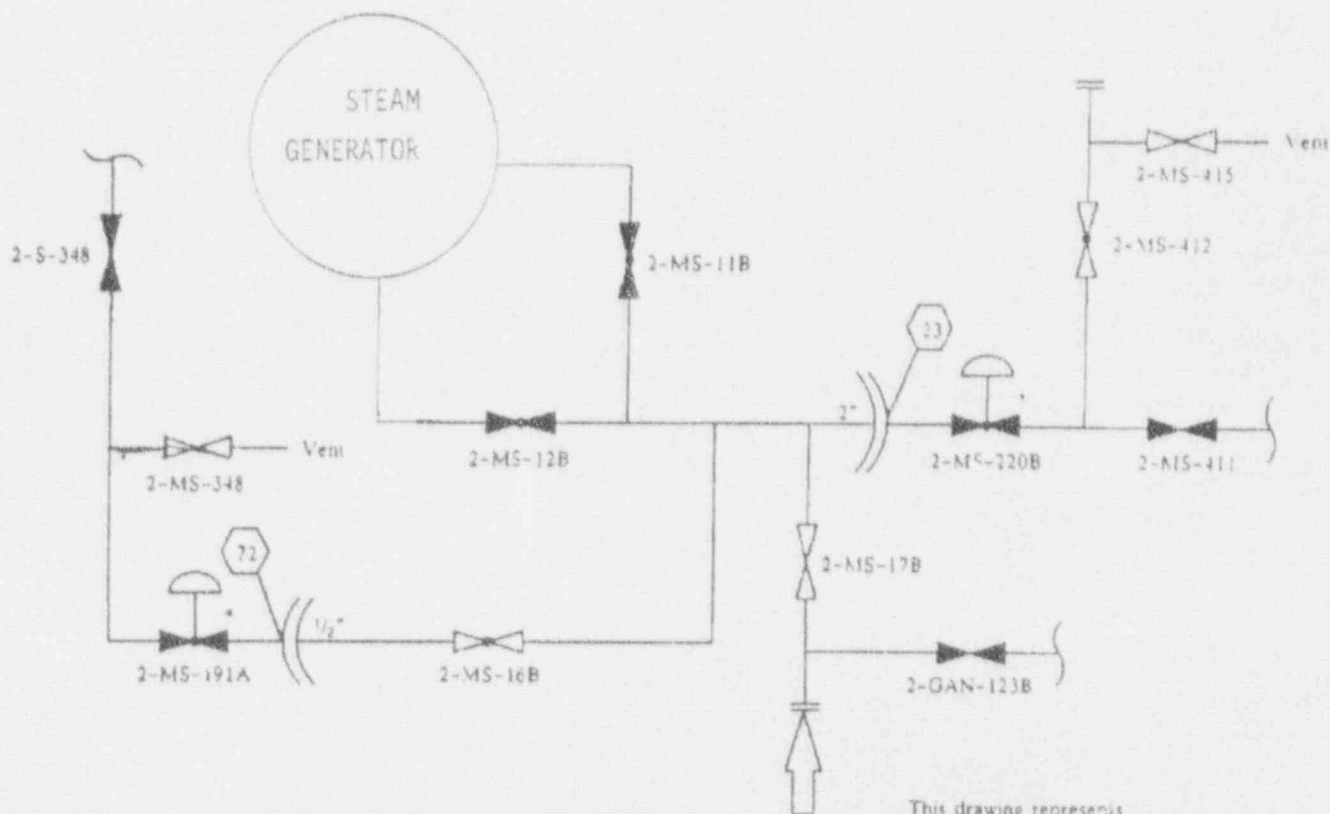
Figure 9.6

The root cause of the high leakage is due to wear in the plug and seat area of the valve due to steam cutting.

The plant was in Mode 6, shutdown for refueling operations. Reactor Coolant System (RCS) temperature was 52 degrees Fahrenheit and pressure was 0 PSIG. Type B and C leakage rate testing of containment penetrations was in progress. On 10/05/90 the #2 Steam Generator Blowdown Penetration Isolation valves were being leakage rate tested. (See the diagram attached for the valve line-up). An attempt was made to pressurize the penetration volume to accident pressure (Pa-56 PSIG) thru the flange at valve 2-MS-17B. Test pressure could not be attained and the source of the leakage was investigated. Inspection of the vent paths thru 2-MS-348 and 2-MS-415 indicated leakage thru 2-MS-220B. When the vent path valves 2-MS-412 and 2-MS-415 were closed the test pressure was almost immediately achieved and the leakage rate was essentially zero. This indicates the source of the leakage to be 2-MS-220B.

The root cause of the event is due to steam cutting of the valve seating surfaces.

LOCAL LEAK RATE TEST
VALVE LINEUPPenetration 23/72
2-MS-220B & 191B

The valve was disassembled and inspected. The inspection revealed a worn seat and plug. These items along with the valve stem and various gaskets were replaced. Since this valve is located on the secondary side of the plant, the necessity for Appendix J Leakage testing requirements was reviewed. Based on this review, it has been determined that the Steam Generator Blowdown valves may not be required to be included in the Appendix J, Type C Leakage Testing Program. Current plans are to submit a request to remove these valves from the Appendix J, Type C test requirements.
