LICENSEE EVENT REPORT (LER)

| NORTH ANNA POWER STATION, Unit 2 | 0 5 0 0 0 3 3 9 | 1 OF 0 4 |

Unit 2 Reactor Trip, March 23, 1985

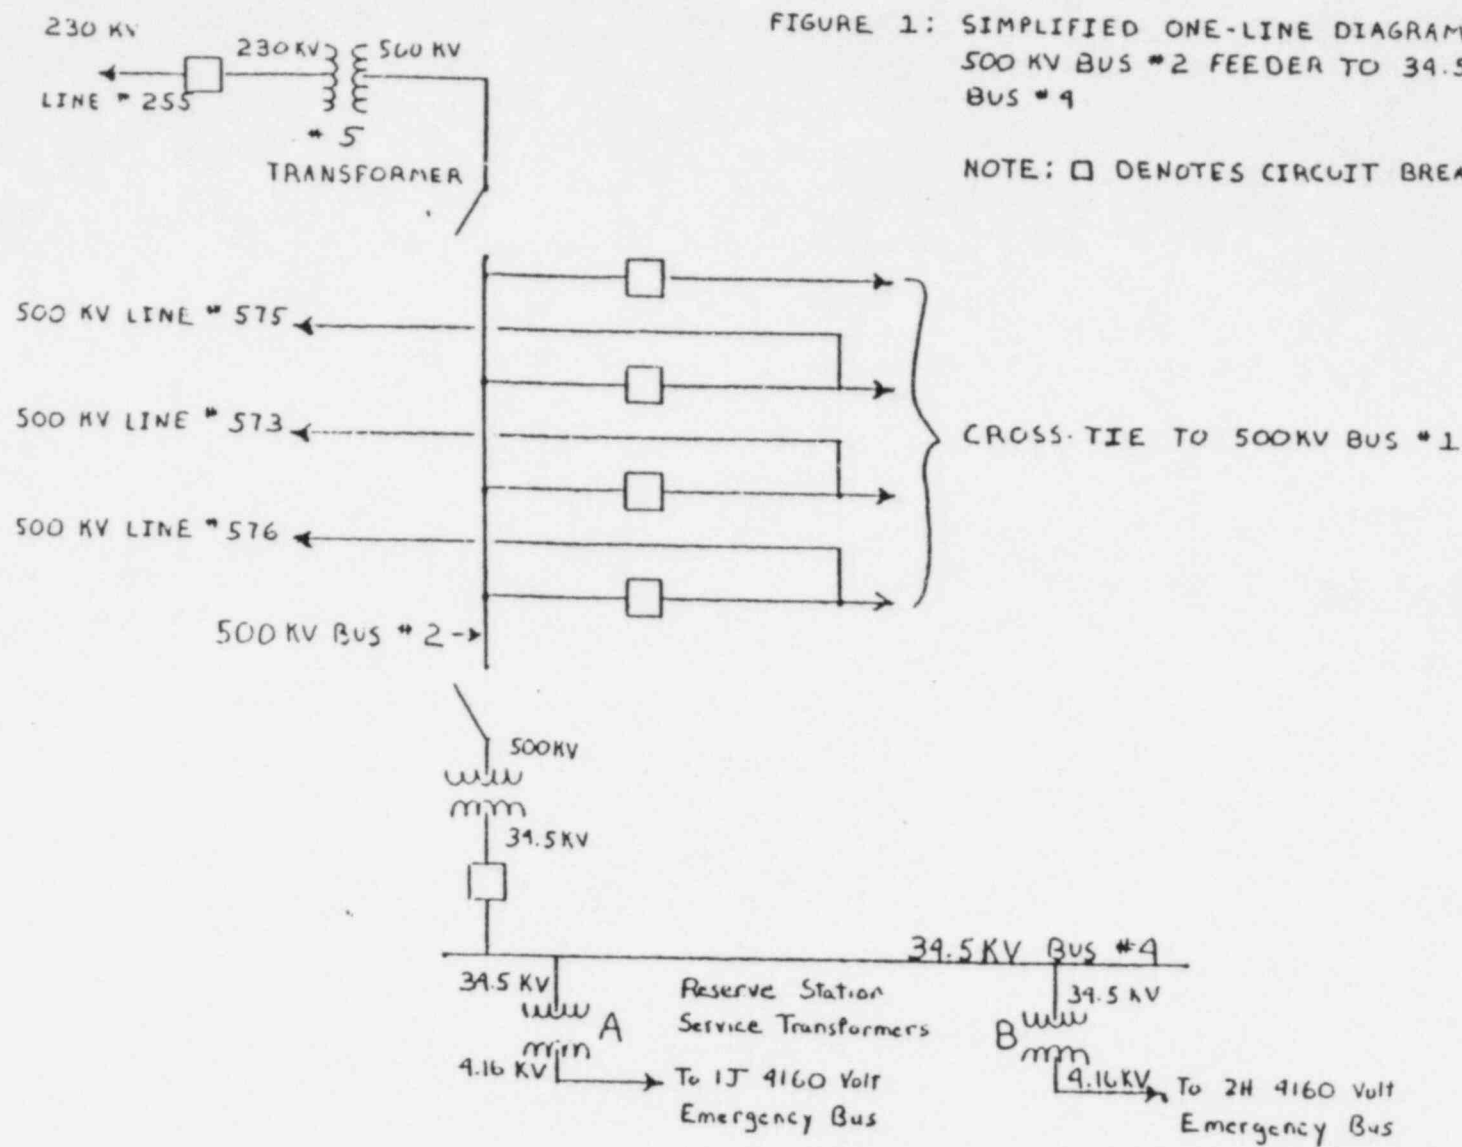
FIGURE 1: SIMPLIFIED ONE-LINE DIAGRAM —
500 KV BUS #2 FEEDER TO 34.5 KV
BUS #4

A loss of power occurred when the #5 switchyard transformer generated a fault signal which initiated a #2 500 KV bus isolation signal (see attached sketch). This resulted in a loss of power to the 2H and 1J 4160 Volt Emergency busses which caused a loss of power to the IRPIs for Unit 2. The 2H and 1J Emergency Diesel Generators automatically started and re-energized their respective busses and the primary plant was stabilized at no-load operating conditions.

The loss of power occurred when the #5 switchyard transformer generated a fault signal which initiated a #2 500KV bus isolation signal (see attached sketch). The isolation of #2 500KV bus resulted in a loss of power to #4 34.5KV bus. This de-energized A and B Reserve Station Service Transformers (RSST) causing a loss of power to the 1J and 2H 4160 Volt Emergency busses. The IRPIs are powered from the 2H 480 Volt Emergency Motor Control Center through a 480V/120V transformer.

Virginia Power's Division Services personnel inspected the #5 transformer and found that it had not faulted. However, they did find that one of three Single Differential Trip (SDT) relays (EIIIS component identifier 87) actuated to initiate the event. All three of the SDT relays were replaced. A similar problem with this type of relay at a Virginia Power fossil power station occurred earlier in 1985. The relays that were removed are to undergo testing by Division Services personnel to determine the cause of the spurious actuation.

An engineering evaluation has been requested to determine the feasibility of design modifications to the North Anna Switchyard that would keep the 500KV bus #2 energized in the case of a #5 switchyard transformer fault. The feasibility of alternate power supplies for the Individual Rod Position Indicators is also being investigated.
