GENE-523-136-1092  
DRF 137-0010-5  
Revision 0

ENGINEERING ASSESSMENT OF THE  
HATCH 2 AHC INDICATIONS

October 1992

GE Nuclear Energy

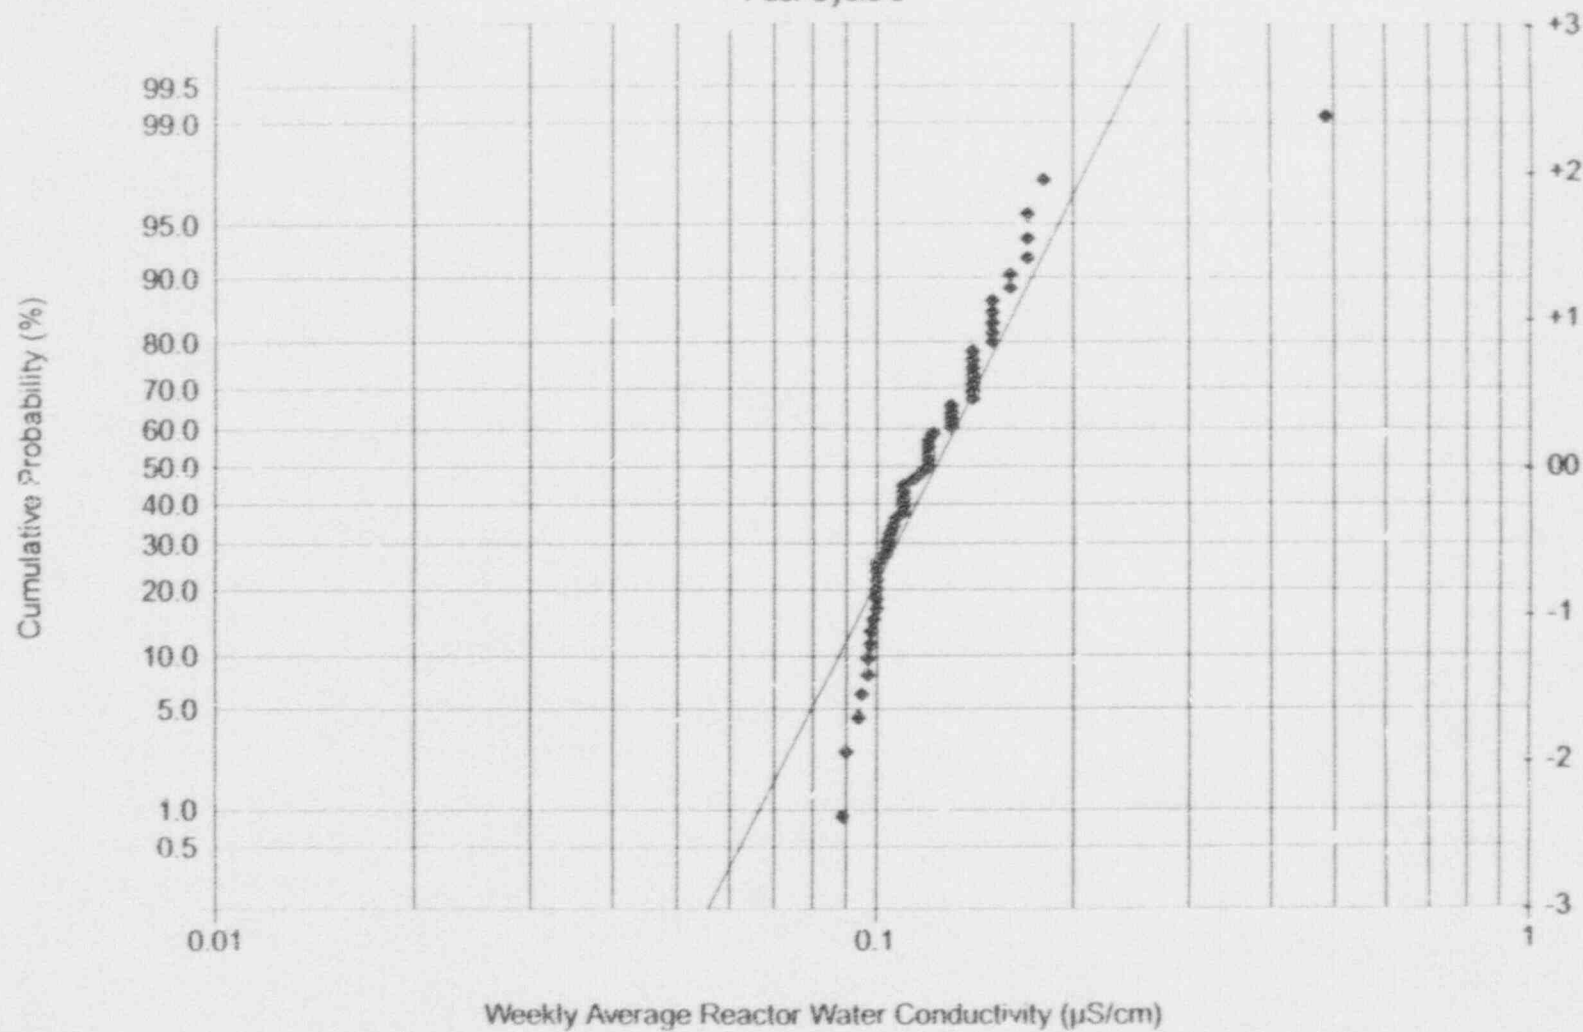
FIGURE 2

Similar behavior has been observed for SCC growth rate for Alloy 600 (the AHC material and the SSP material). Figure 2 shows the weekly average reactor water conductivity for Hatch-2. From the figure, it is clear that the conductivity levels at Hatch-2 were maintained below 0.2  $\mu\text{S/cm}$  for almost the entire fuel cycle 9. For 0.2  $\mu\text{S/cm}$  and normal water chemistry (NWC), the typical ECP is +100 mV. For NWC conditions at a relatively low conductivity, it is then reasonable to assume an expected crack growth rate of  $2 \times 10^{-5}$  in/hour, consistent with the observed crack growth plateau discussed above.

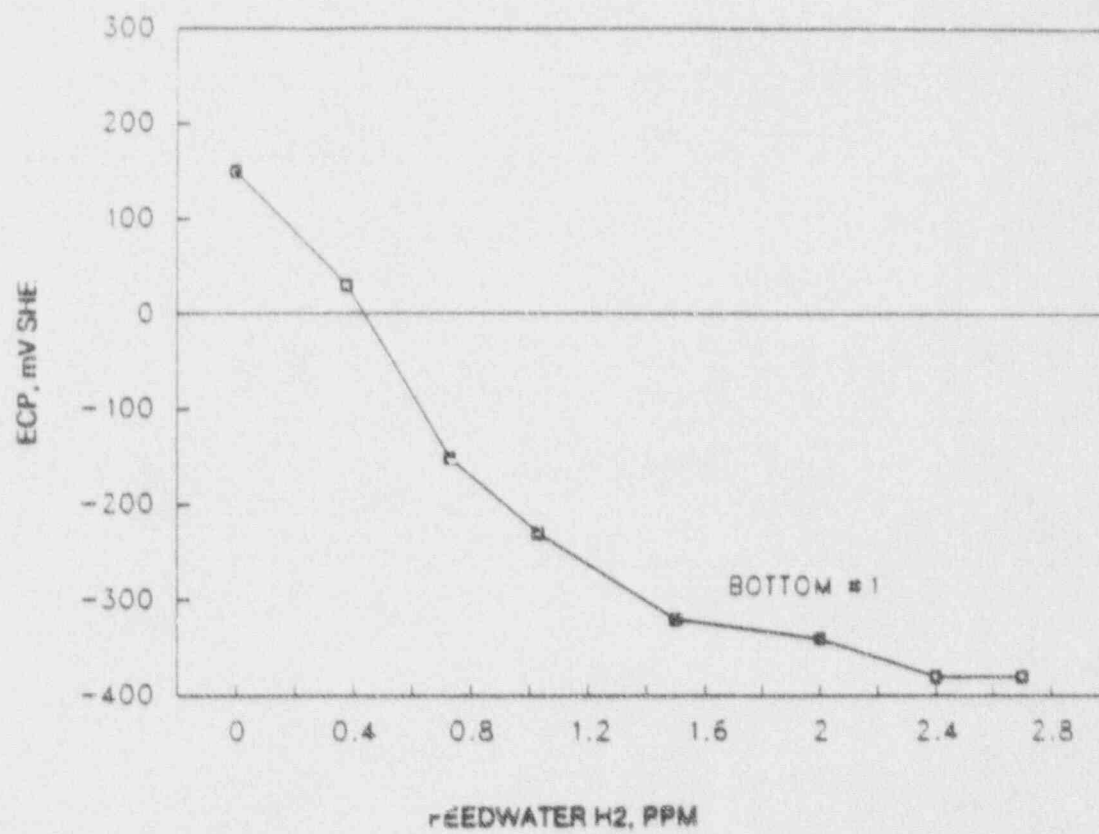
FIGURE 3 Measured ECP at bottom electrode positions (Ref. 2).

Hatch-2 has been operating on hydrogen water chemistry (HWC) at 0.6 ppb  $\text{H}_2$ . Since the conductivity is low, the GF CR&D "PLEDGE" model can be used to predict crack growth rates for HWC conditions. Figure 3 shows measured ECP data as a function of hydrogen injection (Reference 2) for a typical BWR. Based upon this data and a hydrogen injection rate of 0.6 ppm, the ECP is approximately -100 mV. For this ECP, the "PLEDGE" model predicts a significant decrease in crack growth rate as compared to NWC conditions at +100 mV ECP. The crack growth rate is reduced by a factor of 16.3 to  $0.122 \times 10^{-5}$  in/hour. The predicted ligament reduction over the next operating cycle is calculated as follows, assuming 12,000 hours of operation,

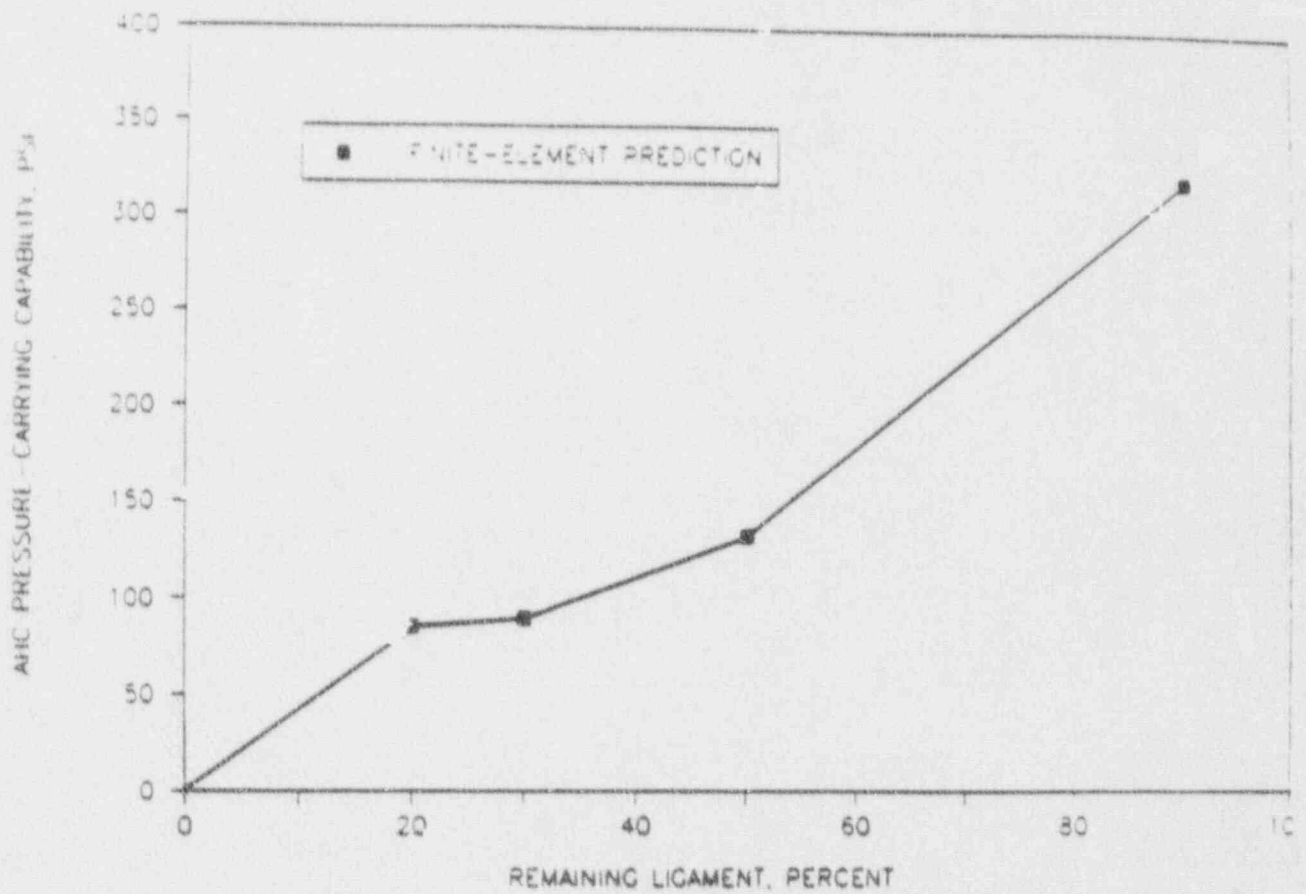
FIGURE 4

The limiting dP of 79.4 psi is used to determine the allowable remaining ligament size for the AHC. Figure 4 shows the finite element predictions. For dP = 79.4 psi, the remaining average ligament size is approximately 20%, or 0.125 inch.

Pressure Capability as a Function of Remaining Ligament

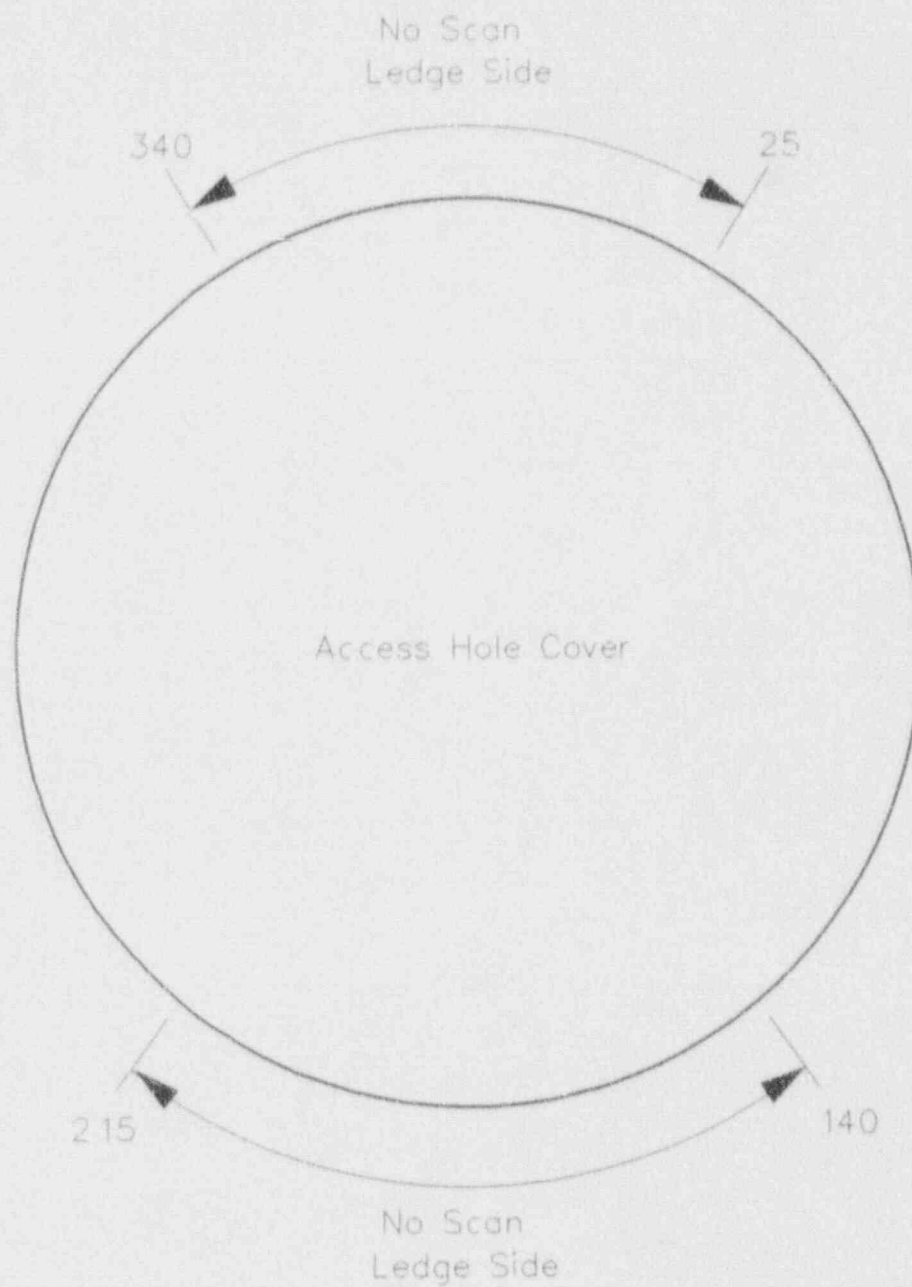
FIGURE 5

Due to limited access in the ledge regions around the AHC, only 67% of the circumference could be inspected, as shown in Figure 5. UT data was obtained using both 45° shear and 60° signals. These results are shown graphically in Figures 6 and 7. Although the 60° signal is

Total Circumference Scanned = 240 degrees (67%)

Avg. Remaining Ligament = 0.26" (42%)

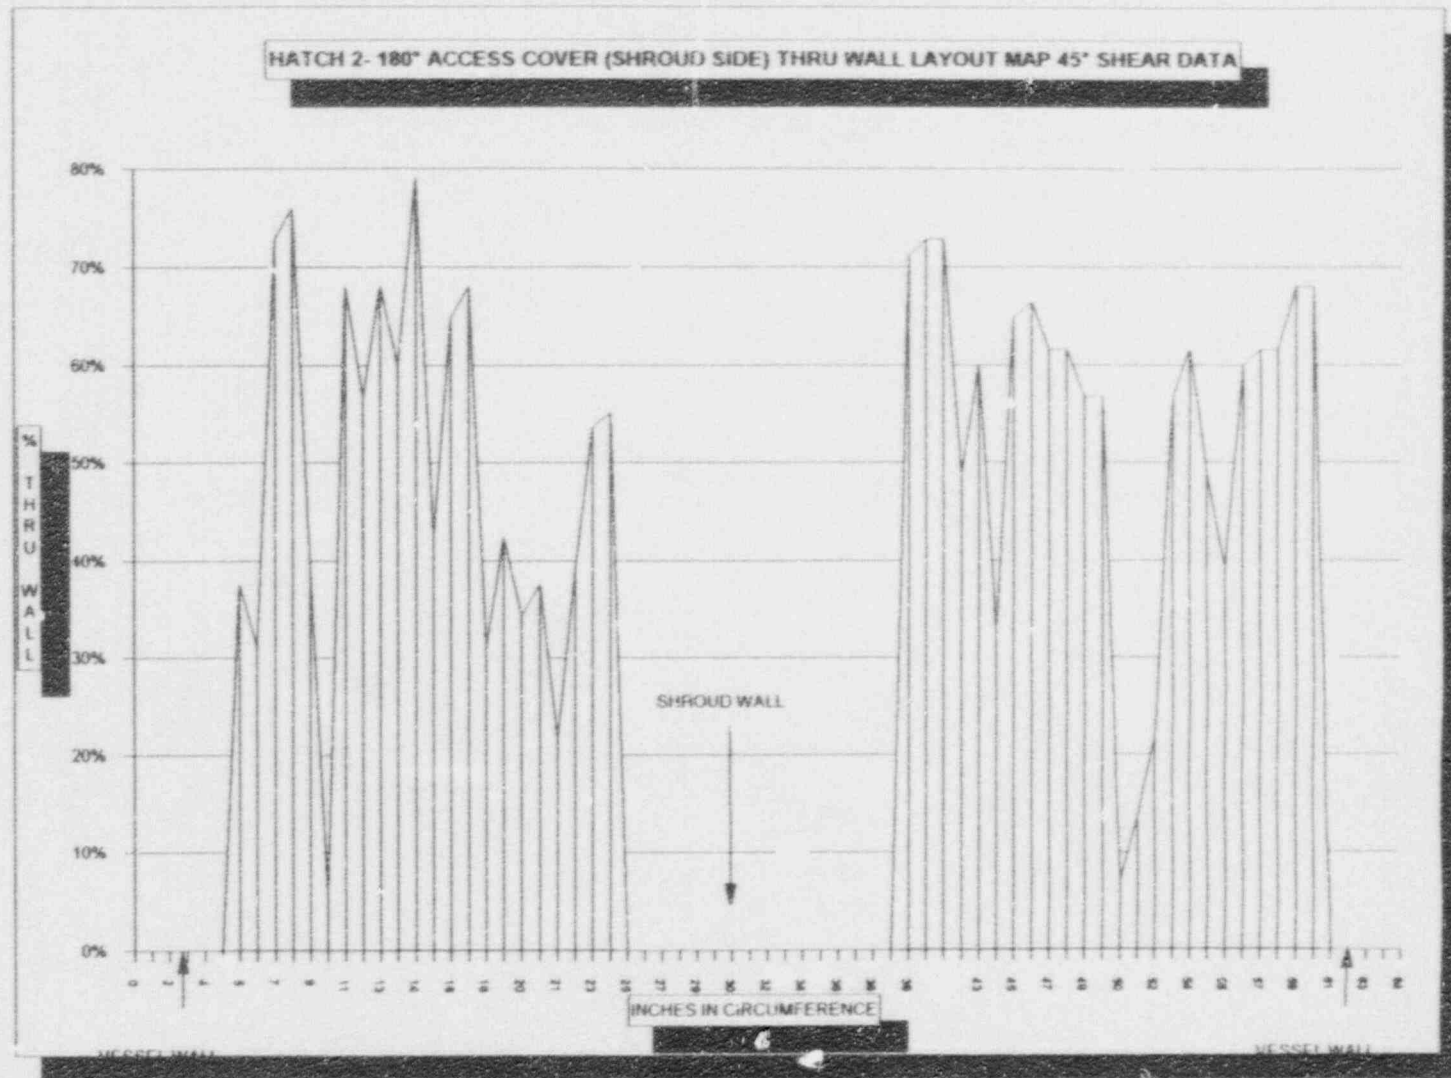
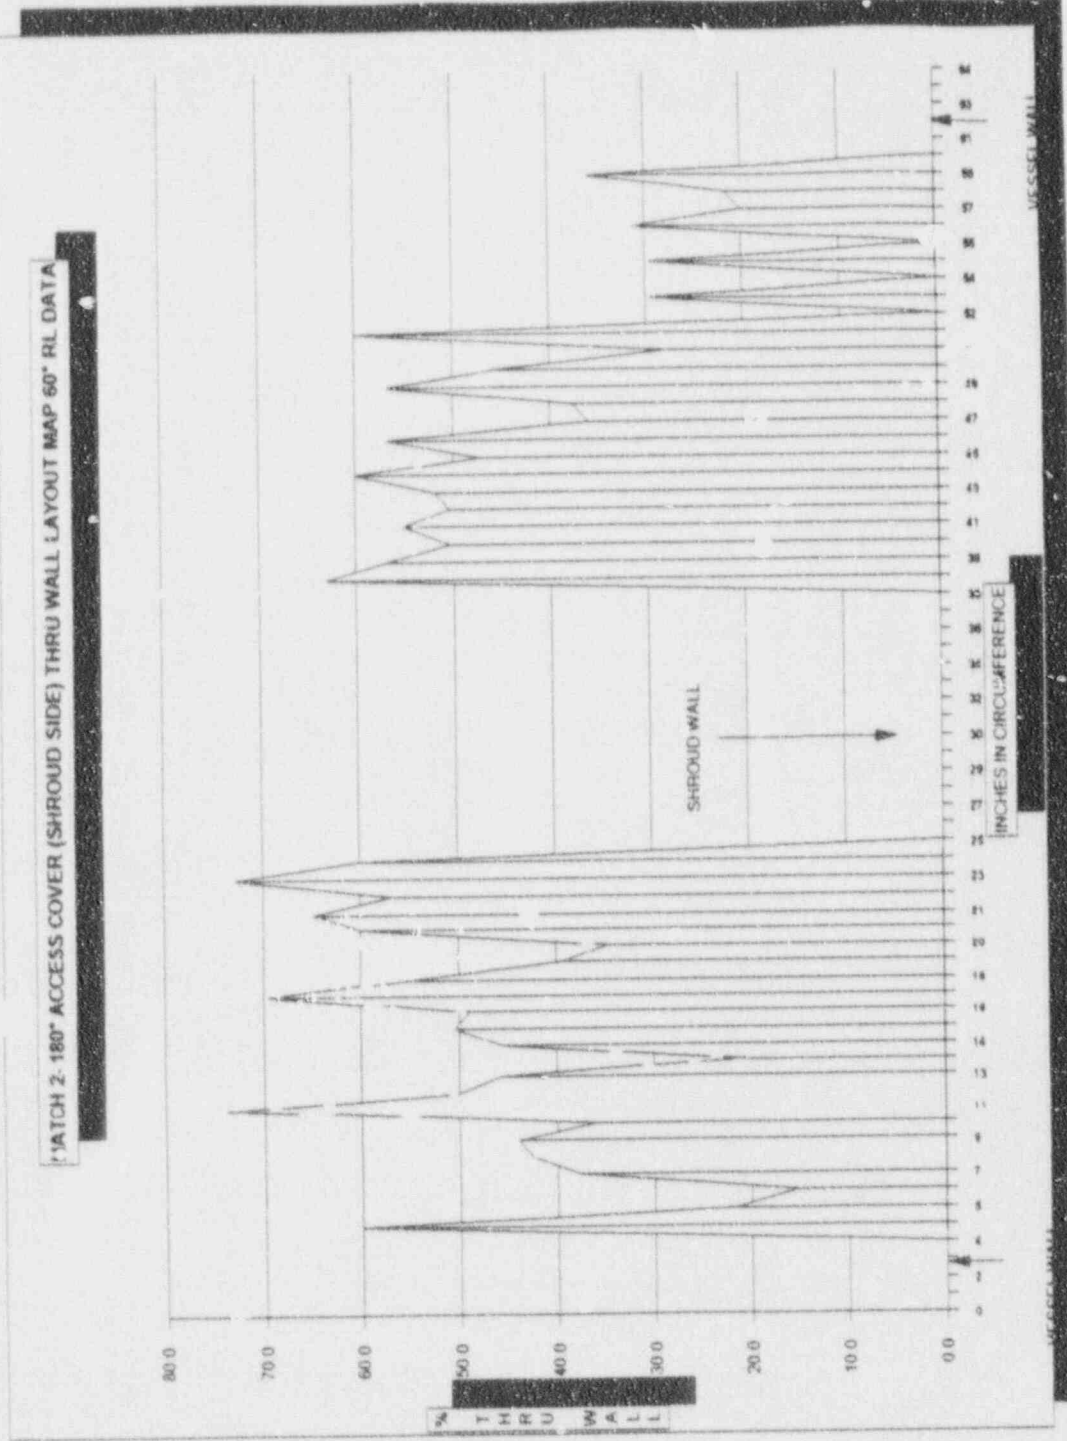
generally more reliable, the average crack depth was conservatively computed using the more limiting signal at each 5° measurement interval. The bounding crack depth profile around the circumference is shown in Figure 8.

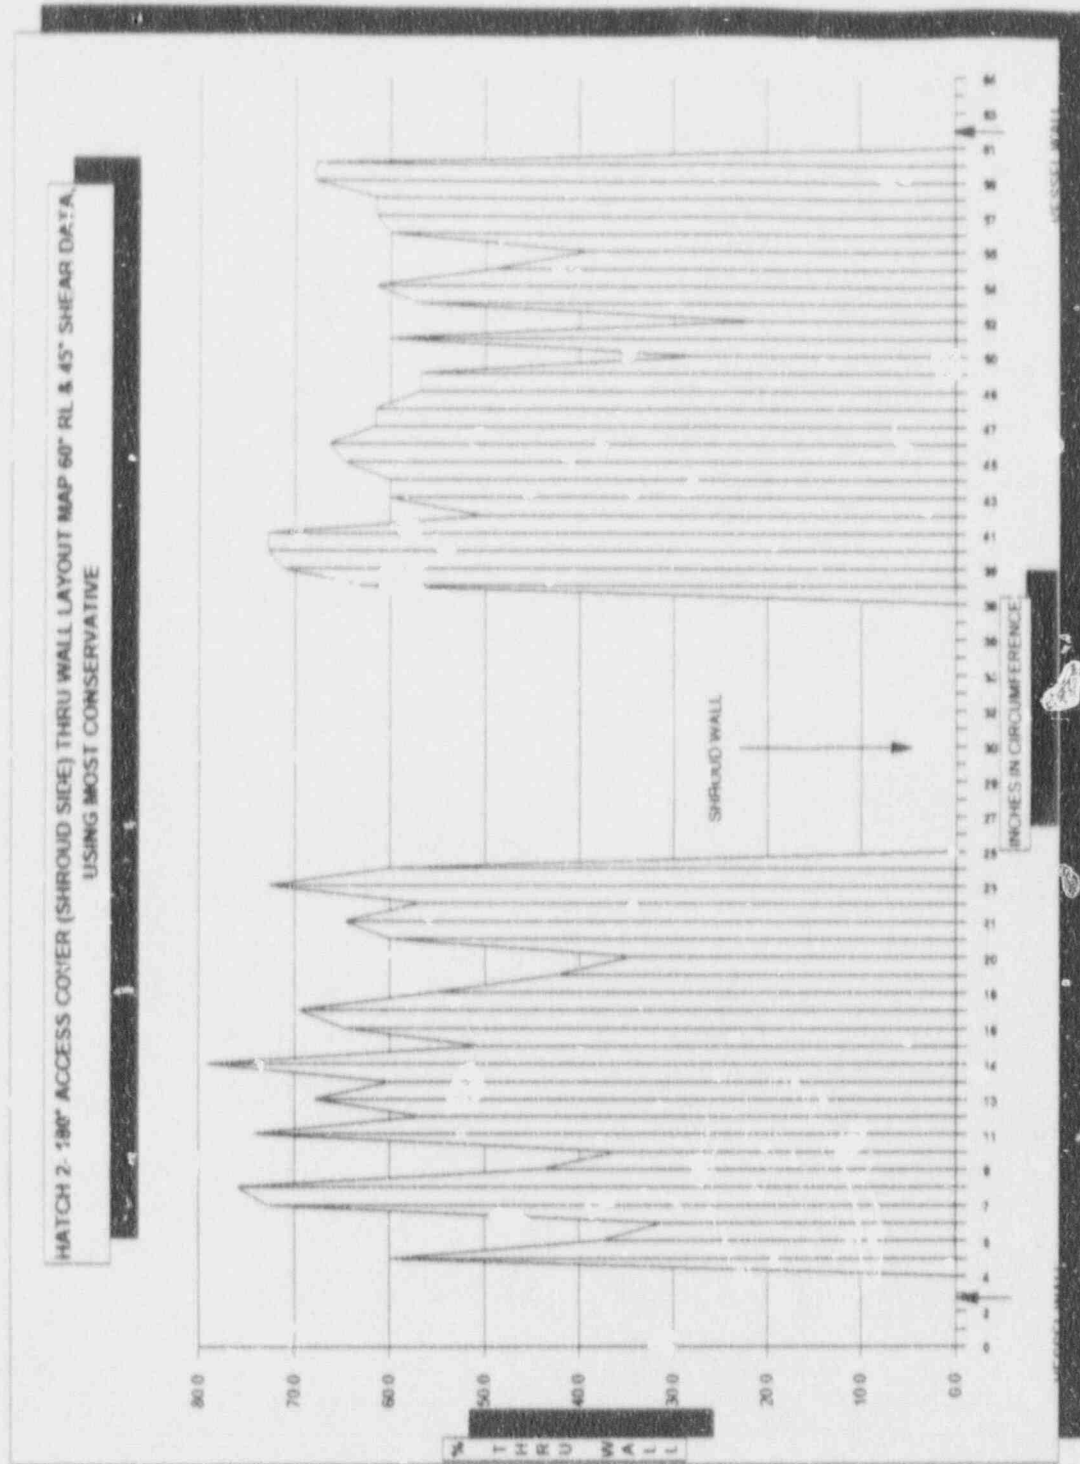
FIGURE 8

Based upon the bounding crack depth profile (measured at 5° intervals), the average crack depth was computed to be 0.365" (or 58% of the thickness). It is assumed that the average crack depth in the ledge regions, where UT inspection was not possible, is also 0.365". Therefore, the measured remaining ligament size (assuming the crack lies within the AHC weld) is,

Clearly the measured ligament size is well above the minimum required ligament size of 0.140 inch (or 22%). The local peak crack depth was 79.2%, which corresponds to a minimum ligament size of 0.130 inch. This value differs from the minimum required ligament by only 0.01 inch. This difference is small and occurs only over a 5° interval.
