## LICENSEE EVENT REPORT (LER)

FACILITY NAME (1) Susquehanna Steam Electric Station - Unit 1										DOCKET NUMBER (2) 0 5 0 0 0 3 8 1 7										PAGE (3) 1 OF 4																					
TITLE (4) SGTS and CREOASS Start (Radiography)																																									
EVENT DATE (5)						LER NUMBER (6)						REPORT DATE (7)						OTHER FACILITIES INVOLVED (8)																							
MONTH			DAY			YEAR			YEAR			SEQUENTIAL NUMBER			REVISION NUMBER			MONTH			DAY			YEAR			FACILITY NAMES						DOCKET NUMBER(S)								
																																	0 5 0 0 0								
0 3			2 3			8 5			8 5			0 1			1			0 0			0 4			2 5			8 5									0 5 0 0 0					
OPERATING MODE (9) 1						THIS REPORT IS SUBMITTED PURSUANT TO THE REQUIREMENTS OF 10 CFR § (Check one or more of the following) (11)																																			
POWER LEVEL (10) 0 0 0						20.402(b)						20.405(c)						X						50.73(a)(2)(iv)						73.71(b)

SUSQUEHANNA STEAM ELECTRIC STATION  
LICENSEE EVENT REPORT 85-011-00  
ER 100450 FILE 841-23  
PLAS- 067

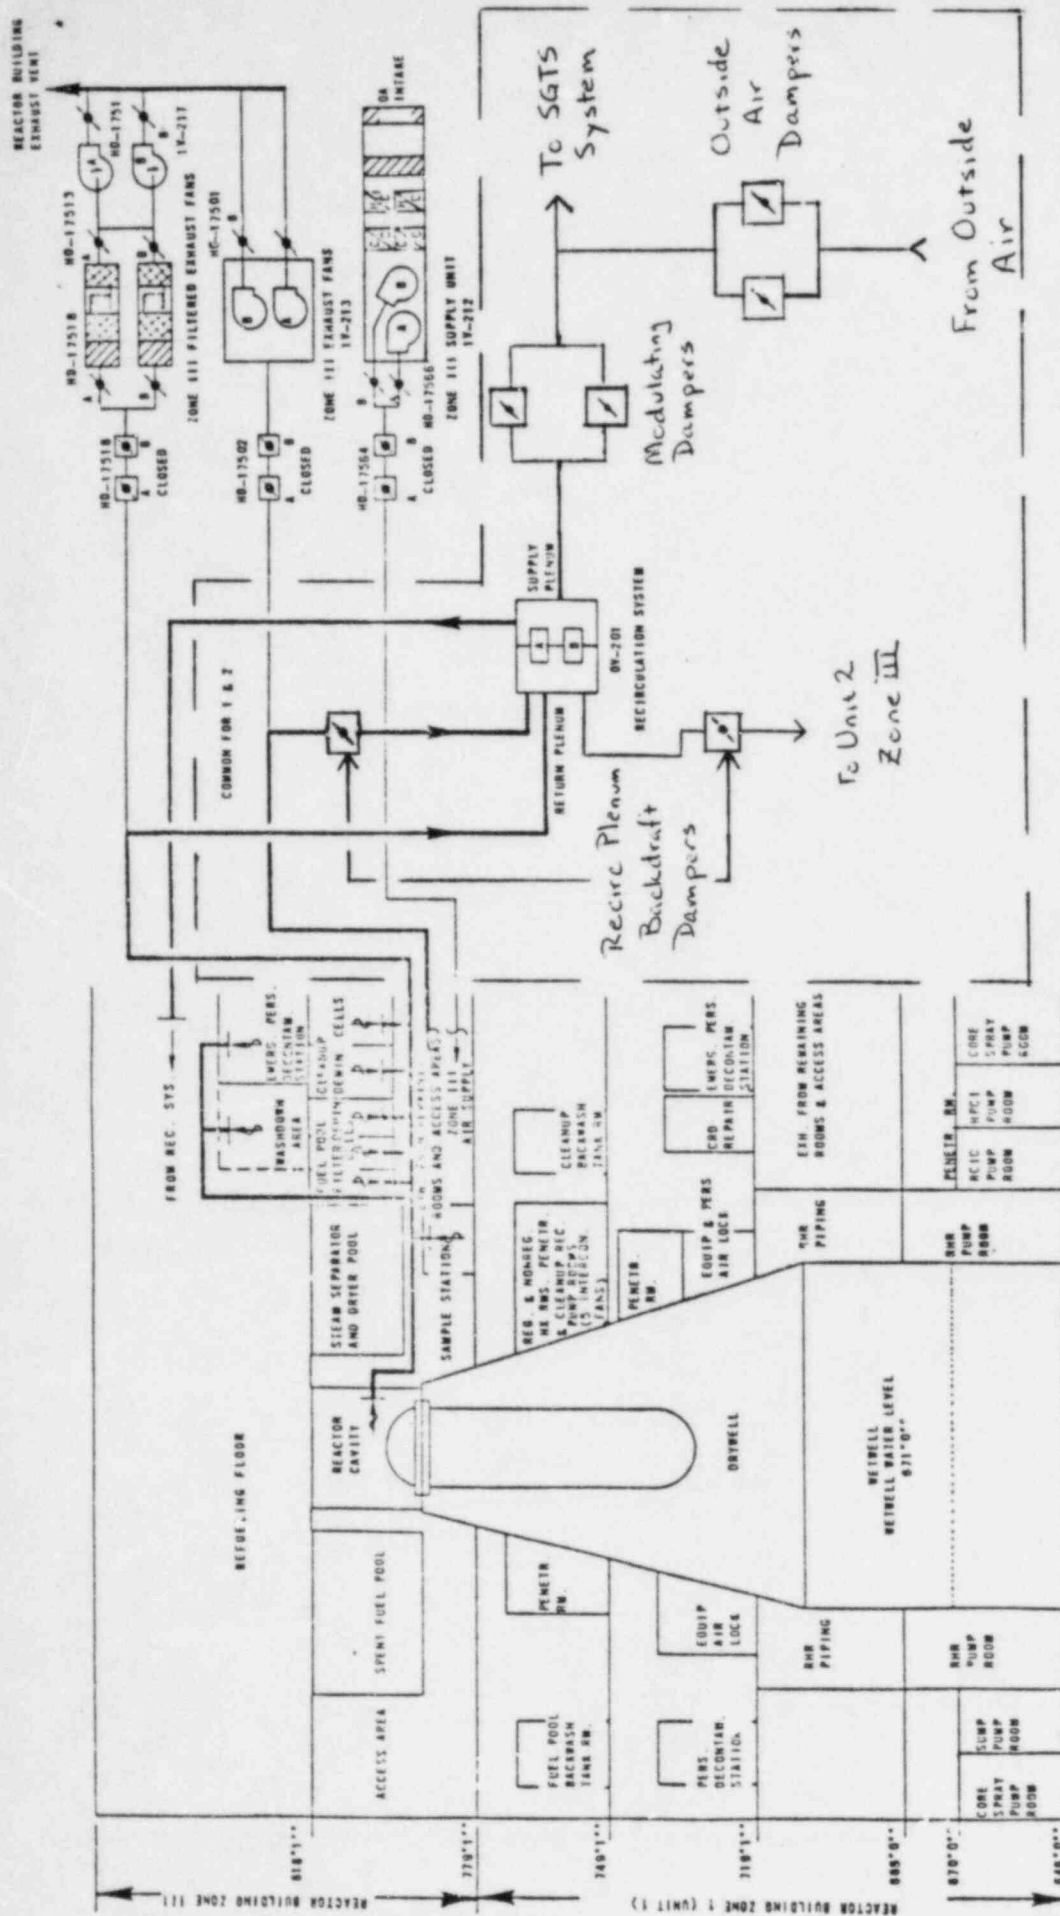
Figure 1

Because only a Division II isolation signal was generated, the normal Zone III, Division I fans remained in service for a short period of time. The secondary containment isolation dampers can take up to six seconds to close, thus the running fans maintained Zone III at the requisite 0.25 in w.g. vacuum while SGTS train 'B' was running. Since Zone III dp was being maintained, the modulating damper from the recirculation plenum to Zone III remained essentially closed. The outside air damper that controls makeup air flow to SGTS has a 120 second time delay to open on a Division II isolation signal. Thus, with the modulating damper from the recirculation plenum closed and the outside air damper closed, the SGTS train 'B' had no suction path and tripped on low flow. (See Figure 1.) To prevent recurrence, the low flow trip of the SGTS fans has been bypassed. (The low flow switch was originally intended to trip the SGTS fan in 'Lead' and start the SGTS fan in 'Standby'. Because both SGTS fans are now operated in 'Lead', the low flow trip signal is not required to start a second fan.) Additional engineering evaluation has been requested to determine if further actions are warranted.
