Hope Creek Generating Station

HOPE CREEK GENERATING STATION
DOCKET NO. 50-354
UNIT NO. 1
LICENSEE EVENT REPORT 91-010-01

LICENSEE EVENT REPORT																				
FACILITY NAME (1) HOPE CREEK GENERATING STATION												DOCKET NUMBER (2) 0 5 0 0 0 3 5 4						PAGE (3) 1 OF 5		
TITLE (4): Engineered Safety Feature Actuation - Automatic closure of Reactor Core Isolation Cooling Torus Vacuum Breaker inboard isolation valve during functional testing due to undetermined causes.																				
EVENT DATE (5)				LER NUMBER (6)						REPORT DATE (7)				OTHER FACILITIES INVOLVED (8)						
MONTH	DAY	YEAR		YEAR	*	NUMBER		*	RE	MONTH	DAY	YEAR		FACILITY NAME(S)				DOCKET NUMBER(S)		
0	5	1	5	9	1	-	0	1	0	-	0	1	1	1	1	5	9	2		
OPERATING (9) MODE				THIS REPORT IS SUBMITTED PURSUANT TO THE REQUIREMENTS OF 10CFR: (CHECK ONE OR MORE BELOW) (11)																
POWER LEVEL % 1 0 0				<div style="display: flex; justify-content: space-between;"> <div> 20.402(b) 20.405(a)(1)(i) 20.405(a)(1)(ii) 20.405(a)(1)(iii) 20.405(a)(1)(iv) 20.405(a)(1)(v) </div> <div> 20.405(c) 50.36(c)(1) 50.36(c)(2) 50.73(a)(2)(i) 50.73(a)(2)(ii) 50.73(a)(2)(iii) </div> <div> xx 50.73(a)(2)(iv) 50.73(a)(2)(v) 50.73(a)(2)(vii)

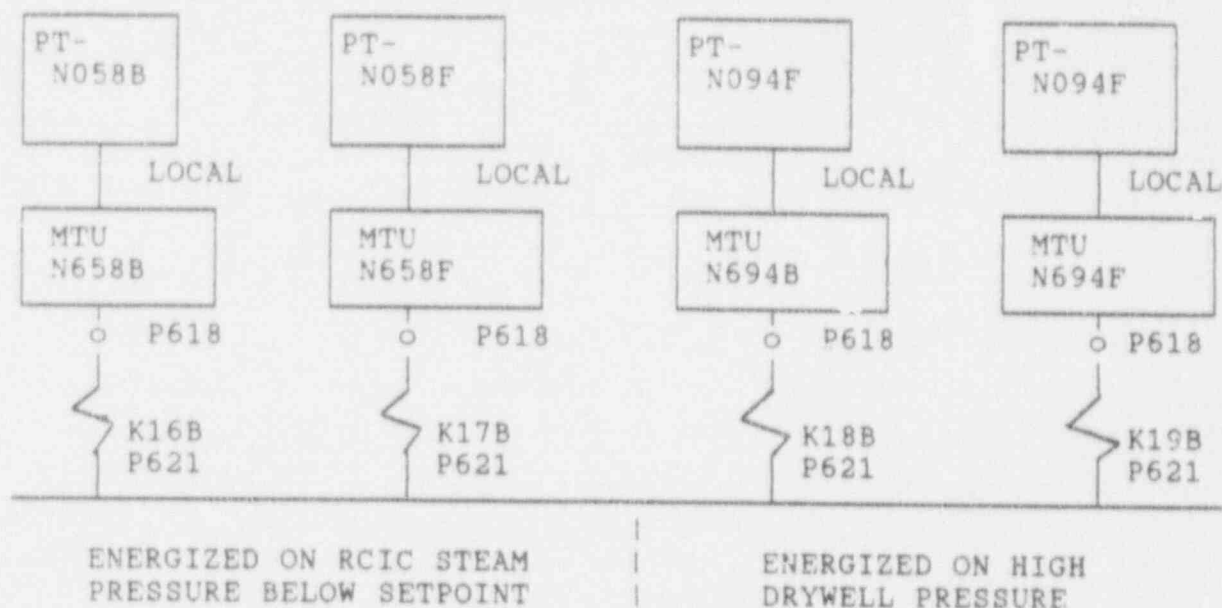
INSTRUMENTATION SCHEMATIC, F052

This event occurred during the performance of a monthly Maintenance Department (Controls) functional test on Division 2 Drywell Pressure instrumentation. Refer to the instrumentation schematic and logic arrangement for F062, shown on Attachment 1.

1. A spike or fault on one of the six components in the "RCIC Steam Pressure Below Setpoint" instrumentation (PT-N058B / MTU N658B / RELAY K16B; PT-N058F / MTU N658F / RELAY K17B) could account for completion of the F062 isolation logic. All components in this circuit will be tested and inspected at the next forced or planned unit outage, as RCIC must be declared inoperable to perform this testing. The subject surveillance test has been performed subsequent to this event, with no problems being noted.

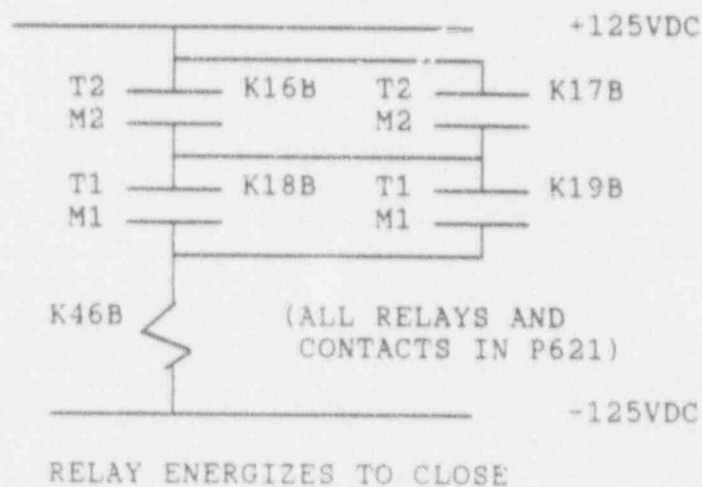
AUTO ISOLATION LOGIC, F062

The logic which initiates auto closure of F062 is a one out of two taken twice logic arrangement. A Division 1 or Division 2 Low RCIC Steam Supply Pressure signal and a Division 1 or Division 2 High Drywell Pressure signal are required to satisfy the F062 auto-closure logic.

As part of the functional test, a Division 2 High Drywell Pressure signal was manually inputted to the logic through trip unit N694F. This signal energized E51-K19B, and closed contact T1-M1. Two minutes after input of the signal, the isolation occurred. In order for isolation of F062 to have occurred, the circuit through the T2-M2 contacts of either E51-K16B or E51-K17B would have to be completed concurrent with the E51-K19B

T1-M1 contact being closed. The ensuing investigation focused on all scenarios that would have completed the logic.

Two potential scenarios were developed that could have resulted in completion of the valve control logic.

1. The subject functional test procedure has been reviewed for potential human factors enhancements.
2. Extensive post event testing and analysis was conducted by the Technical and Maintenance departments. Additional testing to verify proper operation of the logic circuit and valve operation has been performed.
