LOUISIANA POWER & LIGHT CO

WATERFORD SES NO. 3

REPORT ON LICENSE CONDITION NO. 16

EVALUATION OF THE POTENTIAL
ADVERSE EFFECTS OF THE
FAILURE OF CONTAINMENT COATINGS
ON POST ACCIDENT FLUID SYSTEMS

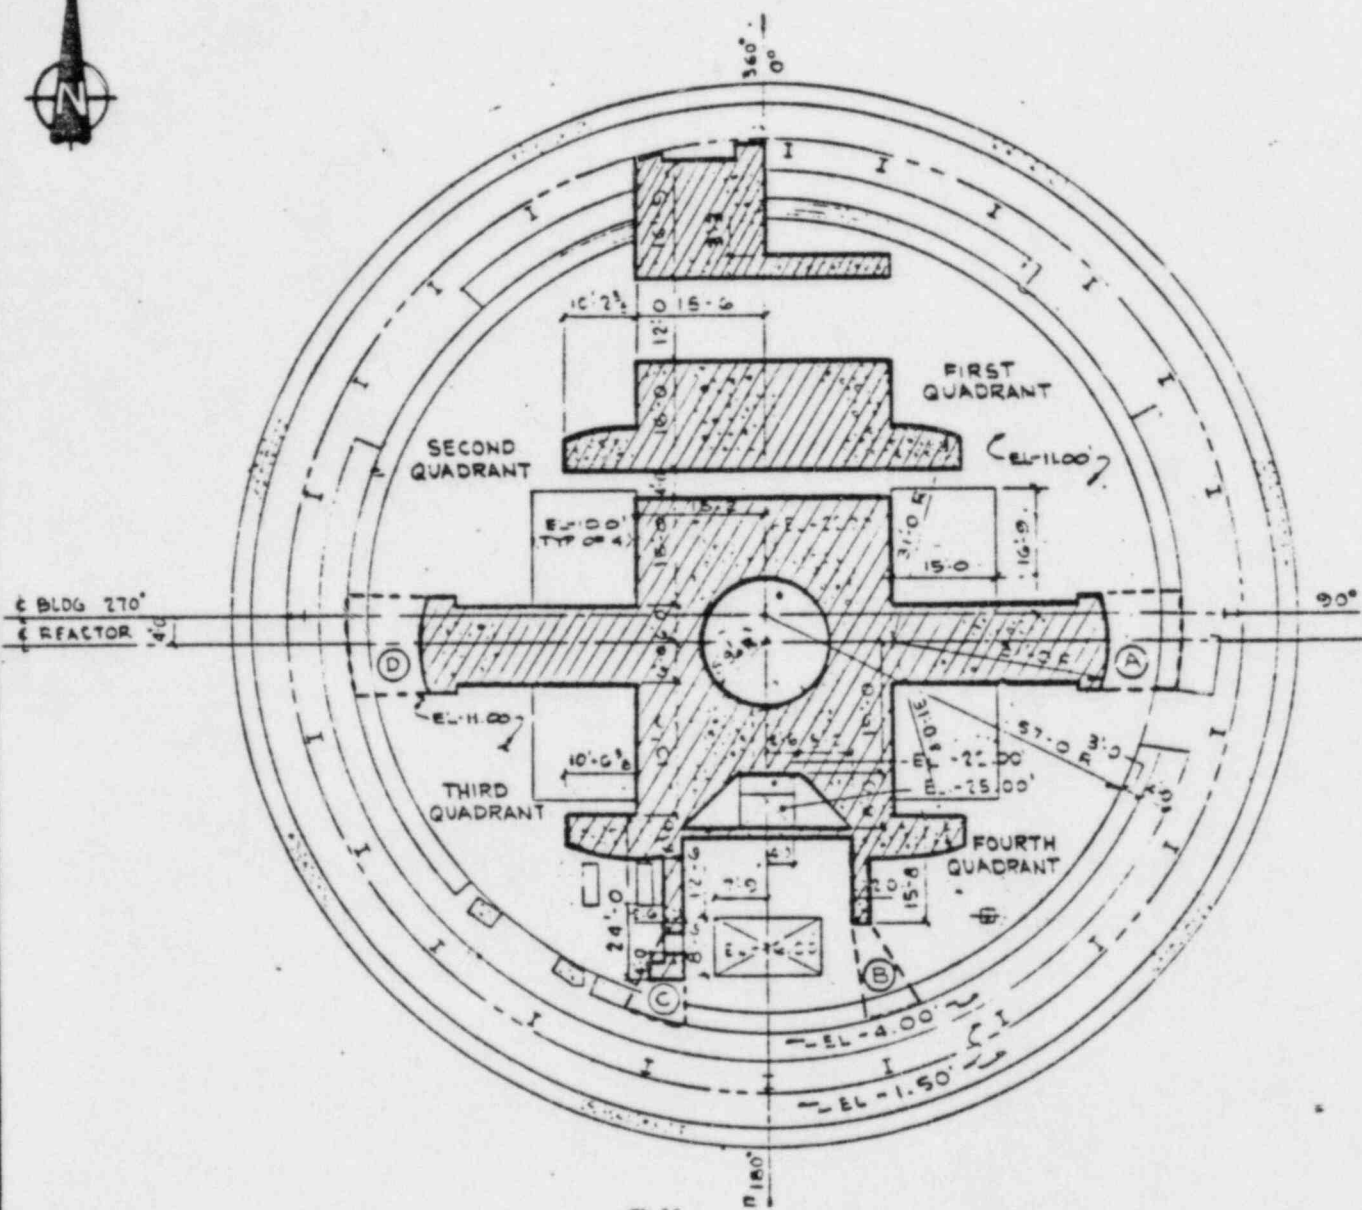
Figure
1

For the purpose of performing a simple, yet still conservative evaluation of the far field effects, it is further assumed that all the failed paint will find its way down to the Containment floor (El. -11') since all the upper elevation floors are gratings. By making this assumption it is only necessary to evaluate several critical locations at El.-11'. To calculate the local water velocity at the selected critical locations, the flow rates shown in FSAR Table 6.3-4 (Reference 2) for the SIS and CSS during long-term recirculating mode were used. Four Regions, A, B, C and D, with potentially higher local velocities were identified in Figure 1. Regions A and D were considered to see whether any paint debris can be transported from the First and Second Quadrants to the Third and Fourth Quadrants. Regions B and C were considered to determine whether any paint debris from the Third and Fourth Quadrants can be transported to the near sump regions (for potentially clogging the SIS Sump screens). In calculating the maximum local velocities at the given region, the break is always considered near the given region to determine the highest value, while the Containment Spray flow is assumed to be uniformly distributed inside the Containment. The maximum local velocity in Regions A and D is calculated as 0.126 ft/sec; Region B is 0.105 ft/sec; and Region C is 0.252 ft/sec. Since all the tumbling debris will eventually orient itself such that the maximum surface area is oriented parallel to the Containment floor (Reference 4), the critical slide velocity becomes the governing parameter for the debris transport along the Containment floor. By comparing the local water velocity against the critical slide velocity (0.181 ft/sec) and the critical tumble velocity (0.074 ft/sec) calculated earlier it can be concluded that although paint

SIS SUMP
FAR FIELD EFFECTS

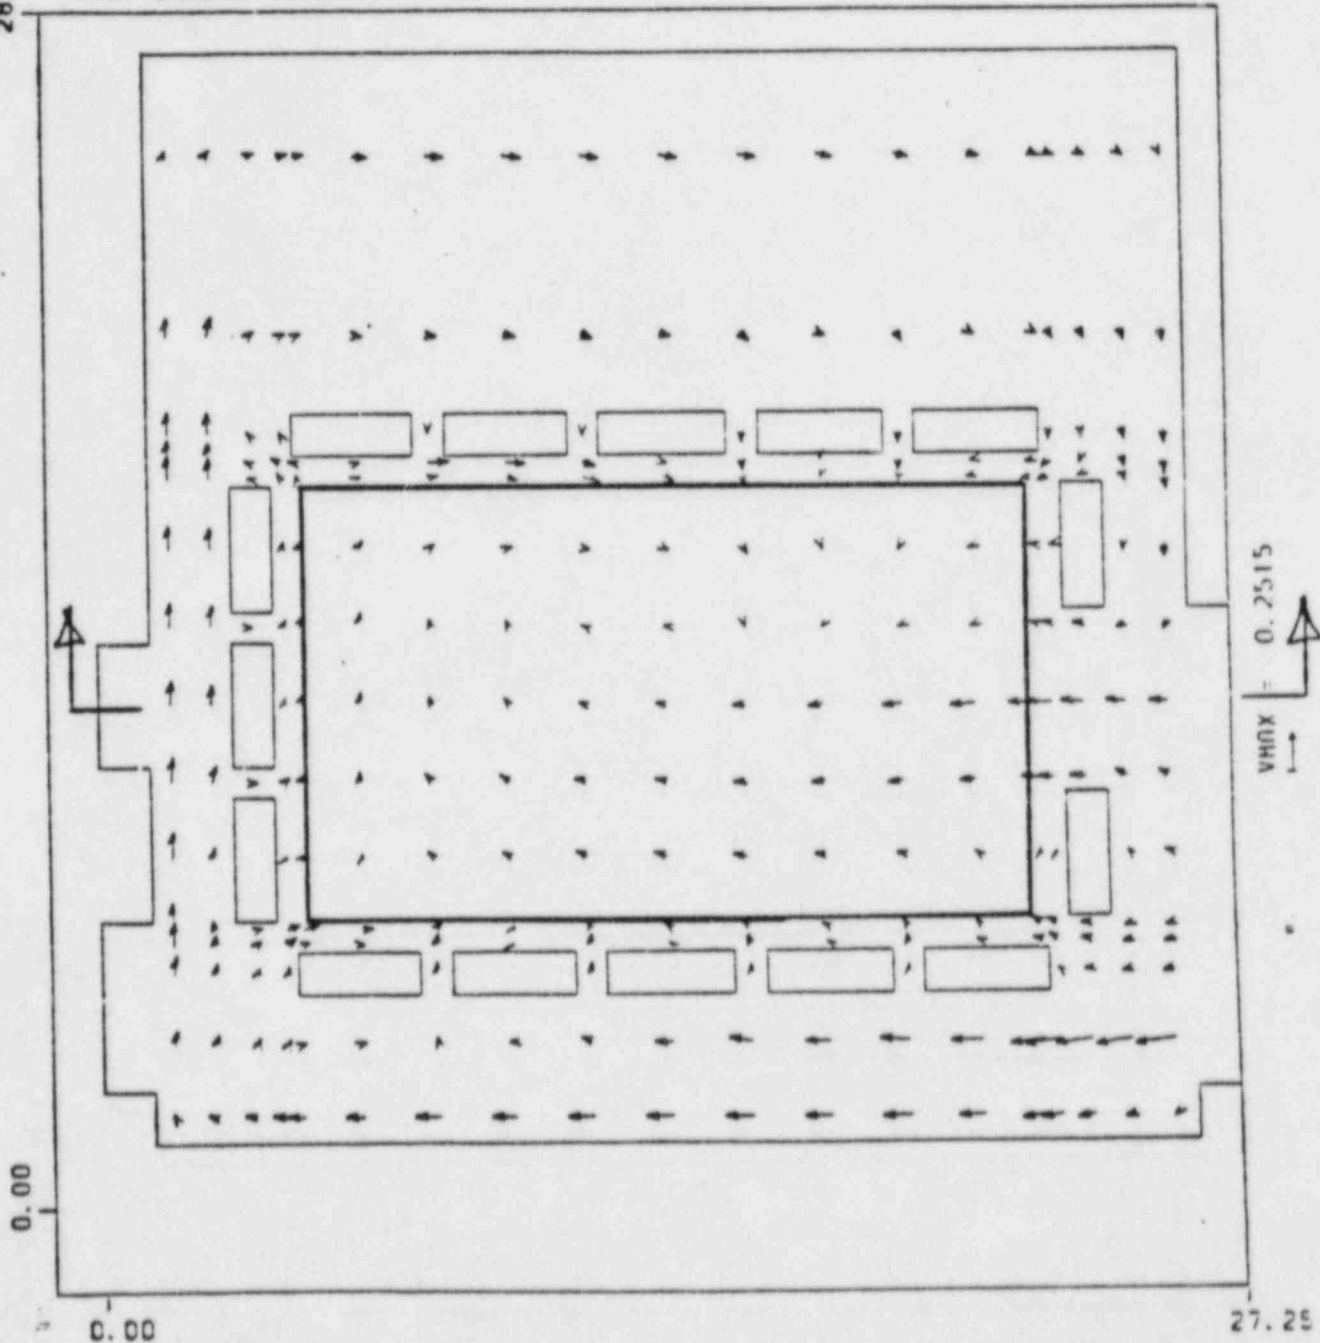
Figure
 5

3-D ANALYSIS
 UNBLOCKED SIS SUMP SCREENS - HORIZONTAL
 ELEVATION - 10.5'

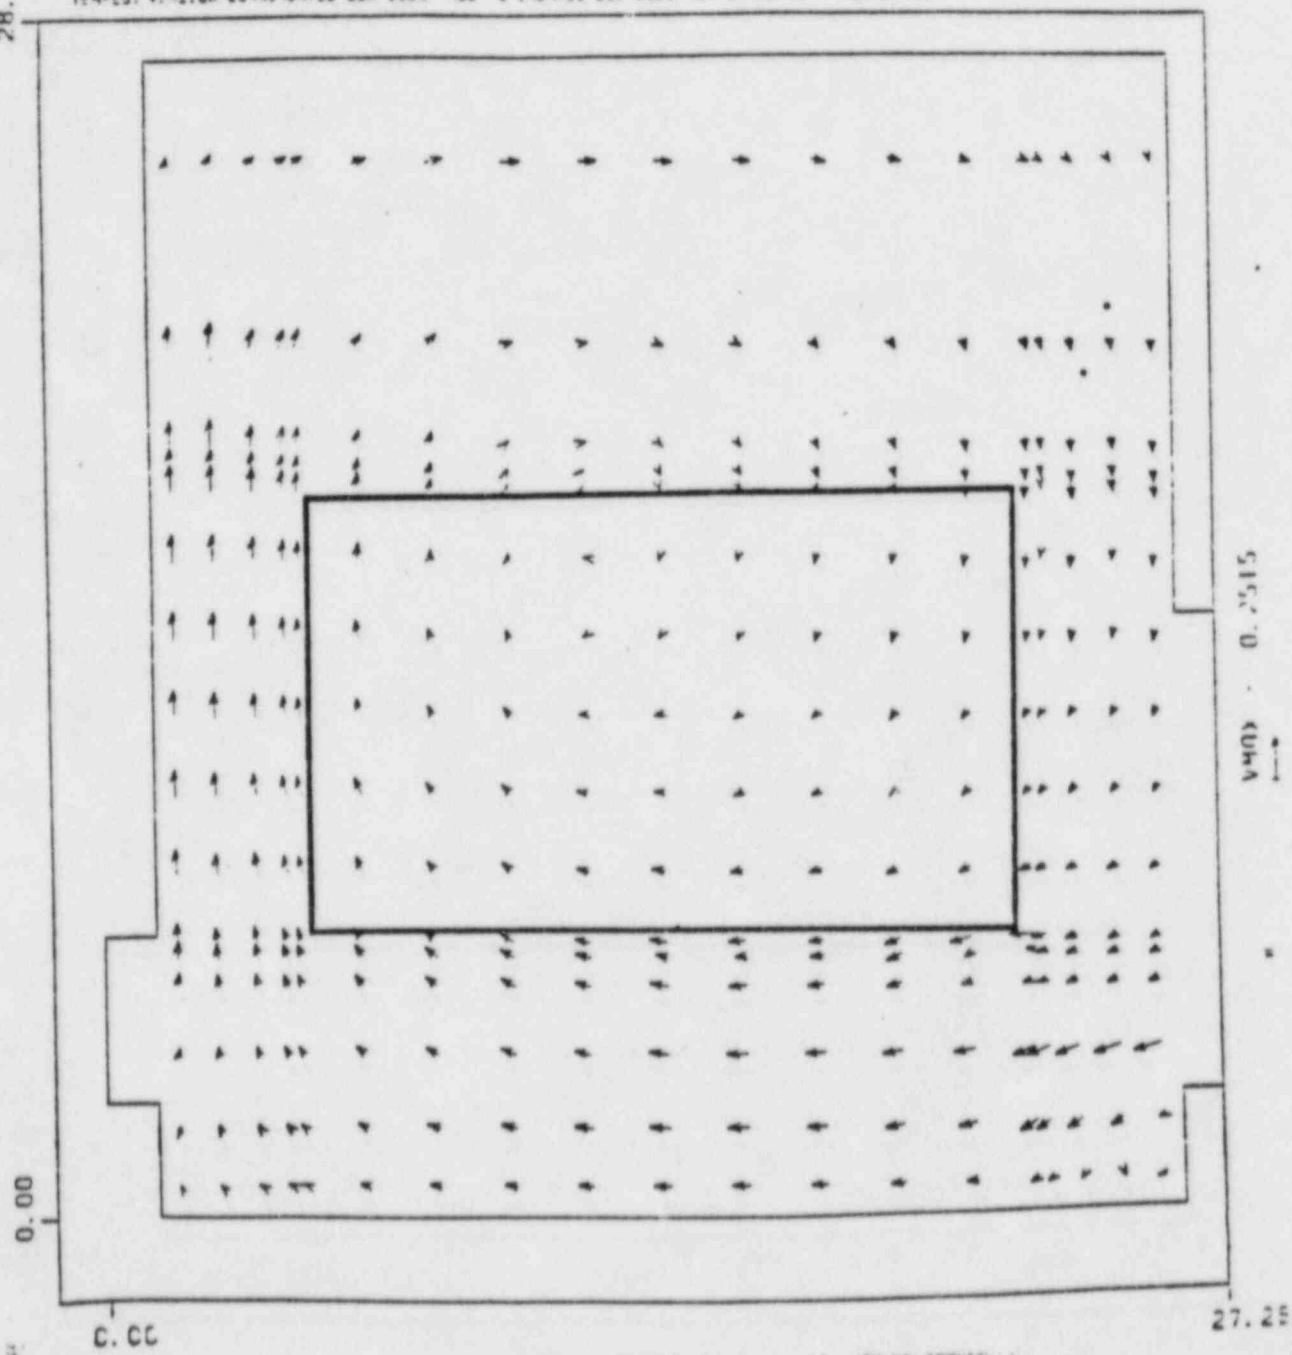
Figure
6

3-D ANALYSIS
UNBLOCKED SIS SUMP SCREENS – HORIZONTAL
ELEVATION – 3.0'

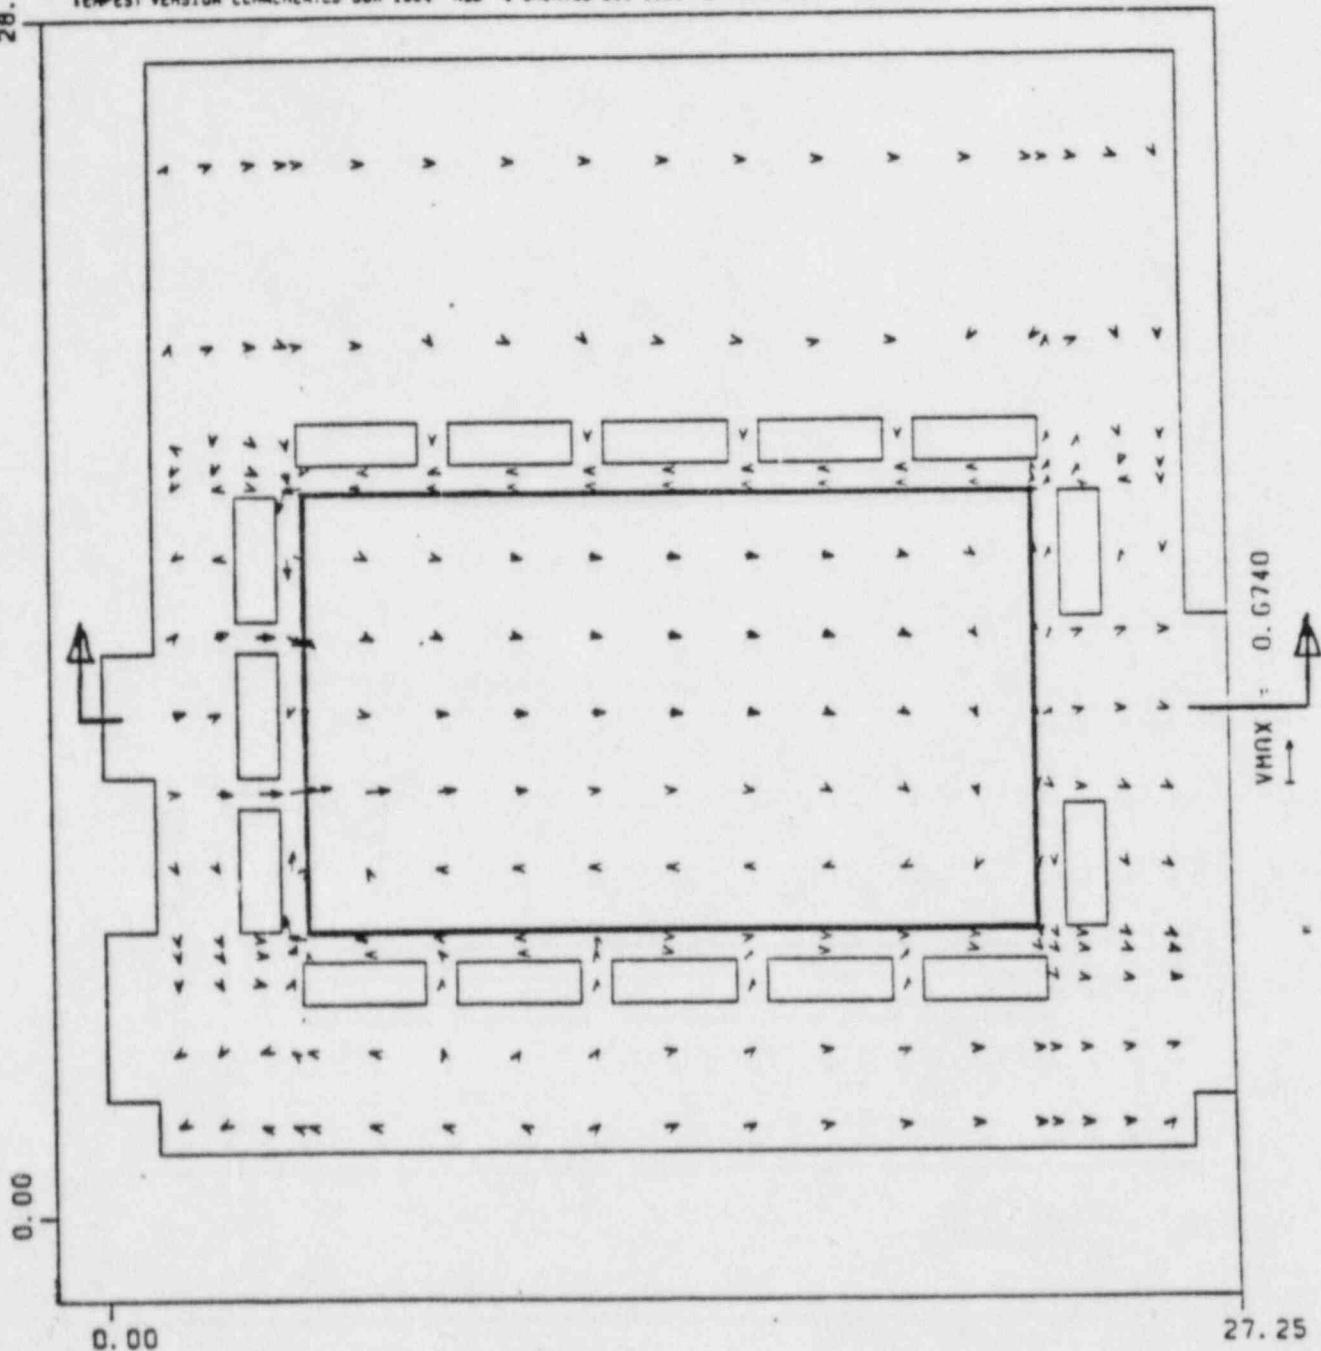
Figure
 8

3-D ANALYSIS
 BLOCKED SIS SUMP SCREENS - HORIZONTAL
 ELEVATION - 10.5'
