Delaval

March 18, 1985

In accordance with the requirements of Title 10, Chapter 10, Code of Federal Regulations, Part 21, Transamerica Delaval Inc., hereby notifies the Commission of a potential defect in a component of a DSR or DSRV-16 Standby Diesel Generator. There exists a potential problem with Oil Plugs in the Crankshaft, which could result in Engine non-availability.

SKETCH SHOWING OIL PLUG ROLLED INTO CRANKSHAFT

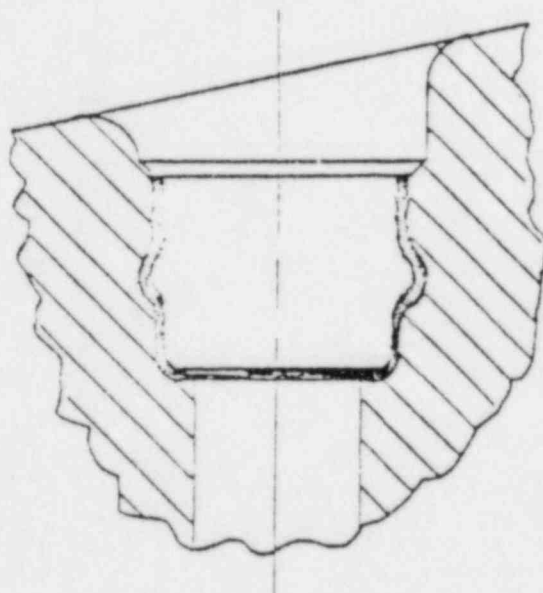
At Gulf States Utilities River Bend Site, a failed Crankshaft Oil Plug was recently discovered during routine maintenance. The failed Plug was 22 gauge material.

On 3/10/80 the Oil Plug material specification was changed from 16 gauge to 22 gauge. On 6/22/82 the material specification was changed back from 22 gauge to 16 gauge.

This Oil Plug, which seals drilled oil passages in the Crankshaft, is installed by Transamerica Delaval. The Oil Plug is rolled into the Crankshaft using an expansion tool. For your information, attached is a sketch showing the Oil Plug as it is installed in the Crankshaft.

If this Oil Plug fails, Engine availability may be affected depending on the amount of oil flow which is lost.

We recommend that all Engines be inspected to determine if any 22 gauge Plugs are installed. The 16 gauge Plug has a wall thickness of .0595. The 22 gauge Plug has a wall thickness of .0299. This wall thickness should be checked by measurement.

Transamerica Delaval recommends all 22 gauge Plugs be replaced with 16 gauge Plugs.

The 22 gauge Plug can be removed and replaced in the Engine without difficulty.
