South Texas Project  
Units 1 & 2  
Docket Nos. STN 50-498, STN 50-499  
Main Cooling Reservoir Meeting

During the meeting HL&P provided details on the studies, analyses, and modifications that have taken place relative to the Main Cooling Reservoir (MCR) embankment adjacent to the power block. These studies and analyses demonstrate that an adequate margin of safety for the MCR embankment can be maintained for all credible failure mechanisms. Therefore, all non-mechanistic effects (such as scour and erosion) associated with a postulated failure of the embankment need not be included in the design basis of the plant.

SOUTH TEXAS PROJECT  
MAIN COOLING RESERVOIR

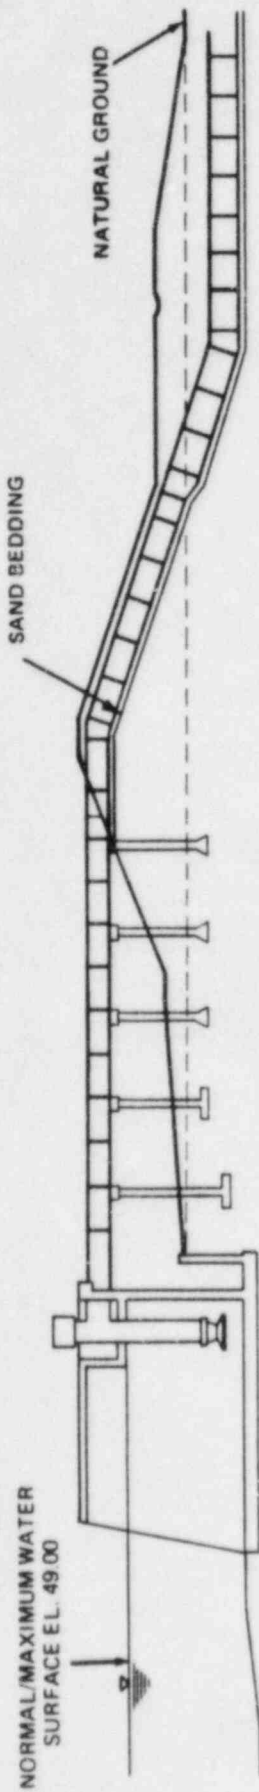
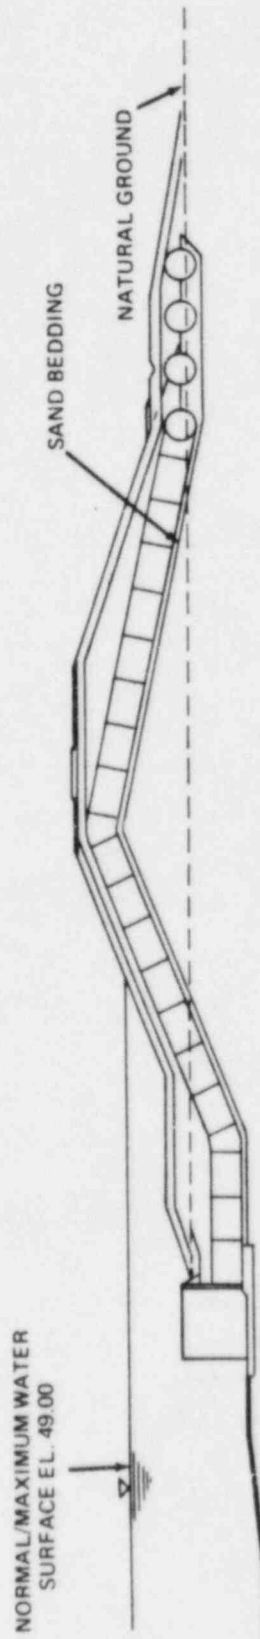
FIGURE 4

The circulating water system intake and discharge pipes penetrate the embankment section adjoining the power block (Figure 4). During the initial evaluations of the MCR embankment, a concern relative to potential joint leakage and embankment erosion was identified.

The major concern identified by the CRB relates to the watertightness of joints in the pipe sections penetrating the embankment under embankment settlement and hydraulically-induced longitudinal movement. The pipe joints under these loads could open causing leakage which could lead to embankment failure by erosion or by static overstress due to high pore pressures.

CIRCULATING WATER  
INTAKE & DISCHARGE  
PIPES BEFORE  
MODIFICATIONS

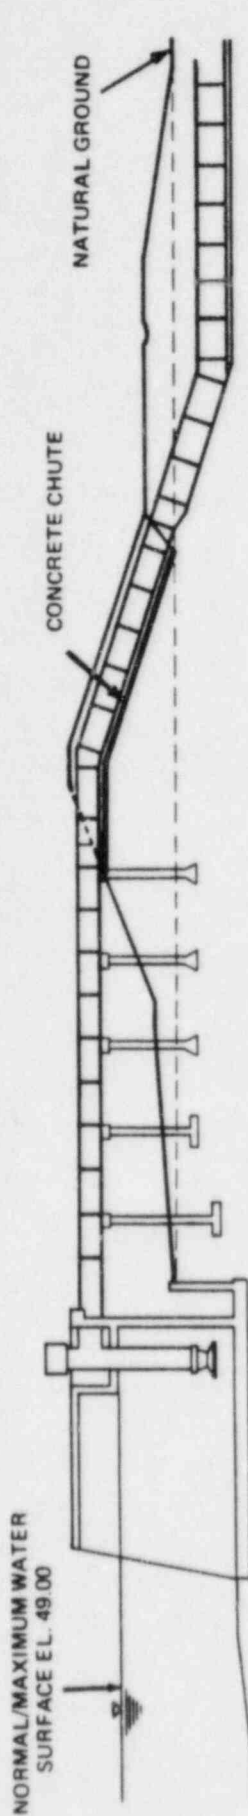
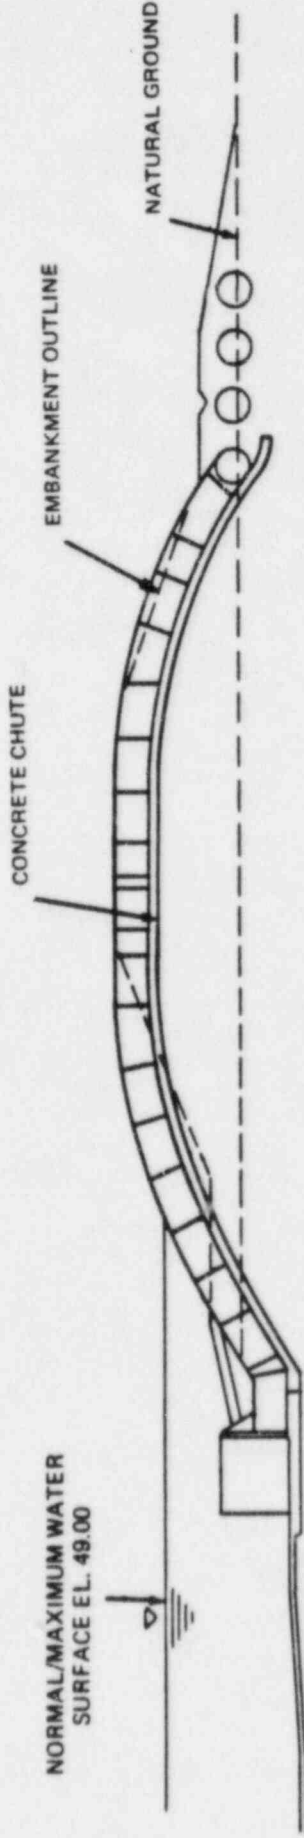
FIGURE 5

CIRCULATING WATER INTAKE & DISCHARGE PIPES AFTER MODIFICATIONS

As part of their evaluation, Harza studied the pipe penetrations and possible remedial measures to eliminate the erosion concern (Reference 6-1). Their recommendations for the circulating water intake and discharge pipes are summarized below (Figure 5):

The above discussed modifications to pipe and structural penetrations eliminate the possibility of fill erosion due to pipe leakage in the embankment and improve the safety of the plant.

The potential for erosion due to pipe leakage has been eliminated by exposing the circulating water pipes penetrating the embankment for inspectability and the provision of erosion resistant concrete chutes around the pipes. Piezometers installed in the toe berm will serve to monitor the embankment performance.

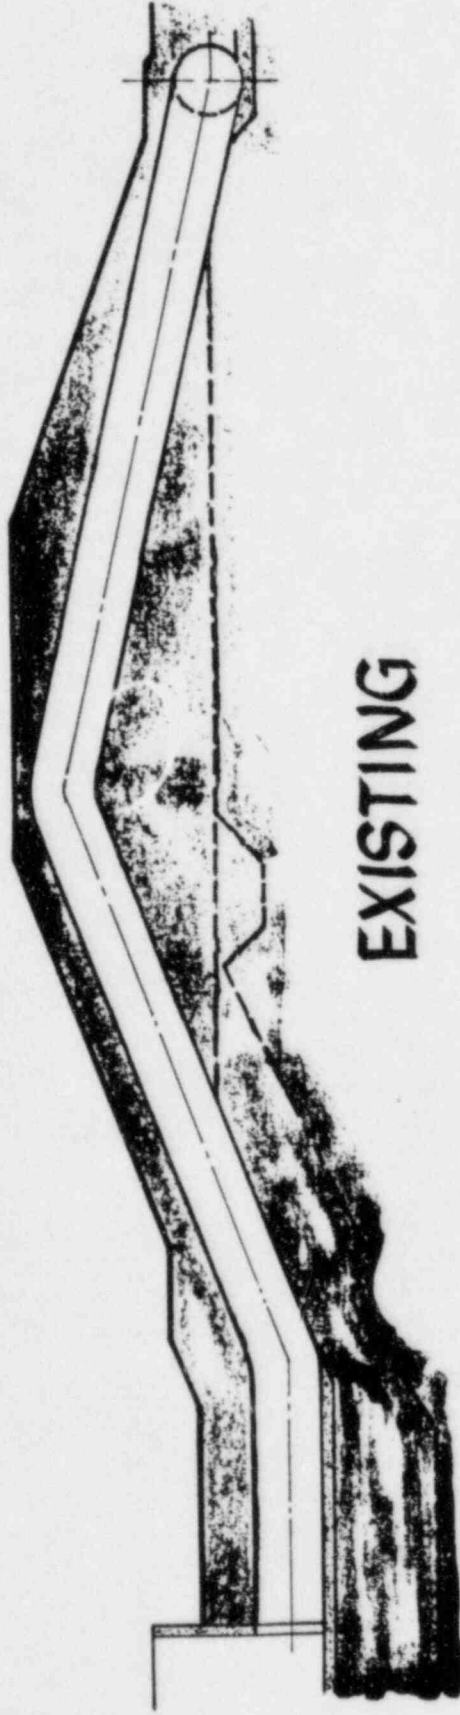
- SEEPAGE FROM RESERVOIR ALONG SAND PIPE BEDDING
- JOINT OPENING DUE TO:  
EMBANKMENT SETTLEMENT  
HYDRAULIC THRUST
- LACK OF INSPECTABILITY - PIPES ARE BURIED

- JOINT OPENING DUE TO SETTLEMENT OR HYDRAULIC FORCES UNLIKELY
- WATERTIGHTNESS NOT GUARANTEED
- LACK OF INSPECTABILITY-MAJOR PROBLEM
- INCREMENTAL FLEXIBILITY OF EXISTING PIPES POSITIVE DESIGN IF INSPECTABLE

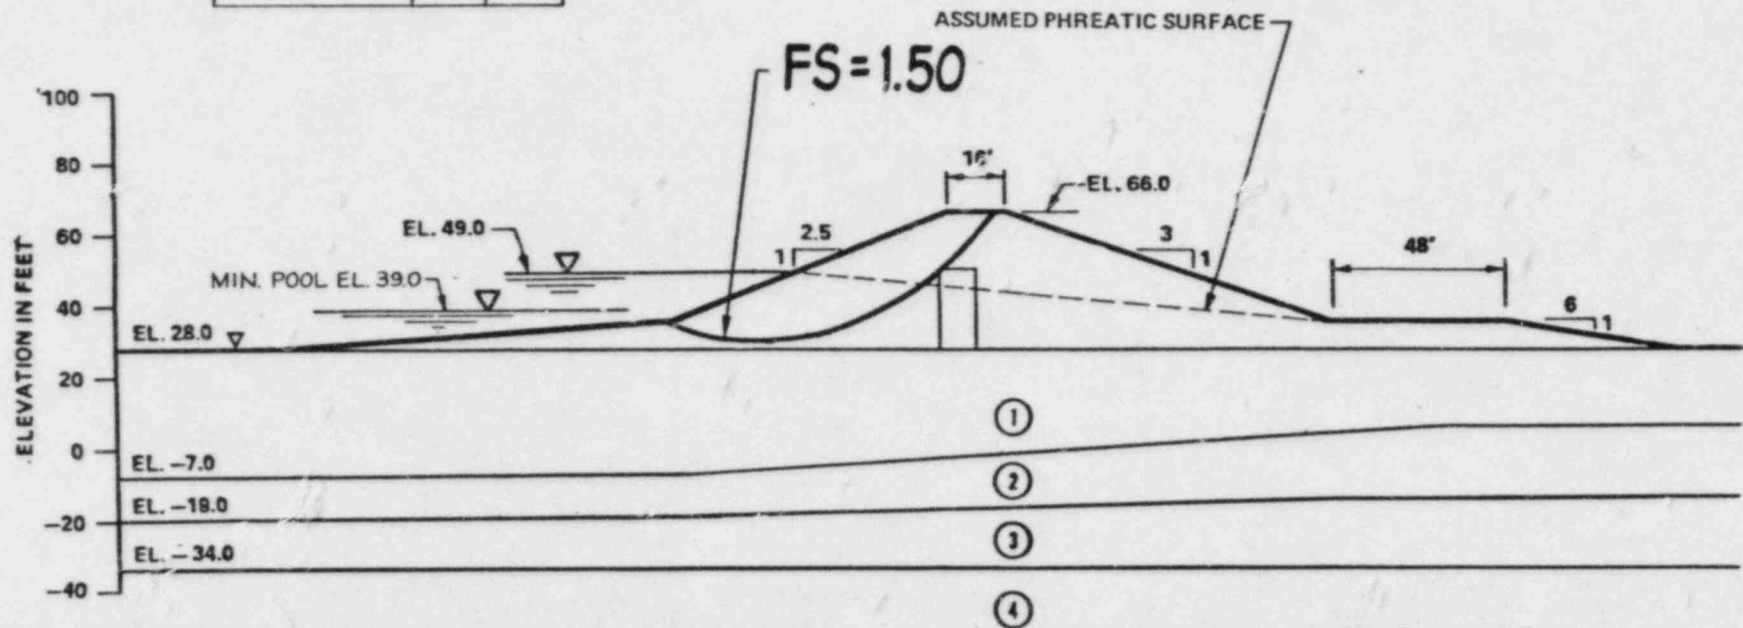
Rapid drawdown on the upstream face at Station 20+00 was analyzed by Harza as representative of the section facing the power block. The water level was assumed to drop from normal pool at El. 49 ft. to the crest of the spillway at El. 39 ft. A combined "R" and "S" shear strength envelope was used for selecting appropriate strength parameters as recommended by the Corps of Engineers. For the expected range of effective overburden pressure within the embankment and the foundation, it was found that the drained strength parameters were lower than the undrained strengths as would be expected for overconsolidated clays under low confining pressure. While rapid drawdown involves undrained shear, drained strength parameters were used for conservatism in accordance with the Corps of Engineers combined "R" and "S" envelope procedures. The change in pore water pressure was assumed equal to the change in total pressure in the upstream face after drawdown. Laboratory tests confirmed the validity of the pore water pressure assumption used in the analysis. The computed factor of safety for rapid drawdown of the upstream face at Station 20+00 was found to be 1.50 for drawdown from El. 49 ft. to El. 39 ft. This value is well above the minimum factor of safety of 1.2 normally used in embankment design (Reference 4-1).

Note that critical failure plane for rapid drawdown (F.S. = 1.50) is wholly within embankment
