NRC FORM 366 (5-92)						U.S. NUCLEAR REGULATORY COMMISSION						APPROVED BY OMB NO. 3150-0104 EXPIRES 5/31/95																	
<h2 style="margin: 0;">LICENSEE EVENT REPORT (LER)</h2> <p style="font-size: small; margin: 5px 0;">(See reverse for required number of digits/characters for each block)</p>																		ESTIMATED BURDEN PER RESPONSE TO COMPLY WITH THIS INFORMATION COLLECTION REQUEST: 50.0 HRS. FORWARD COMMENTS REGARDING BURDEN ESTIMATE TO THE INFORMATION AND RECORDS MANAGEMENT BRANCH (MNBB 7714), U.S. NUCLEAR REGULATORY COMMISSION, WASHINGTON, DC 20555-0001, AND TO THE PAPERWORK REDUCTION PROJECT (3150-0104), OFFICE OF MANAGEMENT AND BUDGET, WASHINGTON, DC 20503.											
FACILITY NAME (1) MONTICELLO NUCLEAR GENERATING PLANT												DOCKET NUMBER (2) 05000 - 263						PAGE (3) 1 OF 10											
TITLE (4) During a Re-analysis of the High Energy Line Break, An Error was found in the Existing Analysis

FACILITY NAME (1)		DOCKET NUMBER (2)		LER NUMBER (6)			PAGE (3)
				YEAR	SEQUENTIAL NUMBER	REVISION NUMBER	
MONTICELLO NUCLEAR GENERATING PLANT		05000 263		96	003	00	3 of 10

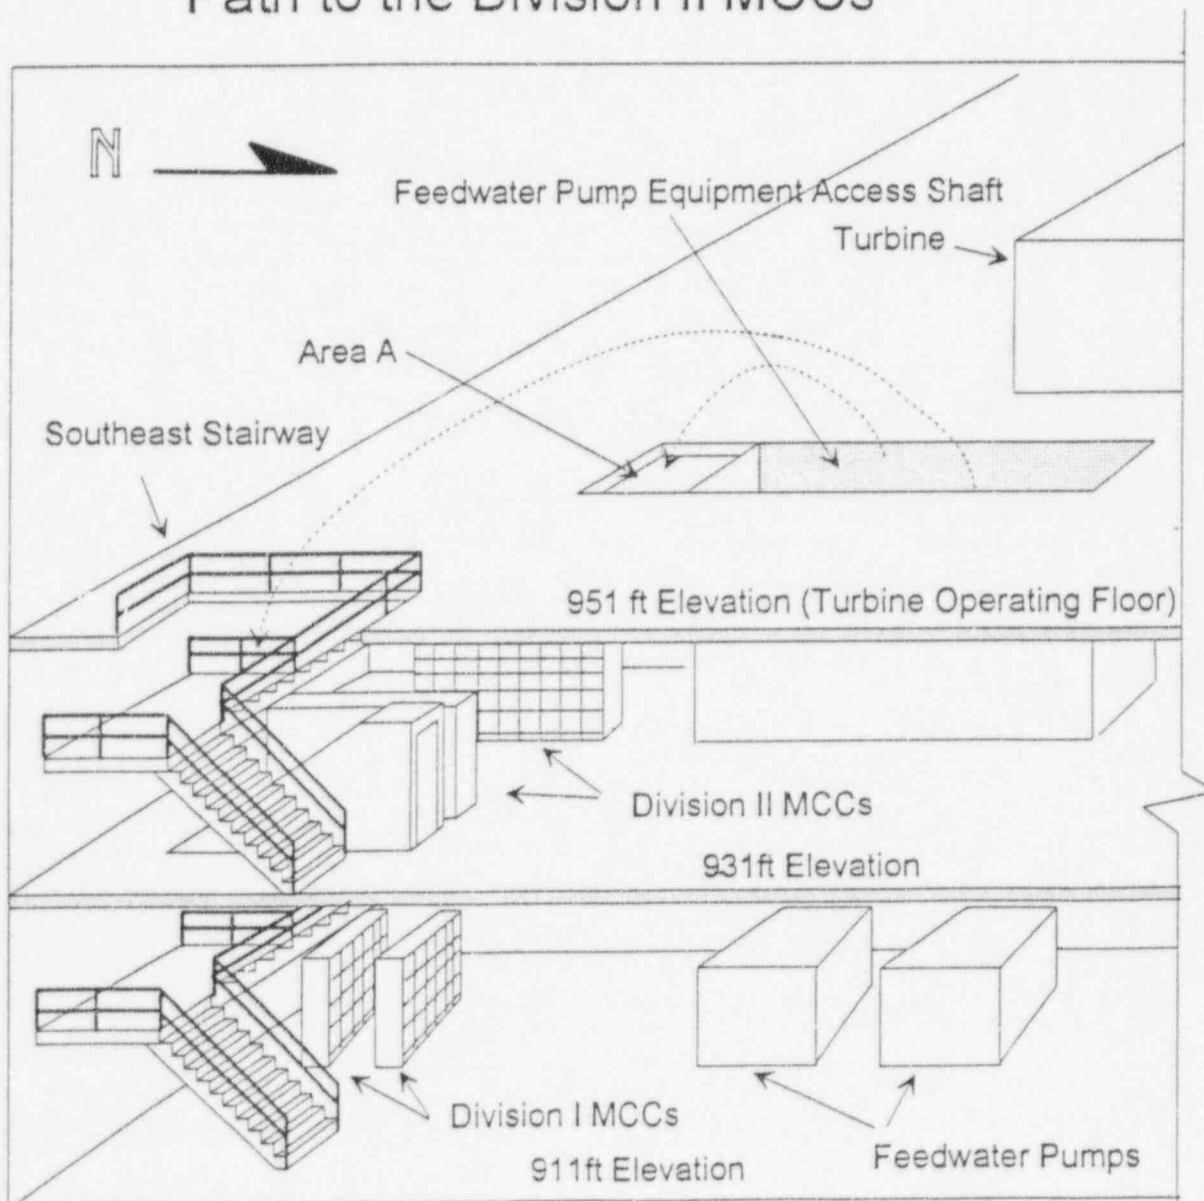
Figure 1
Simplified View of the Turbine Building
(Looking West) Showing Potential Flow
Path to the Division II MCCs

The limiting feedwater line break¹ being re-analyzed was a "terminal end"² break located at one of the feedwater (EIS System Code: SJ) pumps (EIS Component Code: P) on the 911ft elevation of the Turbine Building. Following the break, the steam generated by the break fills the 911ft elevation in the vicinity of the feedwater pumps and is forced up the feedwater pump equipment access shaft (See dotted lines on Figure 1) and down the north hallway on the 911ft elevation (See dotted lines on Figure 2). The stairway between the 911ft and the 931ft elevations is enclosed at the 931ft elevation and isolates the Division II Motor Control Centers (MCCs), MCC-142 and MCC-143, on the 931ft elevation from the steam on the 911ft elevation. However, after rising through the feedwater pump equipment access shaft, the steam pressurizes the 951ft elevation enough to force flow down through the southeast stairway and through a hatch (area "A" on Figure 1; arrows show the flow path). The southeast stairway

and the hatch were erroneously assumed to be enclosed in the RELAP4 analysis; preventing flow down from the 951ft elevation to the 931ft elevation. This downward flow through the stairway and hatch makes the environment in the vicinity of Division II MCC-142 and MCC-143 a harsh environment (greater than 120°F). See the Table 1.

The personnel involved with the RELAP4 analysis were contacted in order to aid in root cause identification. The RELAP4 model erroneously assumed that the southeast stairway was enclosed by fire barriers, with two doors. Actually, there is only one door and it separates the 911ft and the 931ft elevation. No temperature rise was predicted by the RELAP4 model in the

931ft elevation where Division II MCC-142 and MCC-143 are located. The operating turbine floor (951 ft elevation) connection was not open to the Division II 4kV switchgear on the 931ft elevation during the analysis. This is the reason that the Division II 4kV switchgear did not increase in temperature. We believe, that the consultant misinterpreted the NSP drawings of the fire barriers. The barriers were being designed and constructed during the time the analysis was being performed. NSP personnel involved with the construction of the stairway enclosures were contacted to assure that the correct drawings were transmitted to the consultant. This misinterpretation of the fire barrier drawings was a personnel error during the RELAP4 modeling. The RELAP4 licensing basis analysis was performed under a 10 CFR 50, Appendix B, Quality Assurance Program.

- 1) It has been verified that the current GOTHIC model accurately reflects the current plant configuration for the limiting feedwater line break.
- 2) Modifications will be performed such that the HELB of concern does not result in harsh environments for the 4kV switchgear, MCC-142 and MCC-143 areas.
