Crystal River Unit 3

Subject: Licensee Event Report (LER) 96-013-00

Failure to Use Self-Checking by Operator Leads to Unplanned Actuation of Engineered Safeguards Pump

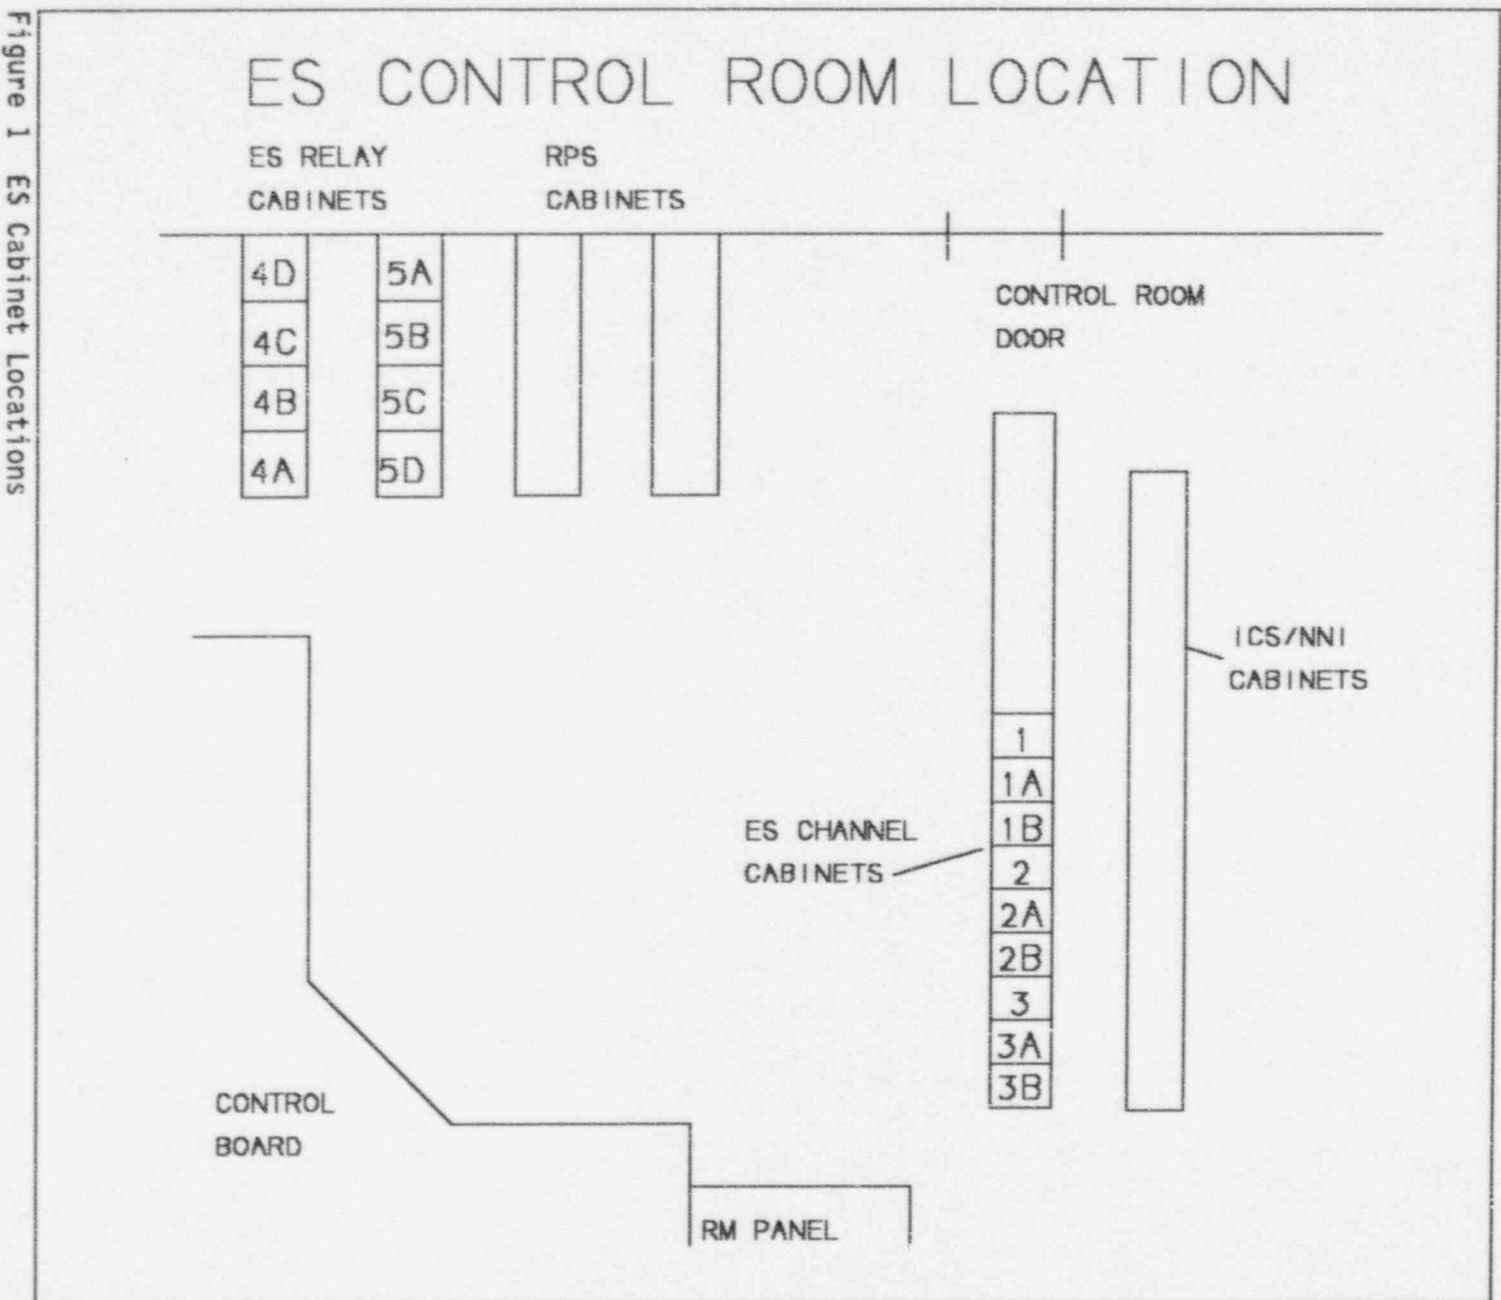
Figure 1 ES Cabinet Locations

Three test and channel cabinets are located in the control room (Figure 1). The ES channel test cabinets have test switches to trip each of the ES channels. The bistables for HPI & LPI channels can be placed in the test operate position tripping the associated channels for the cabinet, i.e. cabinet #1 contains RC1 & RC4, cabinet #2 contains RC2 & RC5, and cabinet #3 contains RC3 & RC6. SP-358C is written to be performed by two Operations personnel reporting to the Shift Supervisor on Duty (SSOD); however, certain steps require the operator to move back and forth between the Main Control Board [MCBD] (MCB) and the ES Cabinets to reposition switches and verify test lights.

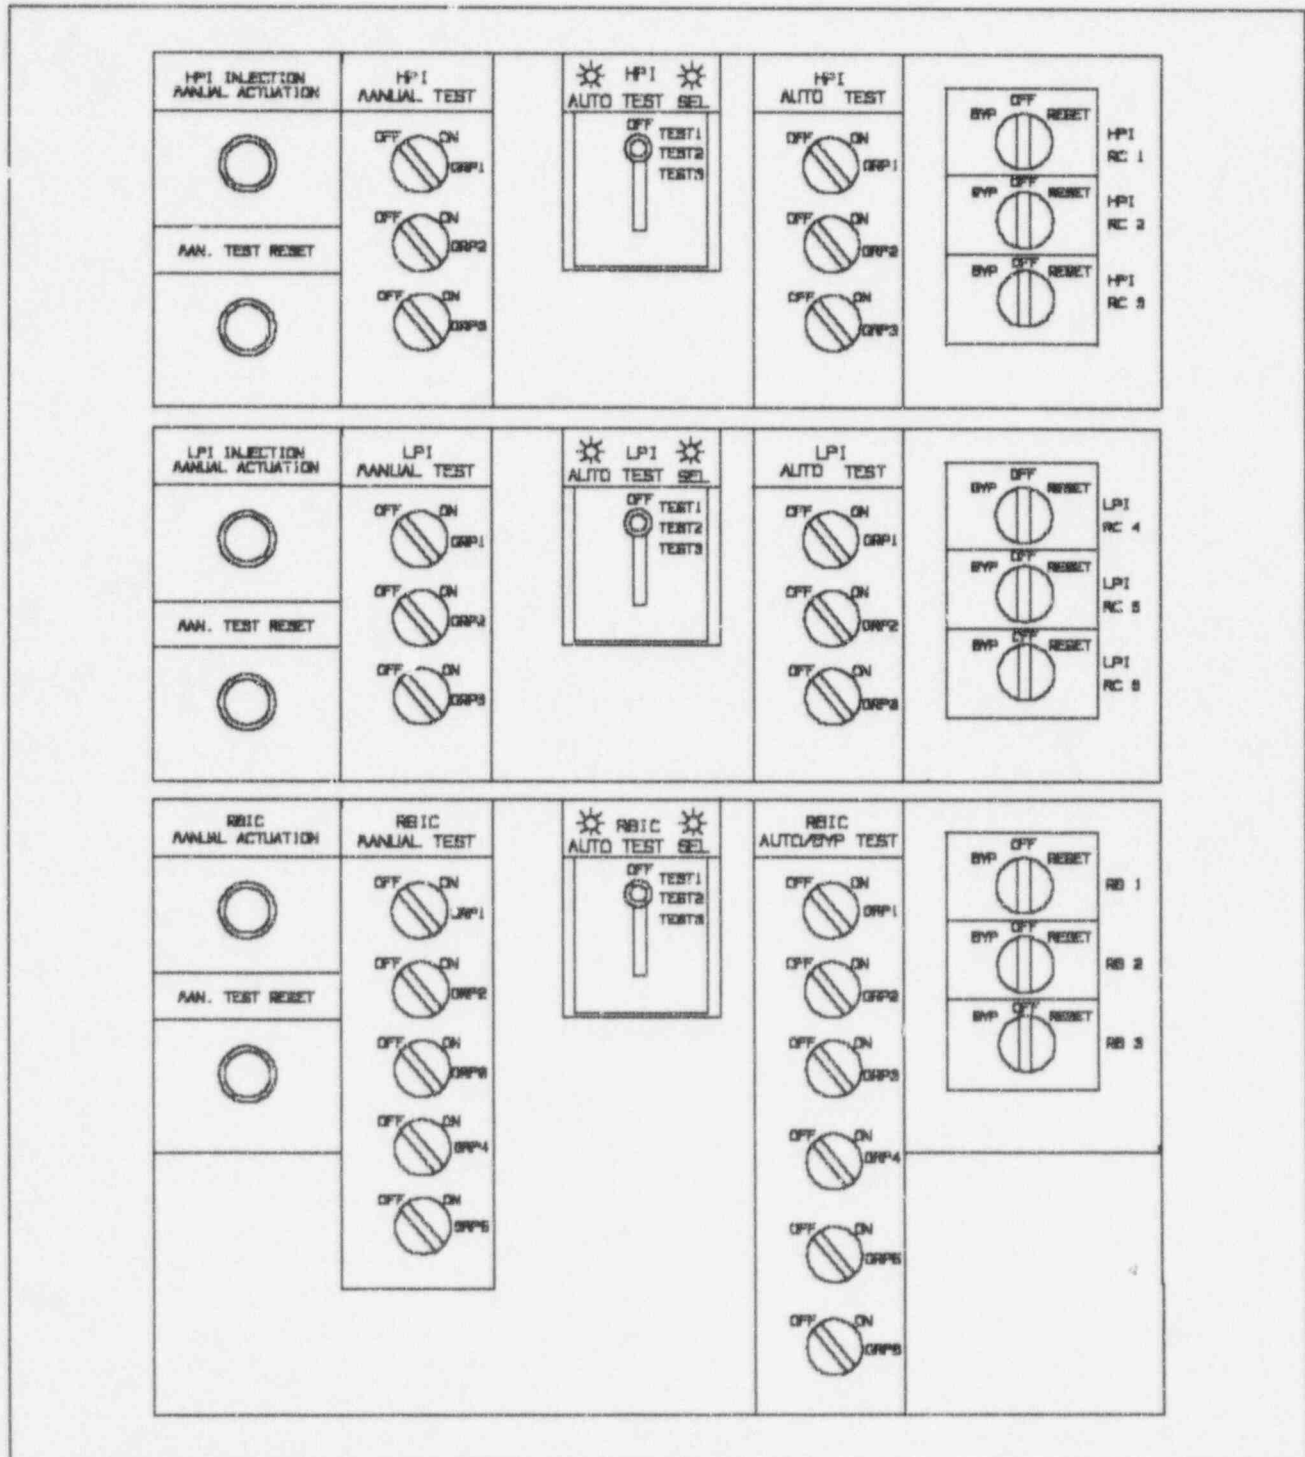
Figure 2 ES MCB Test Switch Arrangement

On April 14, 1996, Florida Power Corporation's Crystal River Unit 3 (CR-3) was preparing to start up from a refueling outage with the unit in MODE 5 (COLD SHUTDOWN). The "B" Decay Heat Removal (DHR) [BP] system was in service. At approximately 1418 hours, during the performance of Surveillance Procedure SP-358C "Operations ES Monthly Automatic Actuation Logic Functional Test #3", an improper switch alignment resulted in the auto start of Decay Heat Closed Cycle Cooling Water (DC) Pump DCP-1A [CC,P]. The DC system provides emergency cooling of Engineered Safeguards (ES) components. The Nuclear Operator (NO) had mistakenly placed the "A" HPI AUTO TEST SELECT switch in the "off" position when the procedure step instruction was to place the HPI AUTO TEST GRP 3 switch in the "off" position. This resulted in the unplanned start of DCP-1A because the associated time delay relays which establish the start signal had not been reset and restoration of the test relays occurred when the HPI AUTO TEST SELECT switch was placed in the "off" position.

7. The MCB switch mistakenly selected (HPI AUTO TEST SELECT) is labeled similarly to the correct switch (HPI AUTO TEST GRP 3). See Figure 2.

SP-358A, B, and C will be reviewed for human performance improvements by August 1, 1996. This review will address the need for improvements in nomenclature, the need to color switch bezels for differentiation, and incorporation of a note on the front of the procedure to stress STAR. Based on this review, any necessary procedure changes will be made by September 30, 1996.
