Re: St. Lucie Unit 1
Docket No. 50-335
Reportable Event: 96-010
Date of Event: July 30, 1996
Operation Prohibited by Technical Specifications Due
to Linear Range Nuclear Instrumentation Out of Service

LICENSEE EVENT REPORT (LER)

Operation Prohibited by Technical Specifications due to Linear Range Nuclear Instrumentation Out of Service

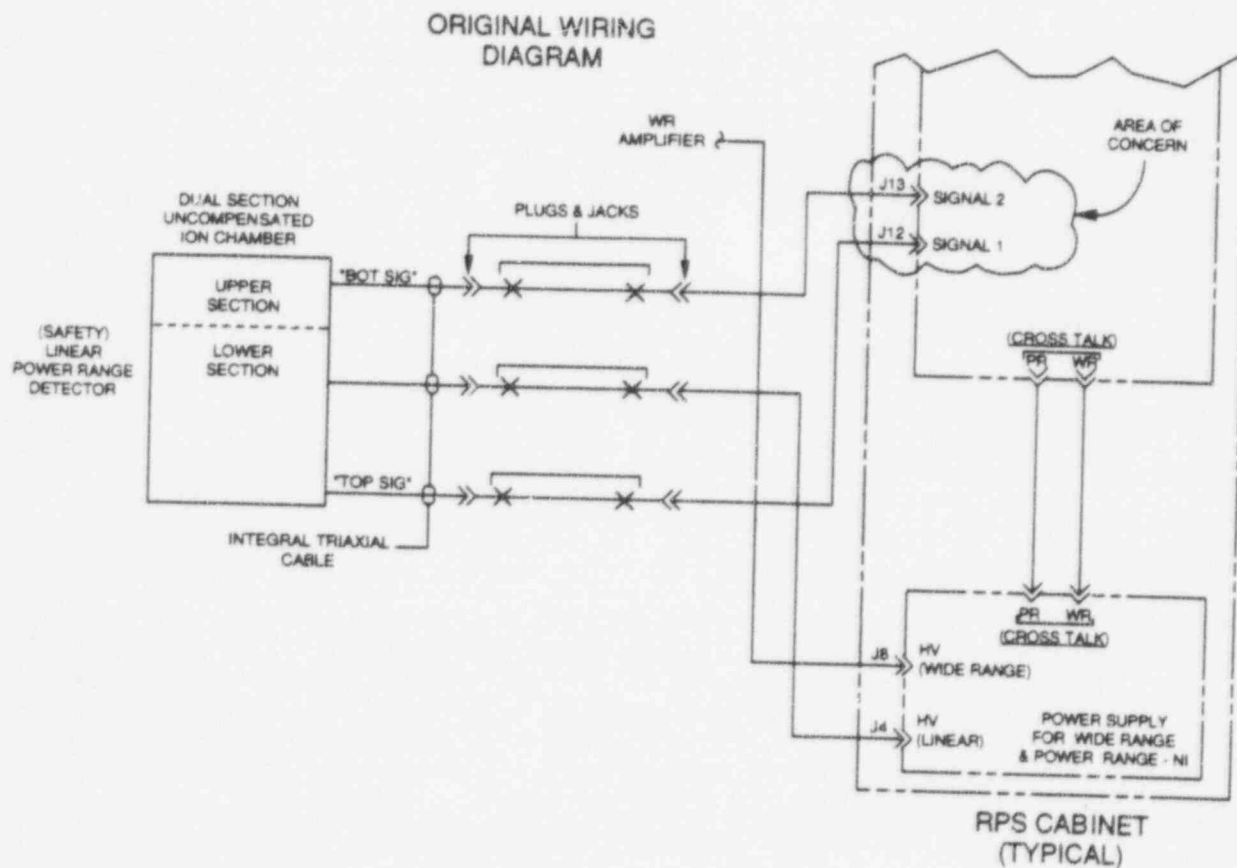
FIGURE 1

The principle cause of the event was that the modification package (PC/M-009-195) for the replacement of the RPS nuclear instrumentation drawers contained a design error which was not detected until full power operation. Specifically, the error resulted from the revision of a controlled wiring diagram (CWD) which reversed the connections for the upper and lower linear range excore NI leads at the RPS cabinet drawers. This error was the result of a design error by the PCM preparer, which was not detected during design verification or post modification testing. Contributing factors to the error are discussed below.

The original CWDs contained differences in nomenclature and internal inconsistencies regarding the terminal connections at the cabinet drawers. This required the designers to make assumptions regarding the correct terminal connections for the replacement NI drawers. One underlying assumption made by both the PC/M preparers and verifiers was that the Unit 1 PC/M was essentially a replication of an earlier Unit 2 PC/M. The Unit 2 PC/M successfully supported a similar NI drawer replacement. The CWD revision was therefore based in part on CWDs from Unit 2. However, the Unit 2 CWDs contained differences in labeling and design that contributed to the error. Additionally, the assumption that the Unit 1 PC/M was a simple replication of the successful Unit 2 PC/M led to insufficient time and emphasis being placed on the design verification.

Another contributing factor to the error was the nomenclature used in the labeling of the NI detector cables. The NI detectors are supplied with the cable connections labeled as "Bottom" and "TOP" referring to top and bottom of the detector and not to their installed configuration relative to the reactor core. In fact at St. Lucie these detectors are installed inverted with the detector cable labeled as "TOP" actually monitoring the bottom of the reactor core. This fact was not understood by the designers or PC/M verifiers. It was incorrectly assumed that the cable identified on the CWD as "BOT SIG" feeding "SIGNAL 2" was the cable from the lower detector that should connect to terminal J13 (refer to Figure 1). Similarly, it was assumed that the cable identified on the CWD as "TOP SIG" feeding "SIGNAL 1" was the cable from the upper detector that should be connected to terminal J12. The correct terminal

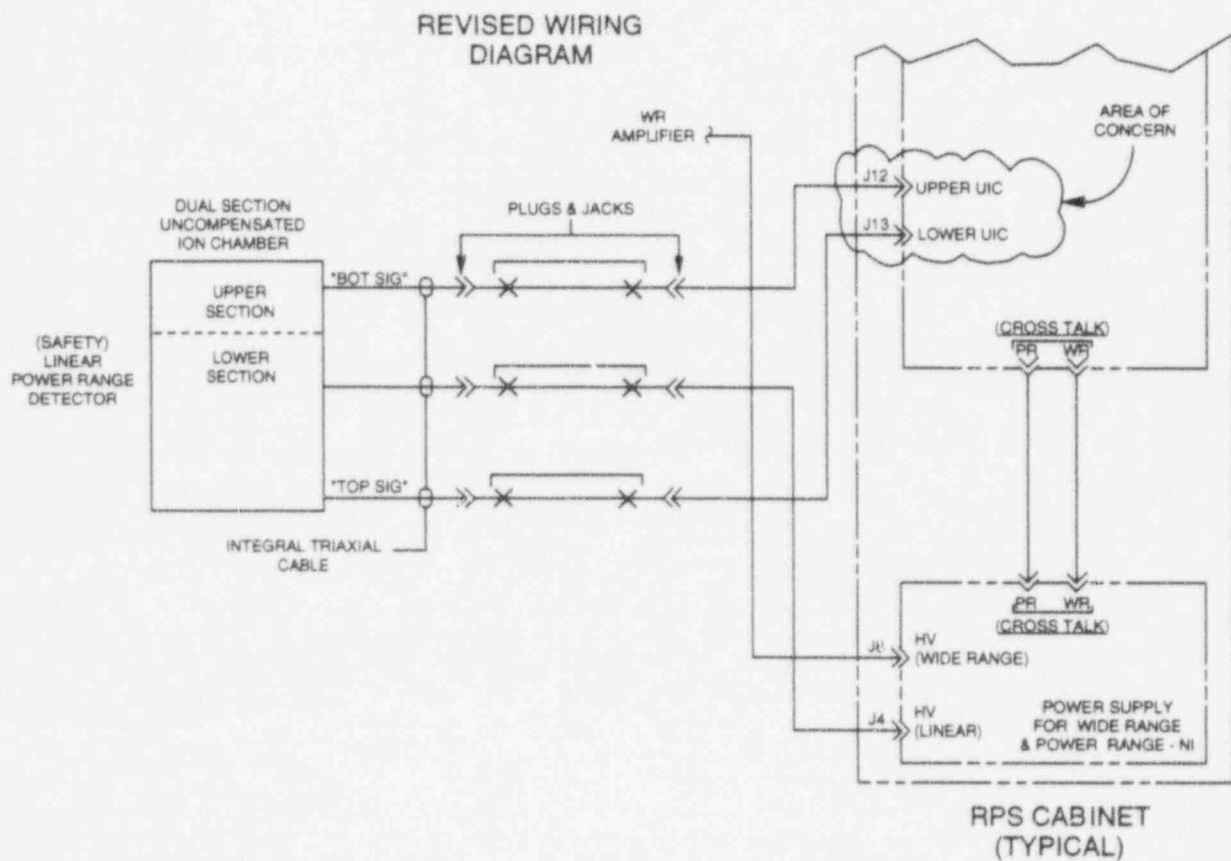
FIGURE 2

connections are shown in Figure 2.

1. RPS linear safety channel nuclear instrumentation drawers (channels A, C and D) were reconnected in accordance with a revised drawing and testing was performed to verify proper NI signal response.
