**Florida
Power**

CORPORATION
Crystal River Unit 3
Docket No. 50-302

Subject: Licensee Event Report (LER) 95-028-01

FACILITY NAME (1)										CRYSTAL RIVER UNIT 3 (CR-3)										DOCKET NUMBER (2)										PAGE (3)																							
TITLE (4)										Operation Outside Design Basis Caused by Personnel Errors and Inadequate Documentation of Borated Water Storage Tank Vacuum Breaker Capacity										0 5 0 0 0 3 0 2										1 OF 1 0																							
EVENT DATE (5)						LER NUMBER (6)						REPORT DATE (7)						OTHER FACILITIES INVOLVED (8)																																			
MONTH		DAY		YEAR		YEAR		SEQUENTIAL NUMBER		REVISION NUMBER		MONTH		DAY		YEAR		FACILITY NAMES						DOCKET NUMBER(S)																													
1		2		1		3		9		5		9		5		---		0		2		8		---		0		1		0		8		3		0		9		6		N/A						0 5 0 0 0					
OPERATING MODE (9)						1						THIS REPORT IS SUBMITTED PURSUANT TO THE REQUIREMENTS OF 10 CFR §: (CHECK ONE OR MORE OF THE FOLLOWING) (11)																																									
POWER LEVEL (10)						1						20.402(b)						20.405(c)						50.73(a)(2)(iv)						73.71(b)

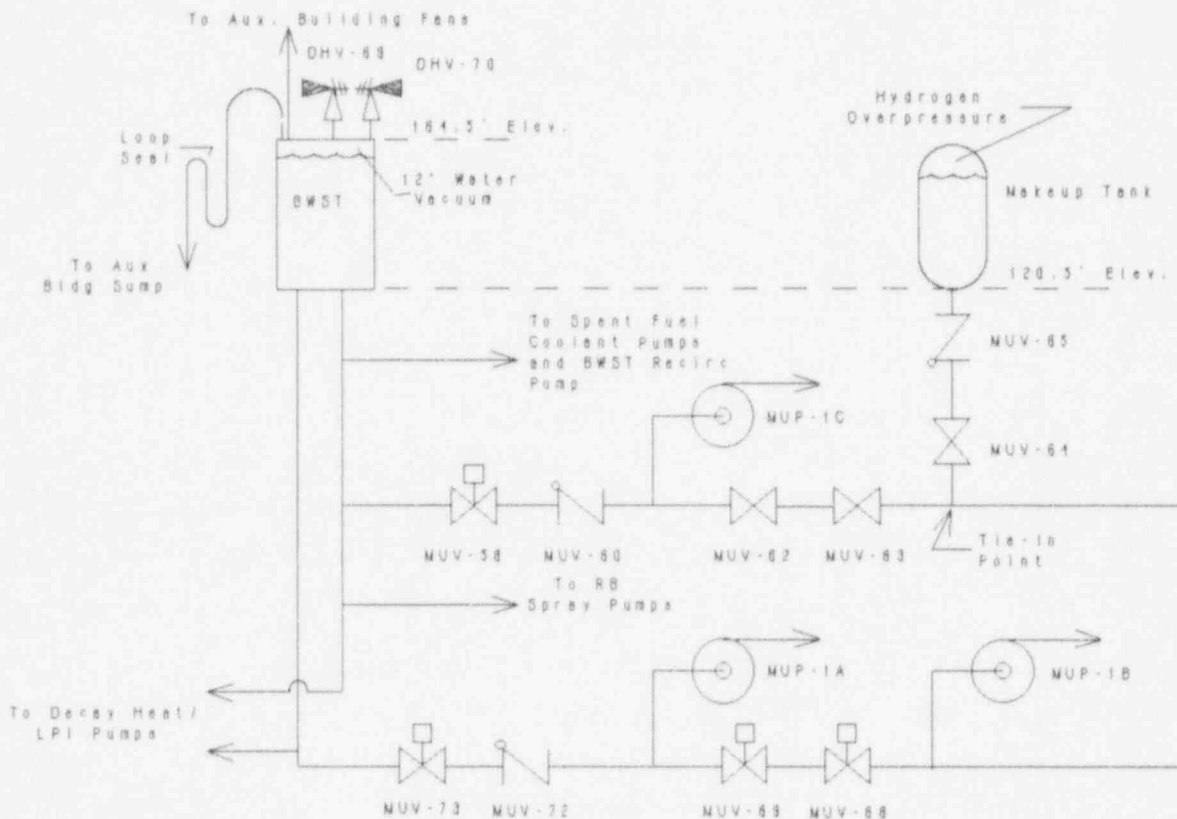
Figure 1

The BWST and RB sump [BE,TK] provide borated water for the Decay Heat (DH) Removal pumps which function as the Low Pressure Injection [BP,P] pumps (LPI) during LOCA's, the Reactor Building Spray [BE,P] (BS) pumps, the Makeup Pumps [CB,P] which function as High Pressure Injection (HPI) pumps [BQ,P] during LOCA's, the Spent Fuel Cooling [DA,P] (SF) pumps, and the BWST recirculation pump. The BWST has four 8-inch penetrations at the top of the tank including the two vacuum breakers, a line to the Auxiliary Building Air Handling Exhaust Fans [UC,FAN] which continuously draw air from the top of the BWST, and an overflow line which has a large loop seal that affords tank overpressure protection. See Figure 1.

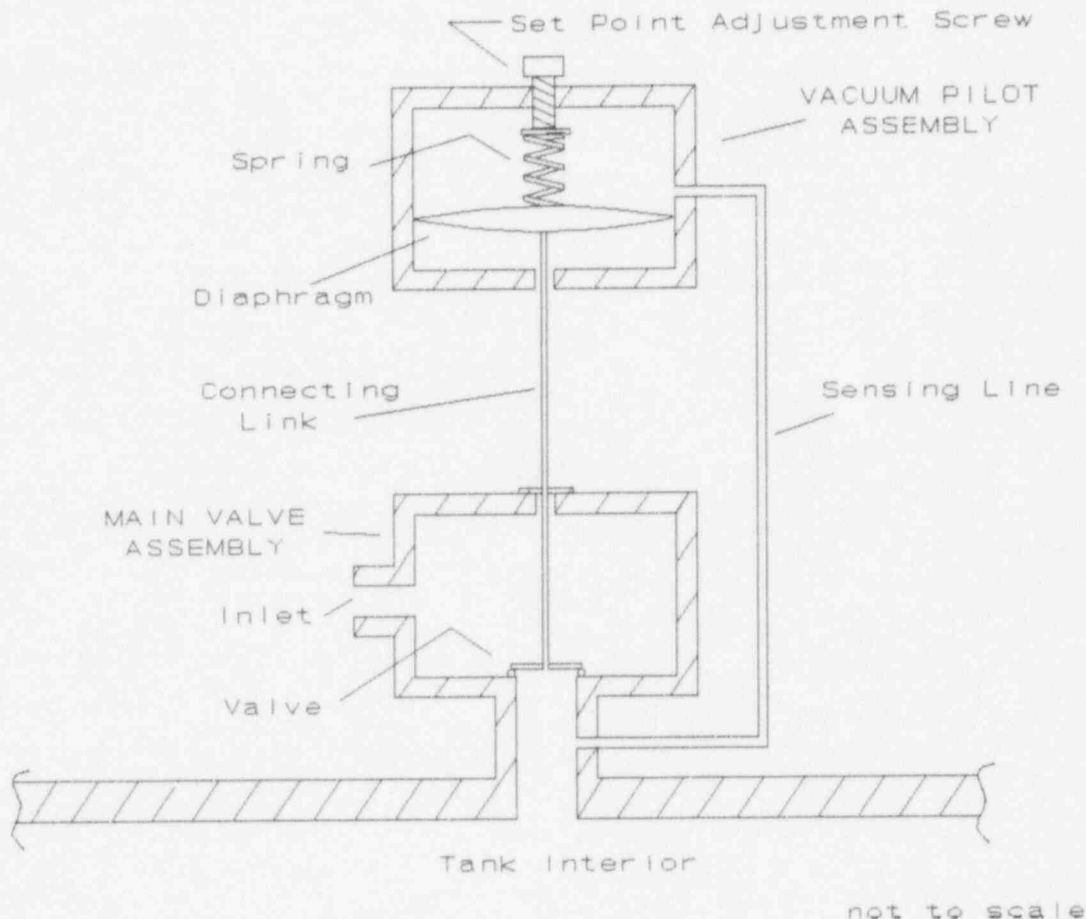
FIGURE 2

The basic function of DHV-69 and 70 is to equalize the pressure inside the BWST to provide protection against a collapse of the tank when vacuum is created during drawdown (see Figure 2). The valve setpoint is critical in maintaining adequate net positive suction head (NPSH) to the Makeup Pumps which are aligned to take suction from the BWST in their High Pressure Injection (HPI) mode during a large break loss-of-coolant-accident (LOCA). Analyses for Makeup/HPI Pump NPSH and Allowable Makeup Tank [CB,TK] (MUT) Overpressure assume a vacuum breaker setpoint for the BWST of 12 inches water vacuum for the most limiting case where the BWST is at its lowest level, the operating Makeup/HPI pump is Engineered Safeguards (ES) selected and Decay Heat/Low Pressure Injection and Reactor Building Spray pumps are being throttled for switchover to the RB sump. A vacuum in the BWST of greater than 12 inches water would reduce pressure on the BWST side of the tie-in point, thereby reducing NPSH available. As noted in the above Event Description, maintaining an open vent path in place of the removed vacuum breaker assured adequate vacuum relief capacity. With this arrangement, there was no impact on the health and safety of the public.

The suspected inoperability of DHV-70 was due to blockage in the sensing line caused by accumulation of corrosion products. A failure analysis completed on February 21, 1996 determined that the root cause of the blocked sensing line was attributed to poor material selection (carbon steel) for the expected valve duty. Normal operation of the valve (valve disc/diaphragm moving upward) creates a pressure pulse which dislodges corrosion products from the valve internals. Debris is then preferentially drawn into the sensing line which operates at a slight negative pressure.

1. The previously installed vacuum breakers have been replaced with a model made entirely of stainless steel. The new model does not utilize small bore sensing lines.
