Northeast  
Utilities System

Attachment: LER 96-012-01

Millstone Nuclear Power Station Unit 3

Containment Leakage in Excess of Technical Specification Limits Due to Valve Leakage

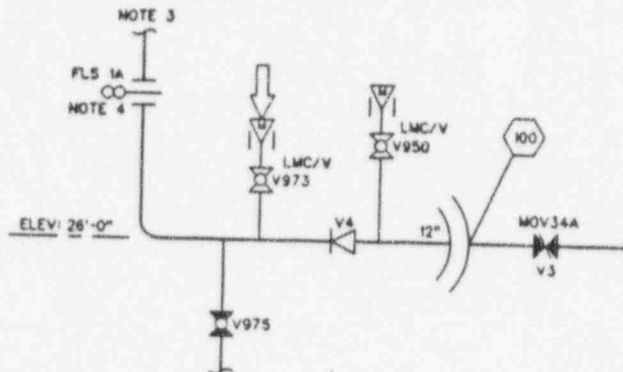
Figure 1, Containment Quench Spray Penetration #100

- o On May 10, 1996, the LLRT leakage through the inboard isolation check valve (3QSS\*V4) on the Containment Quench Spray line (12-inch) penetration #100 was 156,000 sccm. This leakage, added to the "as-found" total for all other valves as of May 10, 1996, had not exceeded the Technical Specification limit, and by itself is not reportable. However, it is included in this LER because it was a major contributor to the total eventually exceeding the Technical Specification limit five days later. See Figure 1. The outboard isolation valve would have maintained containment integrity.

The cause of the excessive leakage through the inboard isolation check valve 3QSS\*V4 on the Containment Quench Spray line penetration #100 is attributed to boric acid residue which prevented the disc from fully closing. From the time the line is drained to perform the test, until the leak test is actually completed is approximately two days. It is believed that residual boric acid water in the bowl of the valve, which is the low point in the system, evaporated prior to performing the test. This cause was verified by having the line flushed with demineralized water and retested. The as-left results were acceptable and did not indicate any internal damage when compared to previous leak results. The valve internals were examined during the mid-1995 refueling outage, with no disc or seat wear identified.

The LLRT leakage through the inboard isolation check valve 3QSS\*V4 on the Containment Quench Spray line penetration #100 was 156,000 sccm. This leakage, added to the "as-found" total for all other valves as of May 10, 1996, had not exceeded the Technical Specification limit, and by itself is not reportable. However, it is included in this LER because it was a major contributor to the total eventually exceeding the Technical Specification limit five days later. The leakage through the outboard valve 3QSS\*MV34A was 107.3 sccm, which would have maintained containment integrity.

The corrective action for the inboard isolation check valve 3QSS\*V4 on the Containment Quench Spray line penetration #100 was to perform a flush of the line to remove any boron deposits. Inspection results from the mid-1995 refueling outage did not indicate any adverse conditions including seat or disc damage. The as-left results from the mid-1995 refueling outage were comparable to the as-left results from this outage. Therefore it is concluded that no new damage to the seating surface is present. However, the historical review of this valve as compared to the B train valve: 3QSS\*V8 shows that 3QSS\*V4 has consistently higher leakage. This valve will be reworked during the next refueling outage, to further improve the seating surfaces. A clean water flush of the QSS system will be evaluated to determine if the flush should be performed on a routine basis for each penetration after each as-found LLRT test. In addition, the number of times the system is drained and refilled is being reduced. Currently the line is drained each quarter to allow cycling of the outboard isolation valves: 3QSS\*MV34A/B. In this condition it is possible for boron to enter into the containment side of the penetration, due to the lower pressure condition inside containment (maintained at a slight vacuum). The draining frequency will be reduced to each cold shutdown, which will reduce the potential for boron to be present in the system.

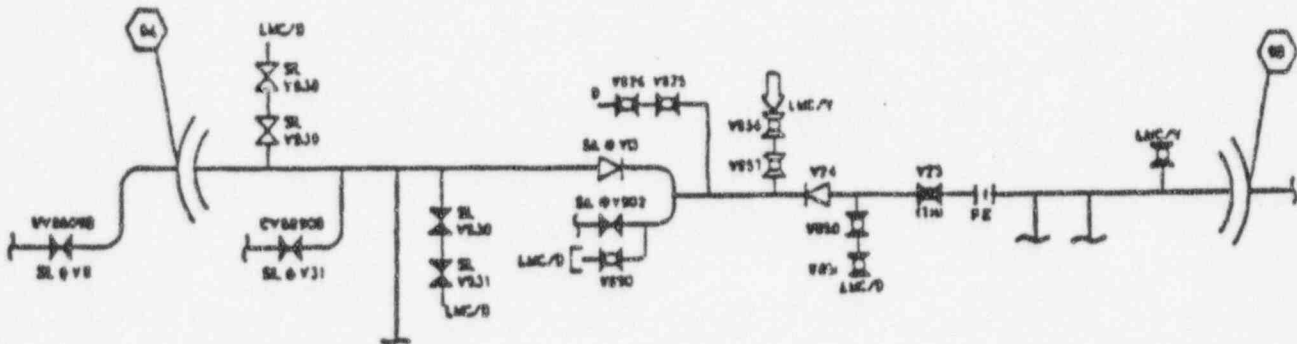
Figure 2, Low Pressure / High Pressure Safety Injection Penetration #98

- o On May 15, 1996, the combined LLRT leakage through both the inboard isolation check valve (3SIL\*V13) on the Low Pressure Safety Injection line (6-inch) penetration #94; and through the inboard isolation check valve (3SIL\*V24) on the High Pressure Safety Injection line (2-inch) penetration #98, was 43,900 sccm. This event, added to the total for all previous LLRTs, exceeded the Technical Specification limit. See Figure 2. The outboard isolation valve would have maintained containment integrity.

The cause of the excessive combined LLRT leakage through both the inboard isolation check valve 3SIL\*V13 on the Low Pressure Safety Injection line penetration #94 and through the inboard isolation check valve 3SIH\*V24 on the High Pressure Safety Injection line penetration #98, was attributed to valve 3SIH\*V24 either being improperly seated or foreign material being present in the valve. A flush of the line was performed and the penetration was retested. The as-left results were acceptable. A review of prior leak results for this penetration indicate that the check valve shows a decreasing leakage trend over the last three outages.

The combined LLRT leakage through both the inboard isolation check valve (3SIL\*V13) on the Low Pressure Safety Injection line penetration #94; and through the inboard isolation check valve (3SIH\*V24) on the High Pressure Safety Injection line penetration #98, was 43,900 sccm. This event, added to the total for all previous LLRTs exceeded the Technical Specification limit. The leakage through the outboard isolation valves 3SIL\*MV8809B and 3SIH\*MV8835 was 132 and 20 sccm respectively, which would have maintained containment integrity.

The corrective action for the inboard isolation check valve 3SIH\*V24 on the High Pressure Safety Injection line penetration #98, was flushing the line with water. A review of previous leak results indicates an improving trend of overall decreasing leakage. Therefore, it is determined that the valve internals are not adversely affected. Valve 3SIH\*V24 will be disassembled for inspection during the next refueling outage if as-found leak rates increase above the current outage as-left results, deviating from the current trend.

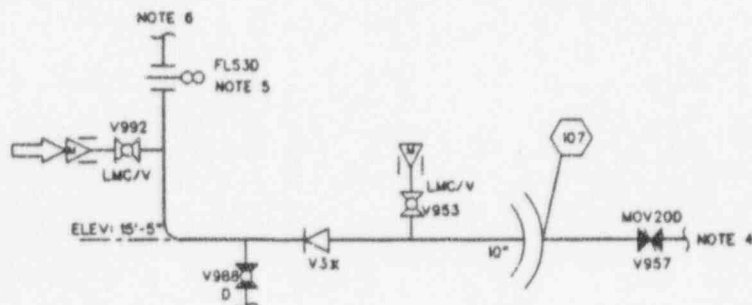
Figure 3, Containment Recirculation Spray Penetration #107

- o Later on May 15, 1996, the LLRT leakage through the inboard isolation check valve (3RSS\*V3) on the Containment Recirculation Spray line (10-inch) penetration #107 was 111,100 sccm. See Figure 3. The outboard isolation valve would have maintained containment integrity.

The cause of the excessive leakage through the inboard isolation check valve 3RSS\*V3 on the Containment Recirculation Spray line penetration #107 is attributed to boric acid residue which prevented the disc from fully closing. From the time the line is drained to perform the test, until the leak test is actually completed is approximately two days. It is believed that residual boric acid water in the bowl of the valve, which is the low point in the system evaporated prior to performing the test. This cause was verified by having the line flushed with demineralized water and retested. The as-left results were acceptable and did not indicate any internal damage when compared to previous leak results. Further evidence of the cause was obtained by a visual inspection of the B train valve 3RSS\*V6, performed this shutdown. Boron was present in the bowl of this valve.

The LLRT leakage through the inboard isolation check valve (3RSS\*V3) on the Containment Recirculation Spray line penetration #107 was 111,100 sccm. The outboard valve 3RSS\*MOV20D leakage was 1850 sccm, which would have maintained containment integrity.

The corrective action for the inboard isolation check valve 3RSS\*V3 on the Containment Recirculation Spray line penetration #107 was flushing the line with water. The history of this valve does not indicate any decreasing valve leakage. An inspection of the other train valve 3RSS\*V6 indicated boron in the valve body. Based on the limited data available, a flush of each penetration is being evaluated. It is believed that performing a closed cooling water flush after each as-found leak test will reduce the level of boron present in the valve.

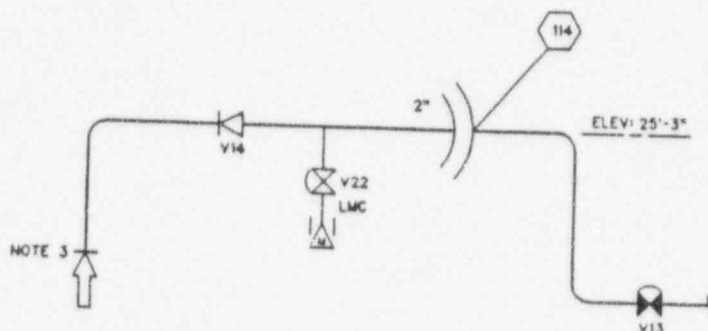
Figure 4, Hydrogen Recombiner Penetration #114

- o On May 24, 1996, the LLRT leakage through the inboard isolation check valve (3HCS\*V14) on the Hydrogen recombiner line (2-inch) penetration #114 was 51,900 sccm. See Figure 4. The outboard isolation valve would have maintained containment integrity.

The cause of the excessive leakage through the inboard isolation check valve 3HCS\*V14 on the Hydrogen Recombiner line penetration #114 was foreign material present in the pipe and disk seating area. The material is believed to be a hydrocarbon byproduct caused by the higher temperatures produced during the hydrogen recombiner process. However, an evaluation of the material was inconclusive.

The LLRT leakage through the inboard isolation check valve (3HCS\*V14) on the Hydrogen Recombiner line penetration #114 was 51,900 sccm. The outboard valve 3HCS\*V13 leakage was 20 sccm, which would have maintained containment integrity.

The corrective action for the inboard isolation check valve 3HCS\*V14 on the Hydrogen Recombiner line penetration #114 was to clean the valve internals of all foreign material. The other train was disassembled and inspected. A small amount of material was removed from the opposite train check valve 3HCS\*V7. The material did not adversely effect valve 3HCS\*V7 because it passed its as-found LLRT. An inspection of the piping downstream and upstream of the B train hydrogen recombiner blower did not identify any evidence of foreign material. It is not clear where the material came from or how long it was present. Therefore, an inspection of valve 3HCU\*V14 will be performed during RFO6 to determine if any material is being created during the operating cycle.

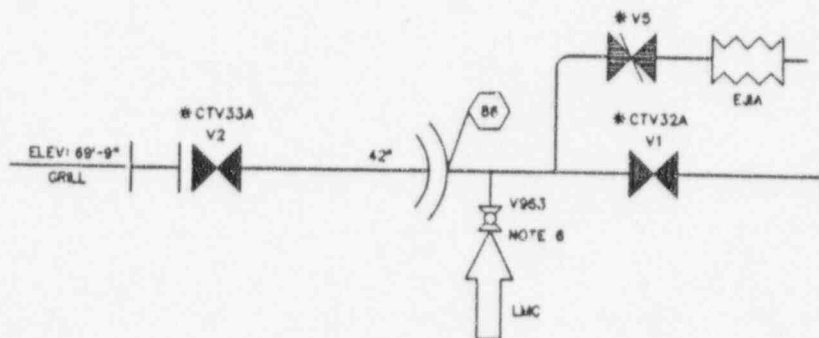
Figure 5, Containment Purge Supply Penetration #86

- o On May 29, 1996, the LLRT leakage through isolation valves on the Containment Purge supply line was unquantifiable due to excessive leakage. The Containment Purge supply line (42-inch) penetration #86 has three isolation valves, one inboard (3HVU\*CTV33A), one outboard (3HVU\*CTV32A), and an additional outboard valve on a 30-inch branch line (3HVU\*V5). The inboard valve and both outboard valves are tested simultaneously because they cannot be tested independently. See Figure 5. The combined leakage through these three valves was unquantifiable due to excessive leakage that prevented the test pressure from being reached. This leakage alone exceeded the Technical Specification 3.6.1.2.c secondary containment bypass leakage limit of 0.042L<sub>a</sub> (20,633.9 sccm), and it exceeded the Technical Specification 3.6.1.2.b Type C limit of 0.6L<sub>a</sub> (294,800.2 sccm). It also resulted in the total leakage exceeding an analyzed condition that had been previously determined. Accordingly, an immediate notification was made on May 29, 1996, pursuant to 10CFR50.72(b)(2)(i) for an event found while shutdown, that if found while operating, would have resulted in an unanalyzed condition that significantly compromises plant safety. No immediate action was required because the plant was in a shutdown condition.

The cause of the excessive combined leakage through the isolation valves 3HVU\*CTV33A, 3HVU\*CTV32A, and 3HVU\*V5 on the Containment Purge supply line penetration #86 has been determined to be an inadequate procedure that resulted in a bulge in the outer valve (3HVU\*CTV32A) seat ring. An evaluation identified several causal factors which contributed to the failures. These consisted of errors in the maintenance procedure which specified the incorrect number of T-ring segments, the method for performance of the "As-Found" and "As-Left" LLRTs, various valve design issues, and conservative administrative leakage criteria. Additionally, the valve was stroked open and closed prior to the "As-Found" test. Therefore, the root cause of this failure could not be conclusively determined.

The LLRT leakage through isolation valves on the Containment Purge supply line was unquantifiable due to excessive leakage. The Containment Purge supply line penetration #86 has three isolation valves, one inboard (3HVU\*CTV33A), one outboard (3HVU\*CTV32A), and an additional outboard valve on a 30-inch branch line (3HVU\*V5). The inboard and both outboard valves are tested simultaneously because they cannot be tested independently. See Figure 5. The combined leakage through these three valves was unquantifiable due to excessive leakage that prevented the test pressure from being reached. This leakage alone exceeded the Technical Specification 3.6.1.2.c secondary containment bypass leakage limit of 0.042L<sub>a</sub> (20,633.9 sccm), and it exceeded the Technical Specification 3.6.1.2.b Type C limit of 0.6L<sub>a</sub> (294,800.2 sccm). It also resulted in the total leakage exceeding an analyzed condition. Accordingly, an immediate notification was made on May 29, 1996, pursuant to 10CFR50.72(b)(2)(i) for an event found while shutdown, that if found while operating, would have resulted in an unanalyzed condition that significantly compromises plant safety. No immediate action was required because the plant was in a shutdown condition.

The corrective action for the isolation valves 3HVU\*CTV32A, 3HVU\*CTV33A, and 3HVU\*V5 on the Containment Purge supply line penetration #86 was to repair the seating surfaces of the 32A/33A valves. The t-ring seat of outboard valve 3HVU\*CTV32A was fully adjusted after it was identified that a bulge existed in one segment of the t-ring. There are 44 20-segments each containing three set screws. The maintenance procedure was compared to the vendor recommendations to ensure full compliance with the adjustment process. An evaluation determined that the number of adjusting segments specified in the maintenance procedure differed from the actual field arrangement. Therefore, the

maintenance procedure will be revised to: correct these errors; give the mechanic more flexibility in tightening the T-ring bolts; and require new replacement allen bolts and washers every time the valve seat is replaced. Additionally it was determined that cycling the valves open and closed prior to performing the "As-Found" test does not identify the condition the valve would have been in during an accident condition. These valves are required to be locked closed during operation in modes 1 through 4. Therefore, the test procedure will be revised to perform an "As-Found" LLRT prior to cycling the valves. The test procedure will also require the "As-Left" test to be performed after the valves are closed prior to entry into mode 4. The frequency of testing will be increased to every cold shutdown whenever the containment purge system is required to be operating. This frequency will be reviewed after two operating cycles to determine the effectiveness of the increased frequency and corrective action. The revised test method will ensure that the valves are functioning properly during the operating cycle. Additionally, an LLRT will be performed on the valves prior to the valve alignment for the Type A test which is scheduled to be performed prior to unit restart. The root cause evaluation also identified potential problems in the leak tightness of the valve design, particularly with regards to the effect of the shaft bearing operation, and actuator operation/air supply on valve seating. Therefore, these components will be evaluated further. The administrative leakage criteria assigned to these valves will also be evaluated due to the small amount of allowable leakage relative to the large size of the valve. Due to the design of this penetration it is difficult to identify if both valves or only one valve caused the excessive leakage. Minor adjustments were performed on the inboard valve t-ring seat. A retest produced very low leak rates.

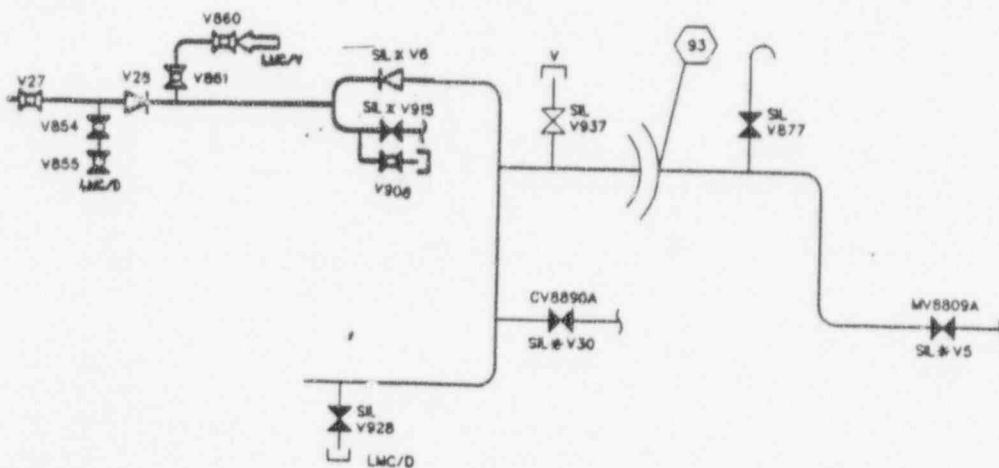
Figure 6, Low Pressure Safety Injection Penetration #93

- o On June 6, 1996, the LLRT leakage through the inboard isolation check valve (3SIL\*V6) on the Low Pressure Safety Injection line (6-inch) penetration #93 was unquantifiable due to excessive leakage that prevented the test pressure from being reached. See Figure 6. The outboard isolation valve would have maintained containment integrity.

The cause of the excessive leakage through the inboard isolation check valve 3SIL\*V6 on the Low Pressure Safety Injection line penetration #93 was a small piece of material wedged between the disk and disk arm anti-rotation device. This prevented the disk from freely moving into the seat with no force applied to the disk. It is believed that the draining sequence for this penetration moved the disk off its seat. When air pressure was applied, the valve remained slightly open causing the test failure. During the disassembly inspection, the disk did fully close when moved from the full open position to the closed position.

The LLRT leakage through the inboard isolation check valve (3SIL\*V6) on the Low Pressure Safety Injection line penetration #93 was unquantifiable due to excessive leakage that prevented the test pressure from being reached. The outboard valve 3SIL\*MV8809A leakage was 403 sccm, which would have maintained containment integrity.

The corrective action for the inboard isolation check valve 3SIL\*V6 on the Low Pressure Safety Injection line penetration #93 was to disassemble the valve and flush the internal surfaces to dislodge the material from the disk arm. A small piece of slag or metal shaving was found that prevented the disk from fully closing. The internals were capable of free movement in both the open and closed direction. When the valve was manually closed from the full open position, the disk moved freely into the seat as designed. Once the disk arm was flushed the disk moved freely into the seat with no applied force. The subsequent retest was completed successfully.
