## LICENSEE EVENT REPORT (LER)

FACILITY NAME (1) Fort St. Vrain, Unit No. 1										DOCKET NUMBER (2) 0 5 0 0 0 2 1 6 7				PAGE (3) 1 OF 0 17			
TITLE (4) Unplanned Liquid Waste Release While Recirculating Through Activity Monitors																	
EVENT DATE (5)			LER NUMBER (3)				REPORT DATE (7)			OTHER FACILITIES INVOLVED (8)							
MONTH	DAY	YEAR	YEAR	SEQUENTIAL NUMBER	REVISION NUMBER	MONTH	DAY	YEAR	FACILITY NAME				DOCKET NUMBER(S)				
0	3	1	7	8	5	8	5	0	0	4	N/A				0 5 0 0 0		
THIS REPORT IS SUBMITTED PURSUANT TO THE REQUIREMENTS OF 10 CFR 50.72(b)(2)(iii) (Check one or more of the following) (11)																	
OPERATING MODE (9)		N															
POWER LEVEL (10)		0 1 0 0

On March 17, 1985, with the reactor shutdown and depressurized, an isolation valve failure resulted in an unplanned release from the plant radioactive liquid waste discharge system.

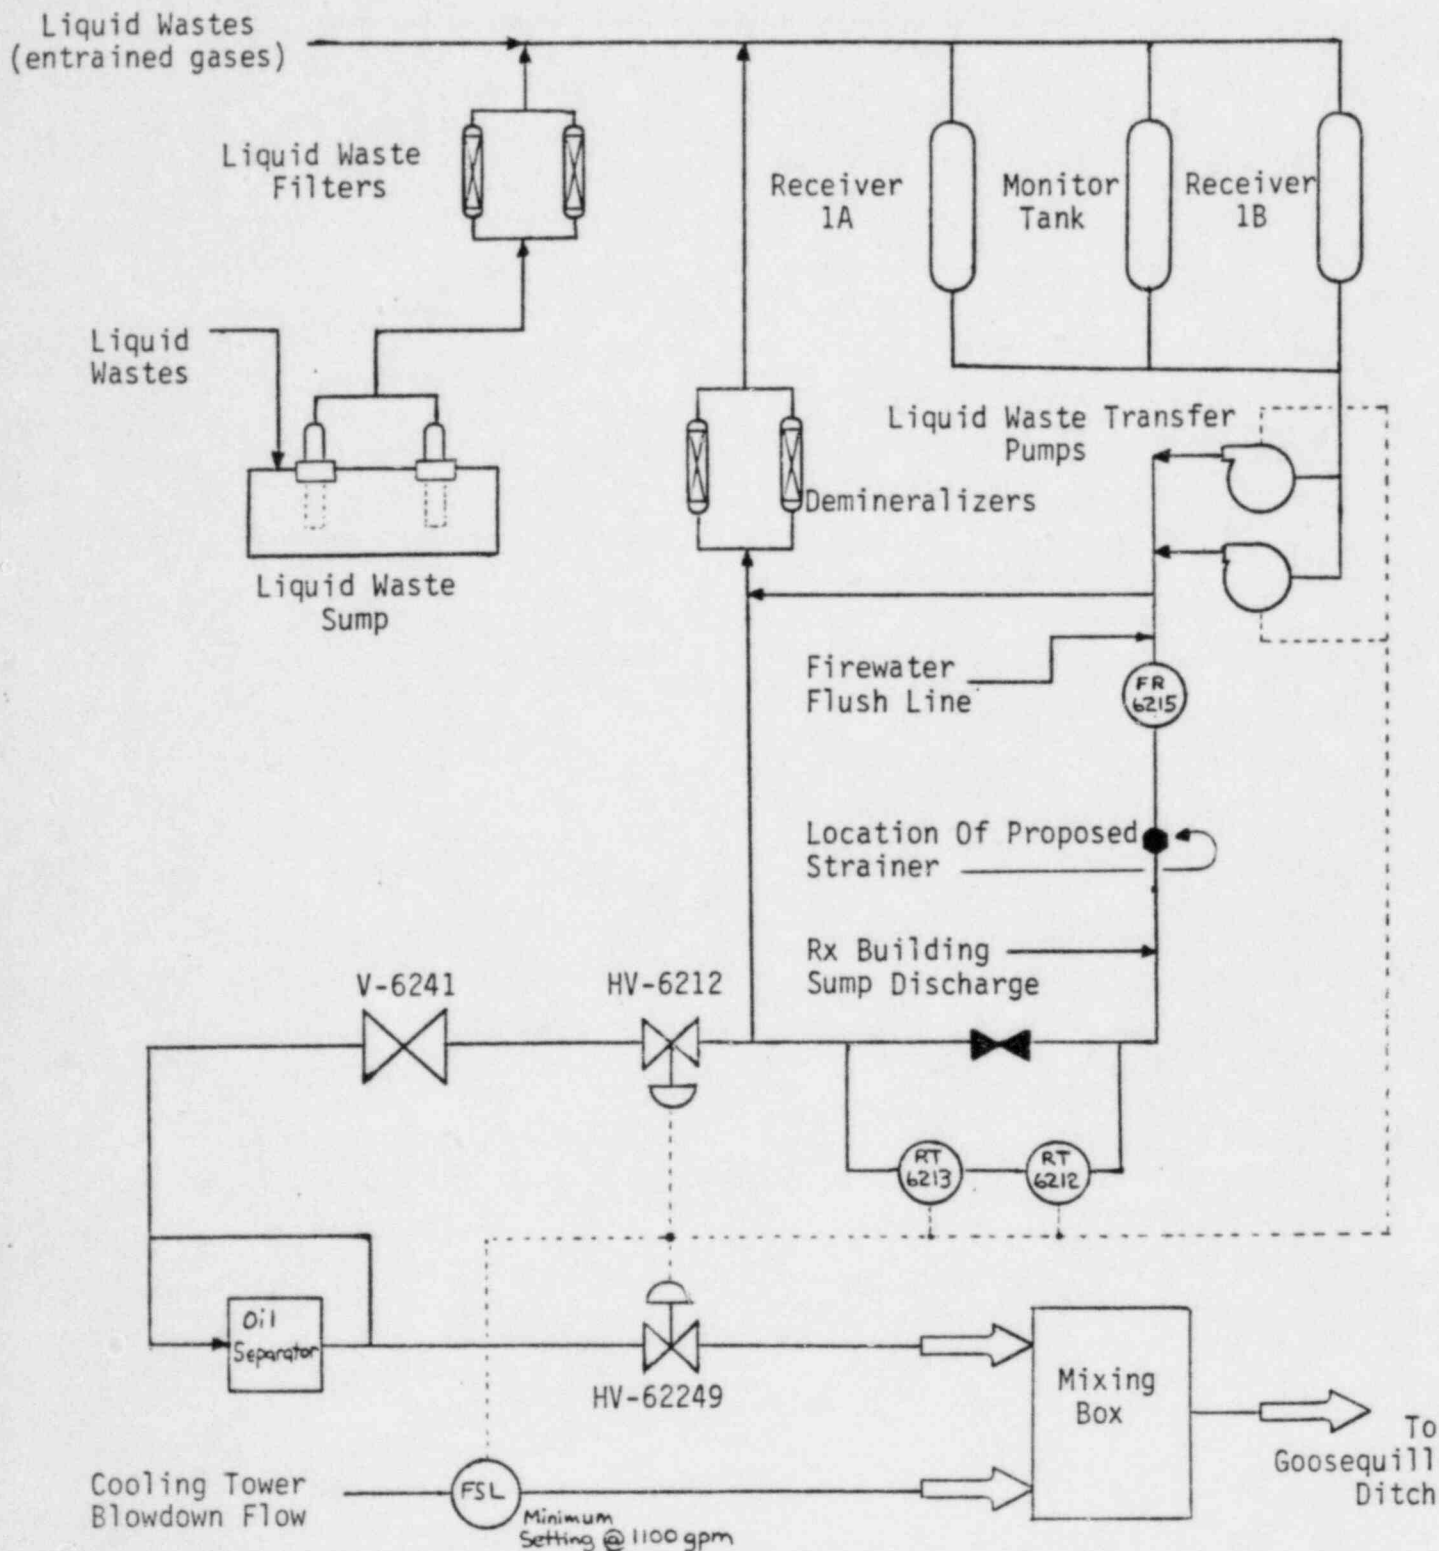
FIGURE 1.

Investigation of the incident continued with operators inspecting valve lineups and testing the isolation functions of potential flow paths. At approximately 1500 hours on March 17, 1985, operators verified that the flow path of the leak was through V-6241 (see Figure 1). This was accomplished by isolating the flow paths to the demineralizers and reactor building sump, then with V-6241 verified to be closed, the liquid waste transfer pumps were started and FR-6215 was monitored. Since operators had previously verified isolation of the flow paths to the reactor building sump and demineralizers, any flow indicated on FR-6215 would be indicative of liquid flow through V-6241. Following the start of the transfer pumps, operators verified on FR-6215 that isolation valve V-6241 was leaking through at a rate of approximately 2.0 gpm. It was noted during the investigation that prior to recirculation through the activity monitors the demineralizers had been inadvertently isolated. However, this condition is not considered to have contributed to the failure of V-6241 to isolate. These findings were reported at 1505 hours to the Shift Supervisor, who then made a Non-Emergency Event Notification to the Nuclear Regulatory Commission at 1624 hours, March 17, 1985. Following a flush of the oil separator, operators released the remaining monitor tank contents at 1213 hours on March 18, 1985, in accordance with the flow rates determined by the Radiation Protection staff calculation.

V-6241 was disassembled in order to determine the specific cause of its failure to isolate. Sediment accumulation in the valve seat was discovered and determined to have prevented proper seating of the valve disc when fully closed. Sediment was removed from the line and the internals of V-6241 were inspected for deficiencies. Valve internals were found to be in good condition, and were reinstalled into the valve body. V-6241 was then leak tested and verified to isolate as designed.

Three potential pathways exist through which sediment could enter the liquid waste discharge line. These pathways are through the reactor building sump discharge line, the firewater flush line, and the liquid waste drains to the receivers (see Figure 1).

Sediment from the reactor building sump is not expected to be significant since all liquids are filtered prior to reaching the liquid waste discharge line. However, the liquid wastes directly routed to the receivers and the firewater used to flush the system are not filtered prior to entering the liquid waste discharge line. Therefore, these two sources are suspected to have contributed to the majority of sediment into the system.

Addition of a strainer in the liquid waste discharge line has been requested and approved. This strainer will be installed upstream of V-6241 and downstream of the point where firewater enters the discharge line (see Figure 1). The filtering capability of the strainer would be such that particulate matter of significant size to affect valve operation would be collected thereby preventing sediment accumulation in the discharge line instrumentation and isolation valves. The Nuclear Engineering Division is preparing the final installation package for this strainer.
